## **GEOTECHNICAL INVESTIGATION:**

Alterations and Additions at **83-85 Bower St, Manly**

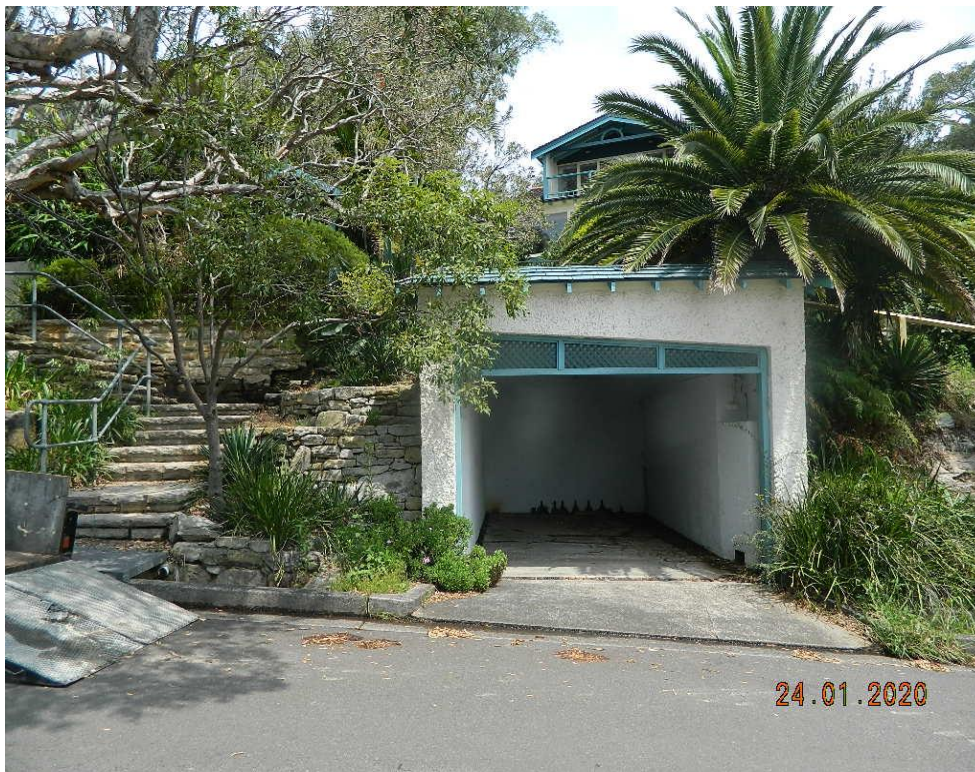
Photo 1

**2.3** At the Bower St Road Reserve is a rendered brick garage that is cut into the slope. Overall it appears stable but has some seepage issues and cracking in the floor slab (Photos 1 & 2). Sandstone stack rock retaining walls line the slope either side of the garage. Stable sandstone bedrock outcrops to the W of the garage. At the Eastern side of the road frontage sandstone steps provide access to the property. A garden bed at a landing along the stairs is formed with a sandstone block wall. The wall is supported on exposed sandstone bedrock (Photo 3). Seepage was moving over the rock at the time of the inspection. A well-constructed  $\sim 1.5\text{m}$  sandstone block retaining wall is located along downhill boundary of the property downhill of the proposed OSD tank (Photo 4).

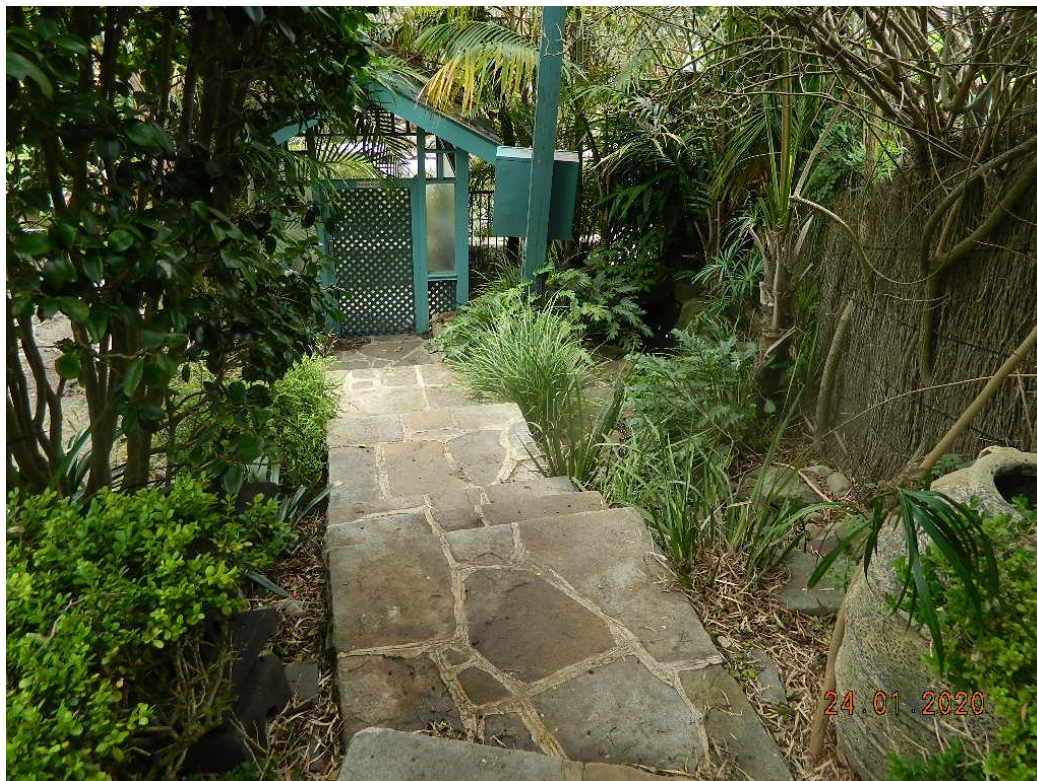
Photo 5

A stone path and steps lead up to the existing house (Photo 5). Sandstone is outcropping near the stone path (Photo 6). The existing two storey rendered brick, sandstone block wall and timber clad house is supported on brick piers, brick walls and sandstone block walls (Photos 7 to 9). The supporting piers and walls stand vertical and show no significant signs of movement (Photo 10). A timber deck is located at the NW corner of the existing house and along part of the W side of the existing house (Photo 11). At the SW corner of the property is a gently sloping lawn (photo 12). S of the deck is the existing pool and cabana (Photo 13). A stable sandstone retaining wall supports the slope S of the pool and a stack rock retaining wall terraces the slope to the W of the pool. A shared concrete parking area, with a rendered brick and timber clad garage is located at the Montpelier Place vehicle entrance (Photo 14).

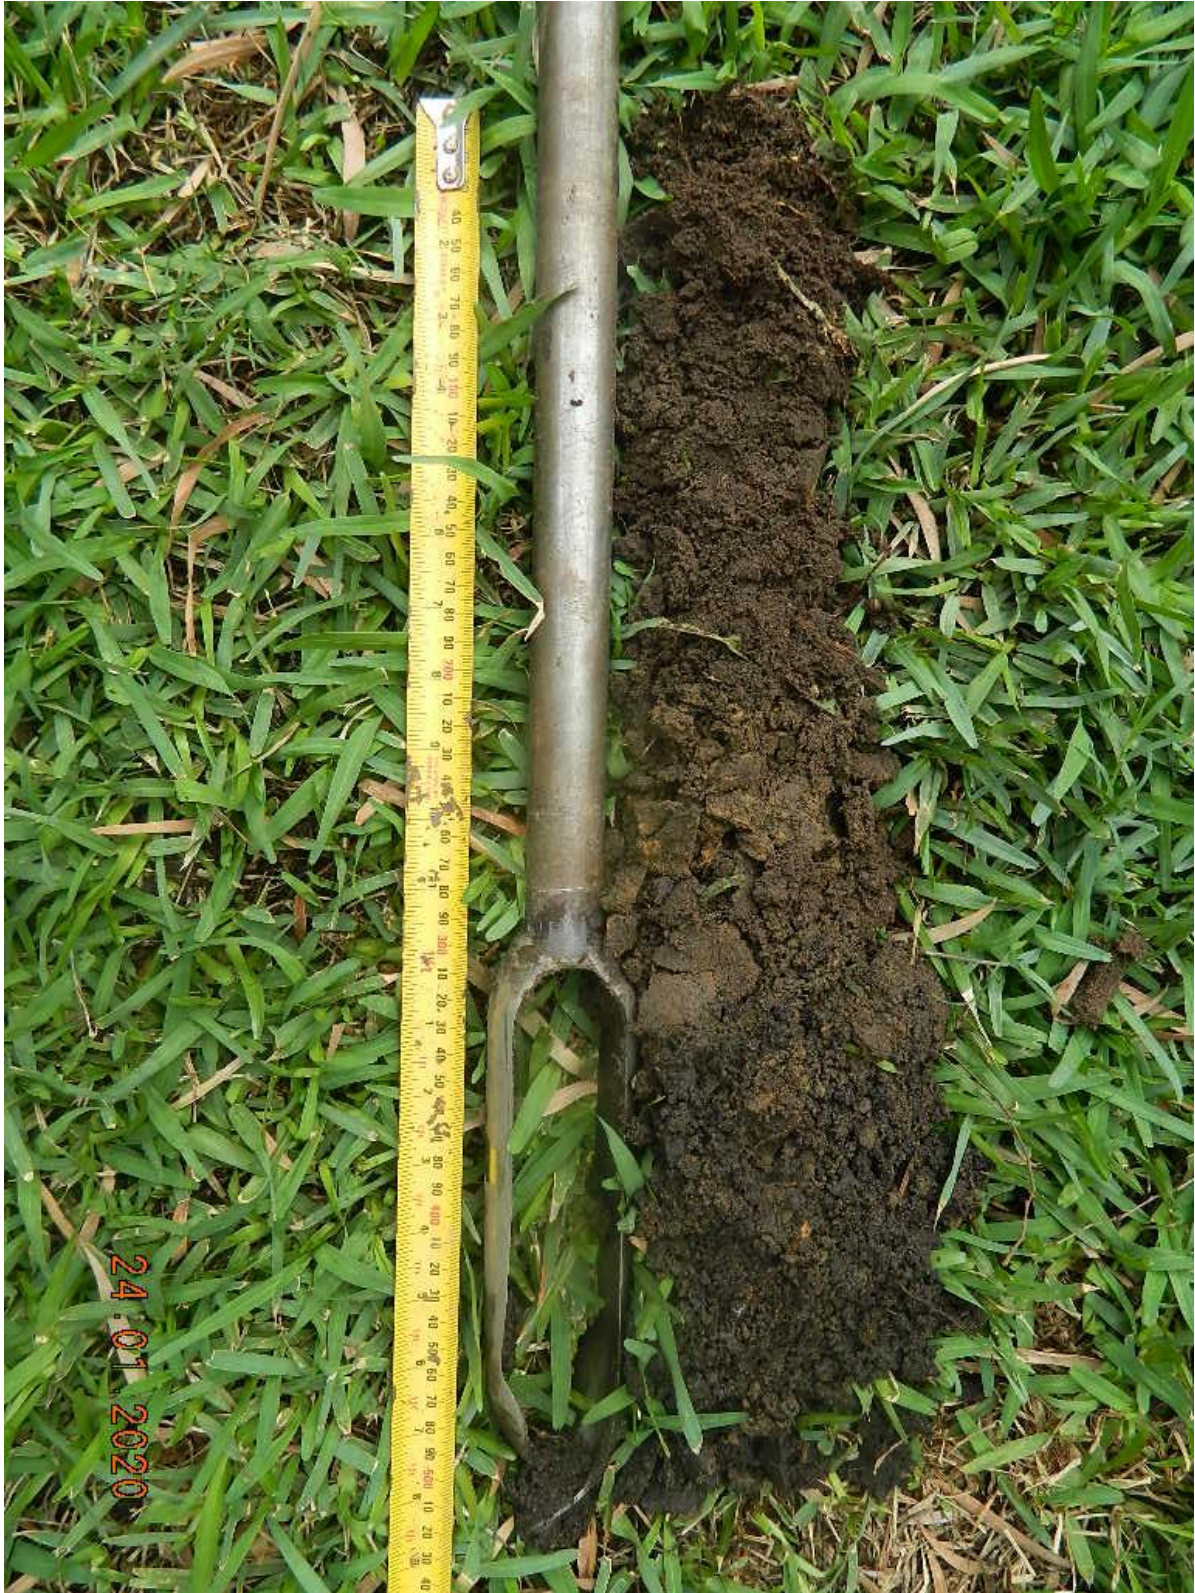
#### AUGER HOLE 1 (~RL22.3) – AH1 (photo 15)

| Depth (m) | Material Encountered |
|---|---|
| 0.0 to 0.3 | <b>SANDY SOIL</b> , brown, fine to medium grained, moist. |
| 0.3 to 0.5 | <b>SANDY SOIL</b> , grey, fine to medium grained, moist. |

Refusal @ 0.5m in Sandy Soil. No watertable encountered.

Photo 15: AH1 – Downhole is from top to bottom

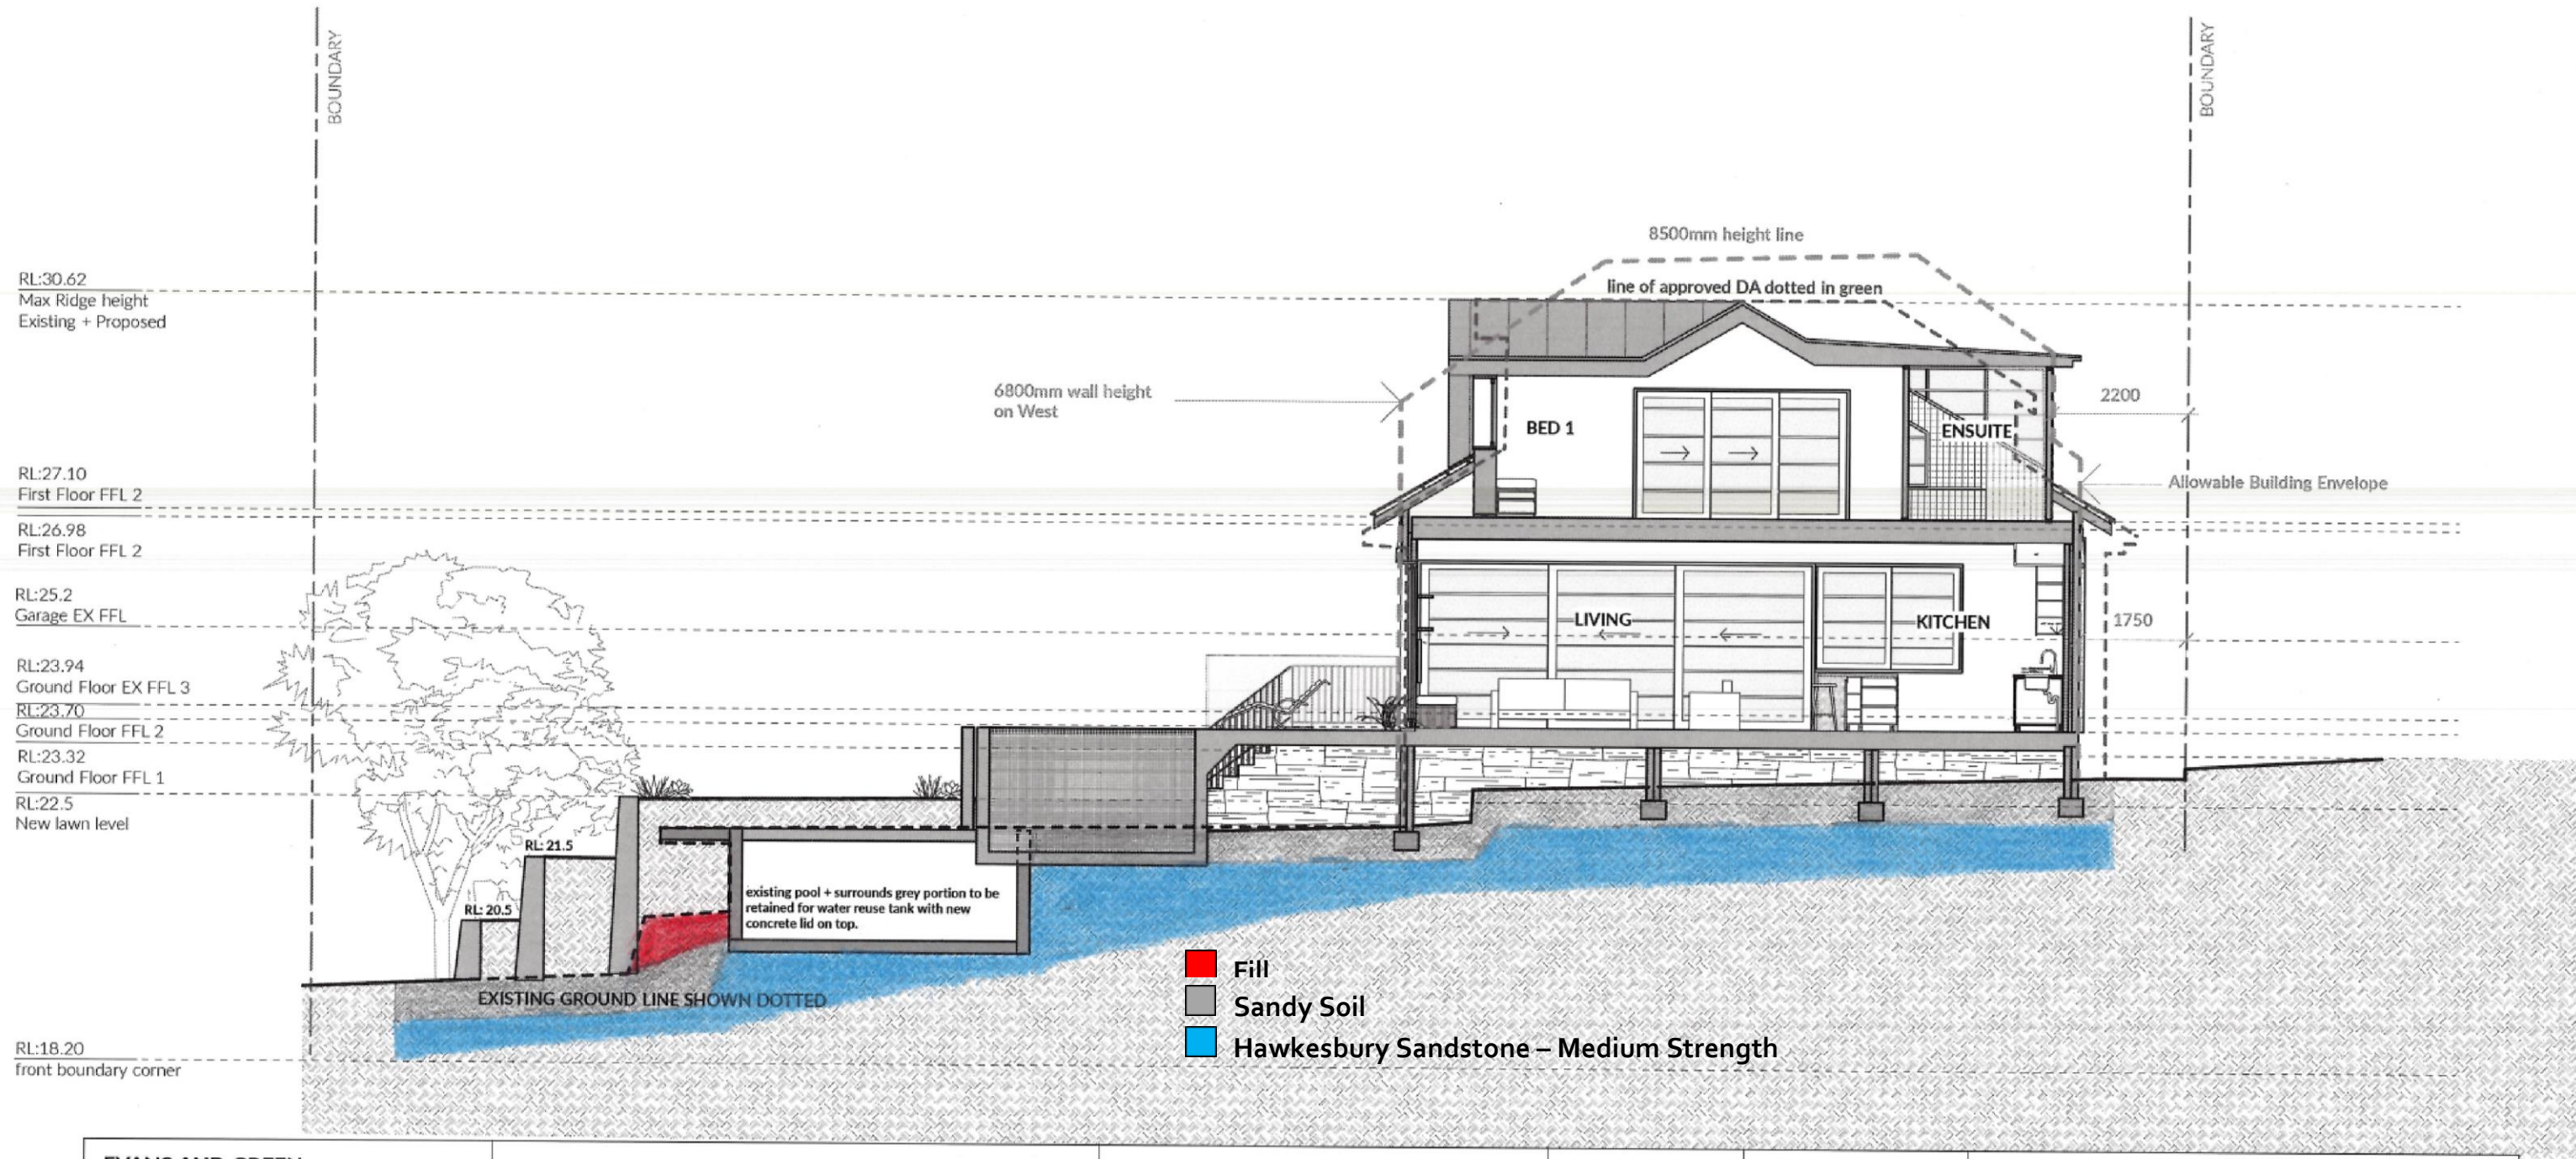
# TYPE SECTION – Diagrammatical Interpretation of expected Ground Materials

The surface features of the block are controlled by the underlying sandstone bedrock that steps down the property forming sub-horizontal benches between the steps. Where the grade is steeper, the steps are larger and the benches narrower. Where the slope eases, the opposite is true. The rock is overlain by sandy soil that fills the bench step formation. In the test locations, the depth to rock ranged between 0.5m to 0.6m below the current surface of the proposed works. The sandstone underlying the property is estimated to be medium strength or better. See Type Section attached for a diagrammatical representation of the expected ground materials.
