20 July 2022

CES Document Reference: CES220609-SHB-AA

RE: Proposed Residential Development at No.20 The Esplanade, Narrabeen NSW 2101 – Geotechnical Investigation and Slope Stability Assessment Report

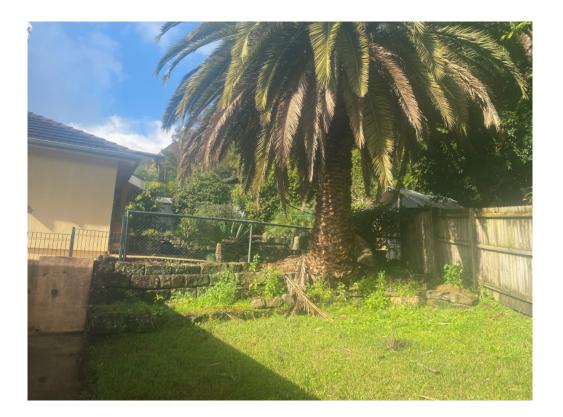
View at the backyard of HA02 location at the south-east corner where the large palm tree exists.

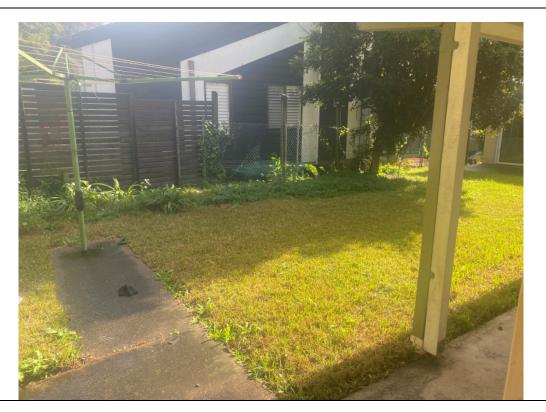
04/07/2022
 2

View at the backyard looking west, with paved footpath.

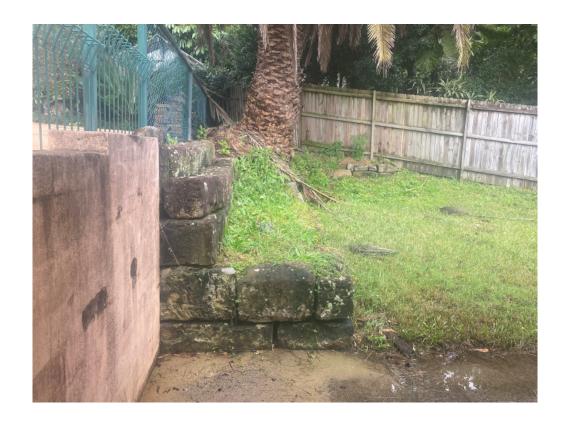
View of the wall separating the site and No.18 The Esplanade, looking south.

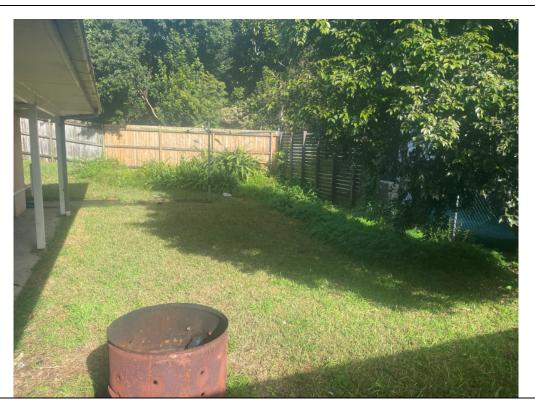
04/07/2022
 4

View of the lawn at the backyard, looking east.

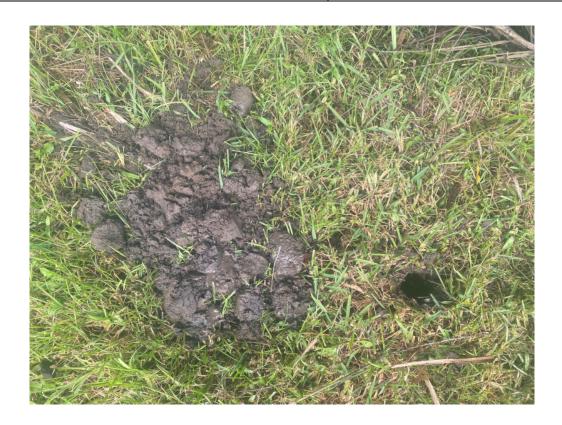
Wet soils were recovered in both boreholes and thus groundwater has been inferred to be present at shallow depths. Both boreholes were terminated at 1.5m due to hole collapse. It should be noted that rainfall occurred on the day of fieldwork investigation.

View of recovered subsurface materials from HA02.

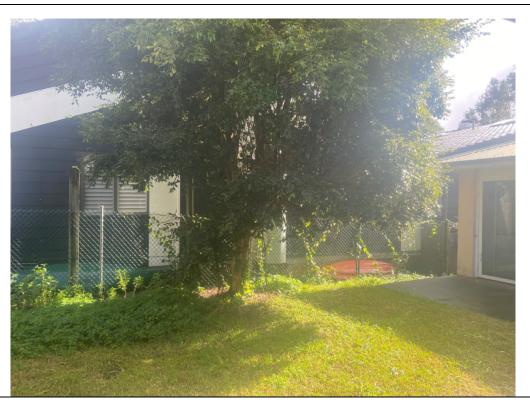
04/07/2022 6

View of the tree at the backyard, looking west.
