Report Title: Geotechnical Report 71 Florida Road, Palm Beach  
Report Date: 4/11/24

## **GEOTECHNICAL INVESTIGATION:**

New House at **71 Florida Road, Palm Beach**

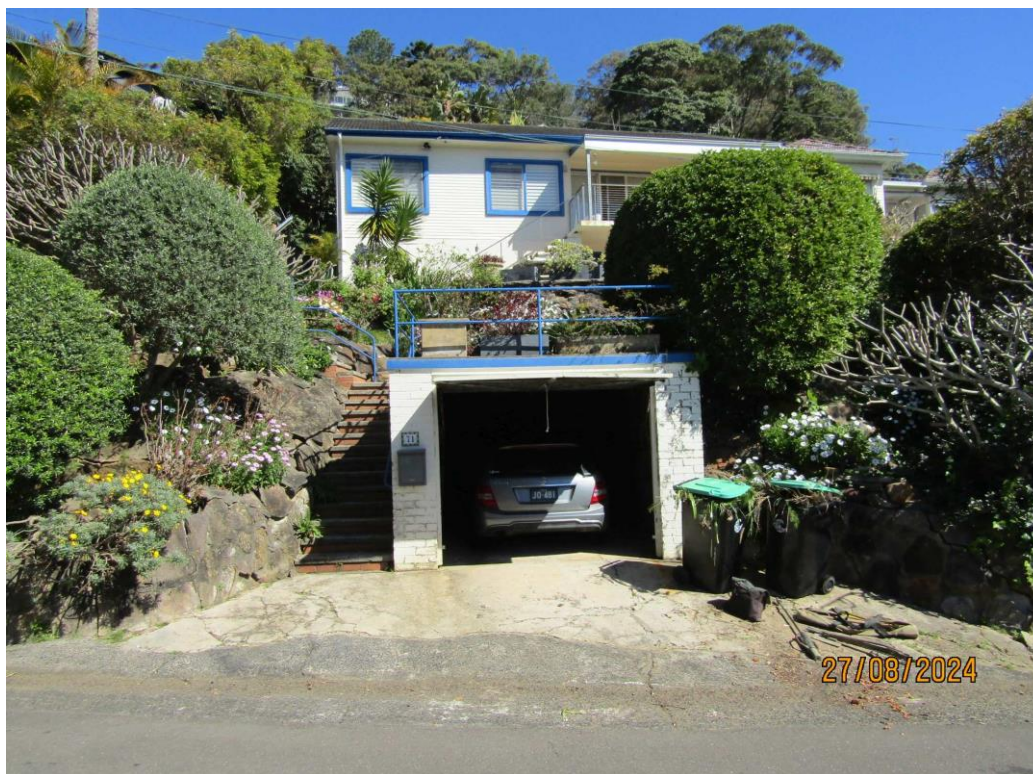
Photo 1

- 2.3** At the road frontage, a concrete driveway runs to a brick garage that is cut into the slope (Photo 1). The garage displays some horizontal cracking but will be demolished as part of the proposed works. Low sandstone flagging and stack rock retaining walls line cut and fill batters beside the garage and at the downhill and uphill sides of the house (Photos 1 to 3). The sandstone flagging beside the garage and at the downhill side of the house displays stepped and vertical cracking, but the majority

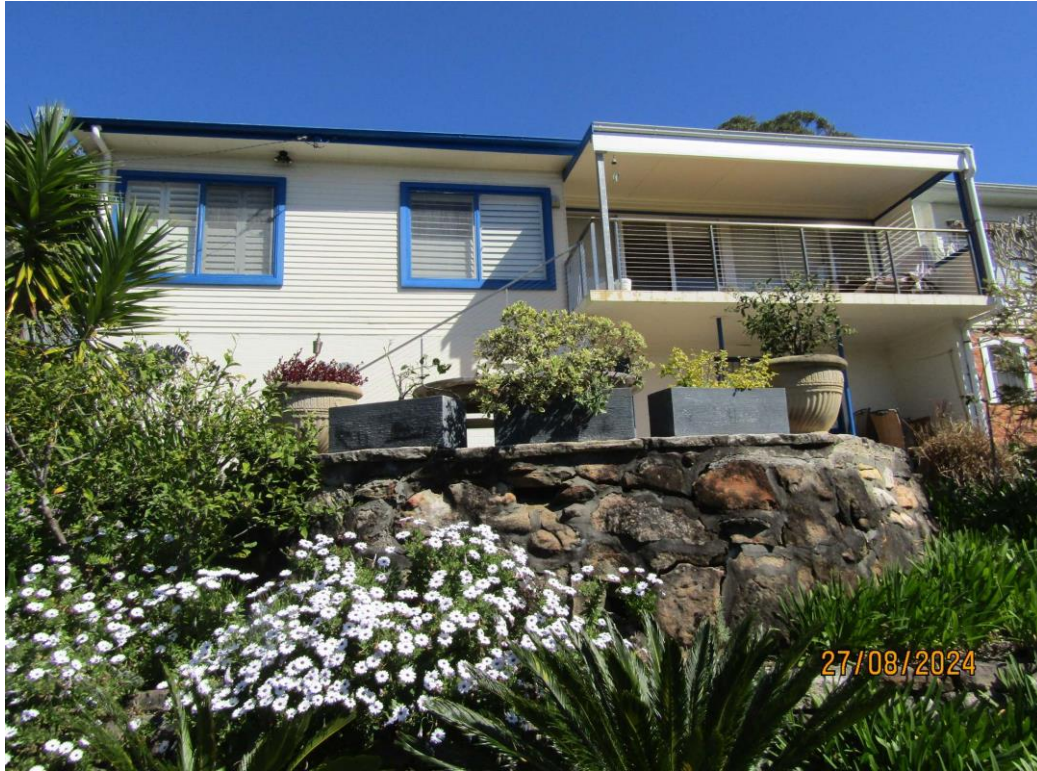
Photo 3

of the flagging will be demolished as part of the proposed works. The two storey house is supported on brick walls (Photos 3 & 4). The external supporting walls show no significant signs of movement. Medium Strength Sandstone bedrock outcrops near the uphill side of the house and near the uphill property boundary (Photos 5 & 6). The adjoining neighbouring properties were observed to be in good order as seen from the street and subject property.

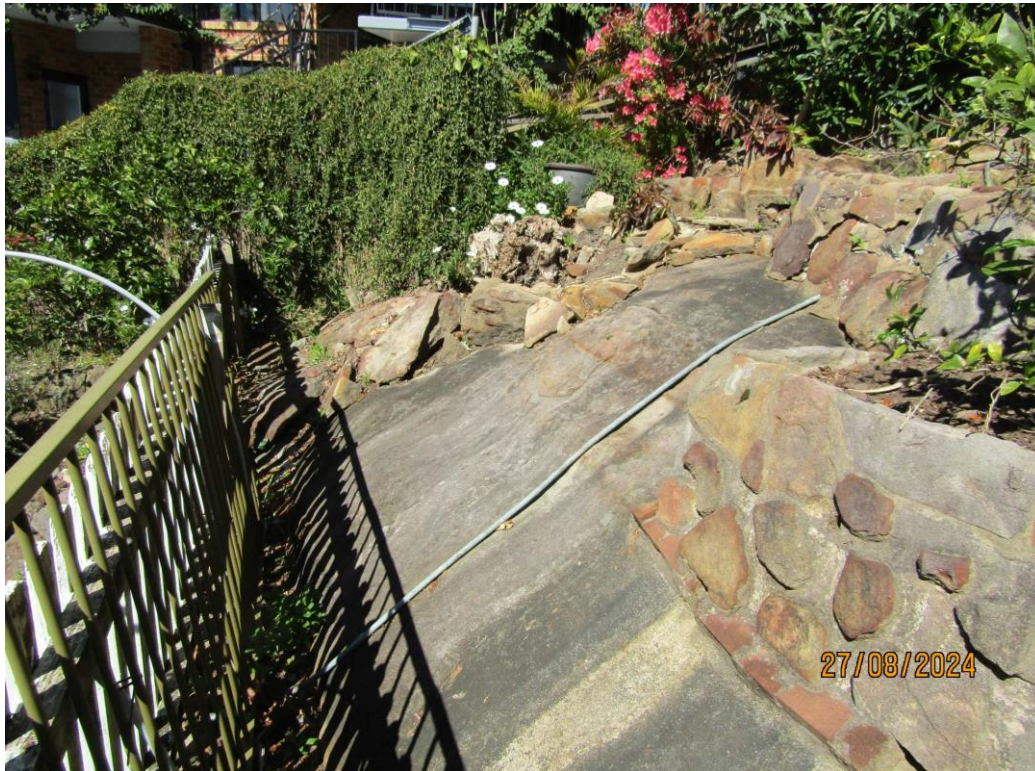
Photo 5

- The garage portion of the excavation is set back ~0.5m from the E common boundary.
- The lower ground floor portion of the excavation comes close to flush with the E common boundary and ~0.5m from the W common boundary.
- The upper ground floor portion of the excavation comes close to flush with the W and E common boundaries, but Medium Strength Sandstone is exposed at the current surface (Photo 5).

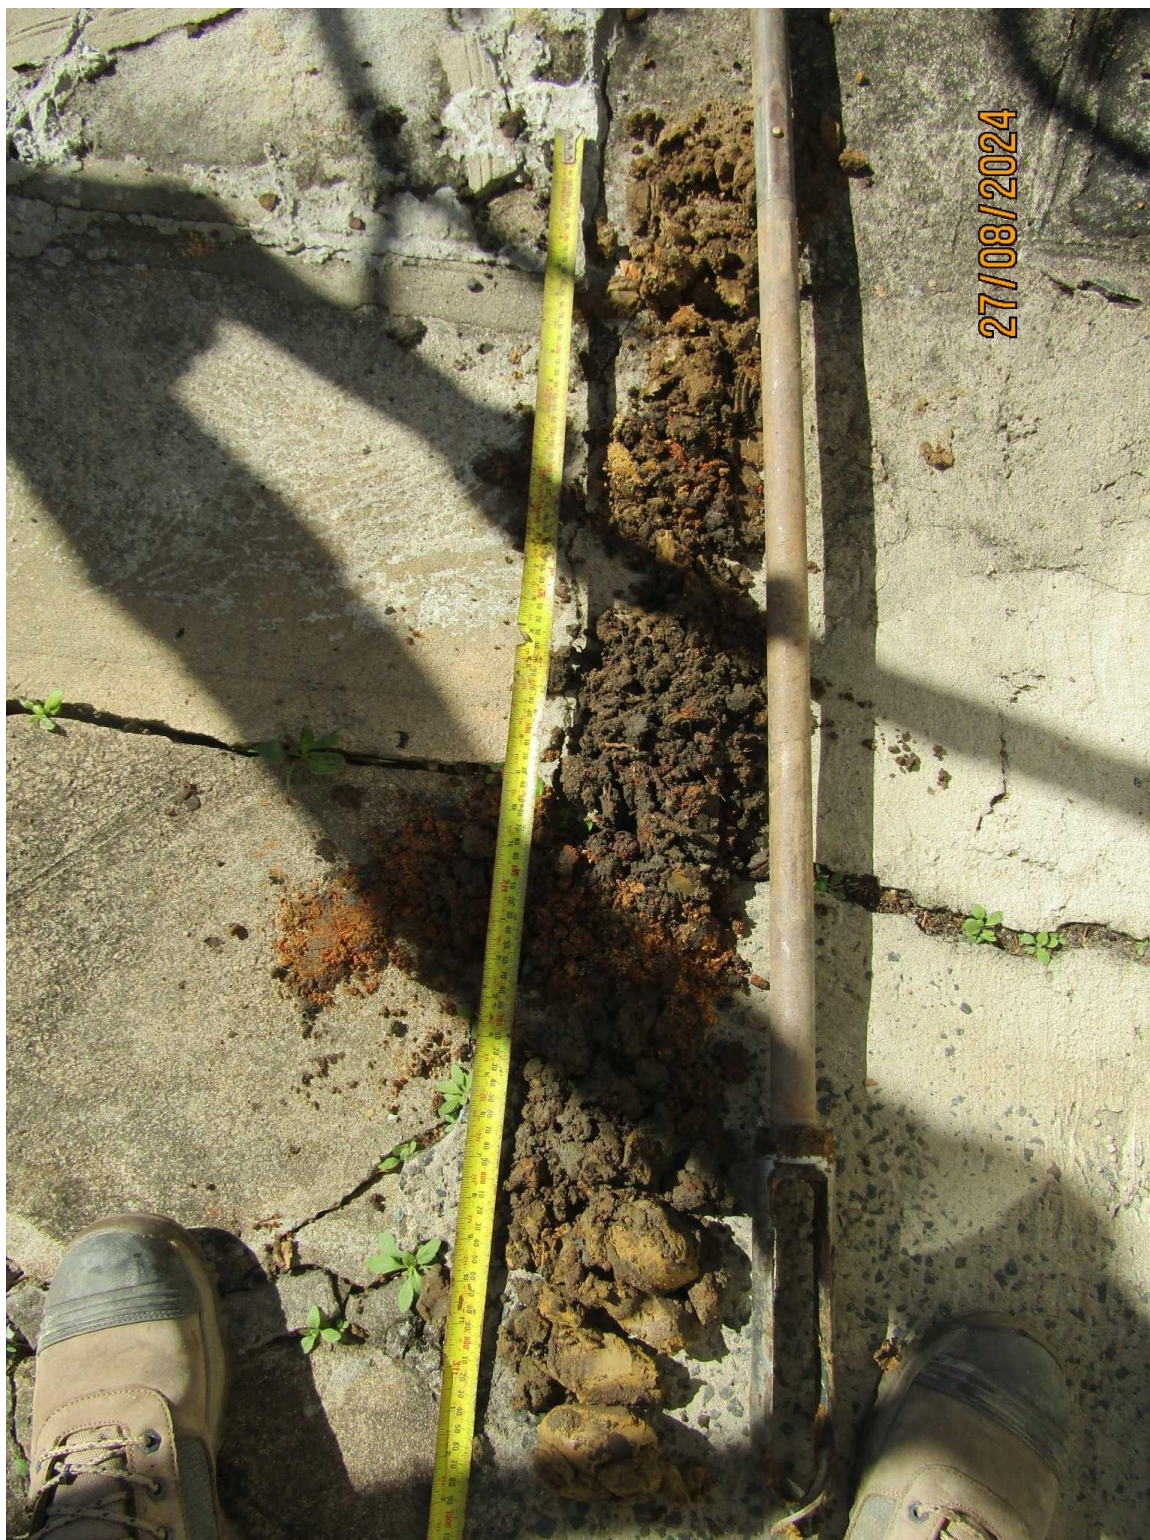
## AUGER HOLE 1 (~RL28.6) – AH1 (Photo 7)

| Depth (m) | Material Encountered |
|---|---|
| 0.0 to 0.4 | <b>FILL</b> , soil, sand and clay, with some rock fragments, brown, dark brown, orange, moist, fine to coarse grained. |
| 0.4 to 0.8 | <b>TOPSOIL</b> , sandy soil and sand, dark brown, orange, moist, fine to medium grained. |
| 0.8 to 1.0 | <b>CLAY</b> , yellow brown, firm to stiff, moist. |

End of hole @ 1.0m in firm to stiff clay. No water table encountered.

Photo 7: AH1 – Downhole is from top to bottom.

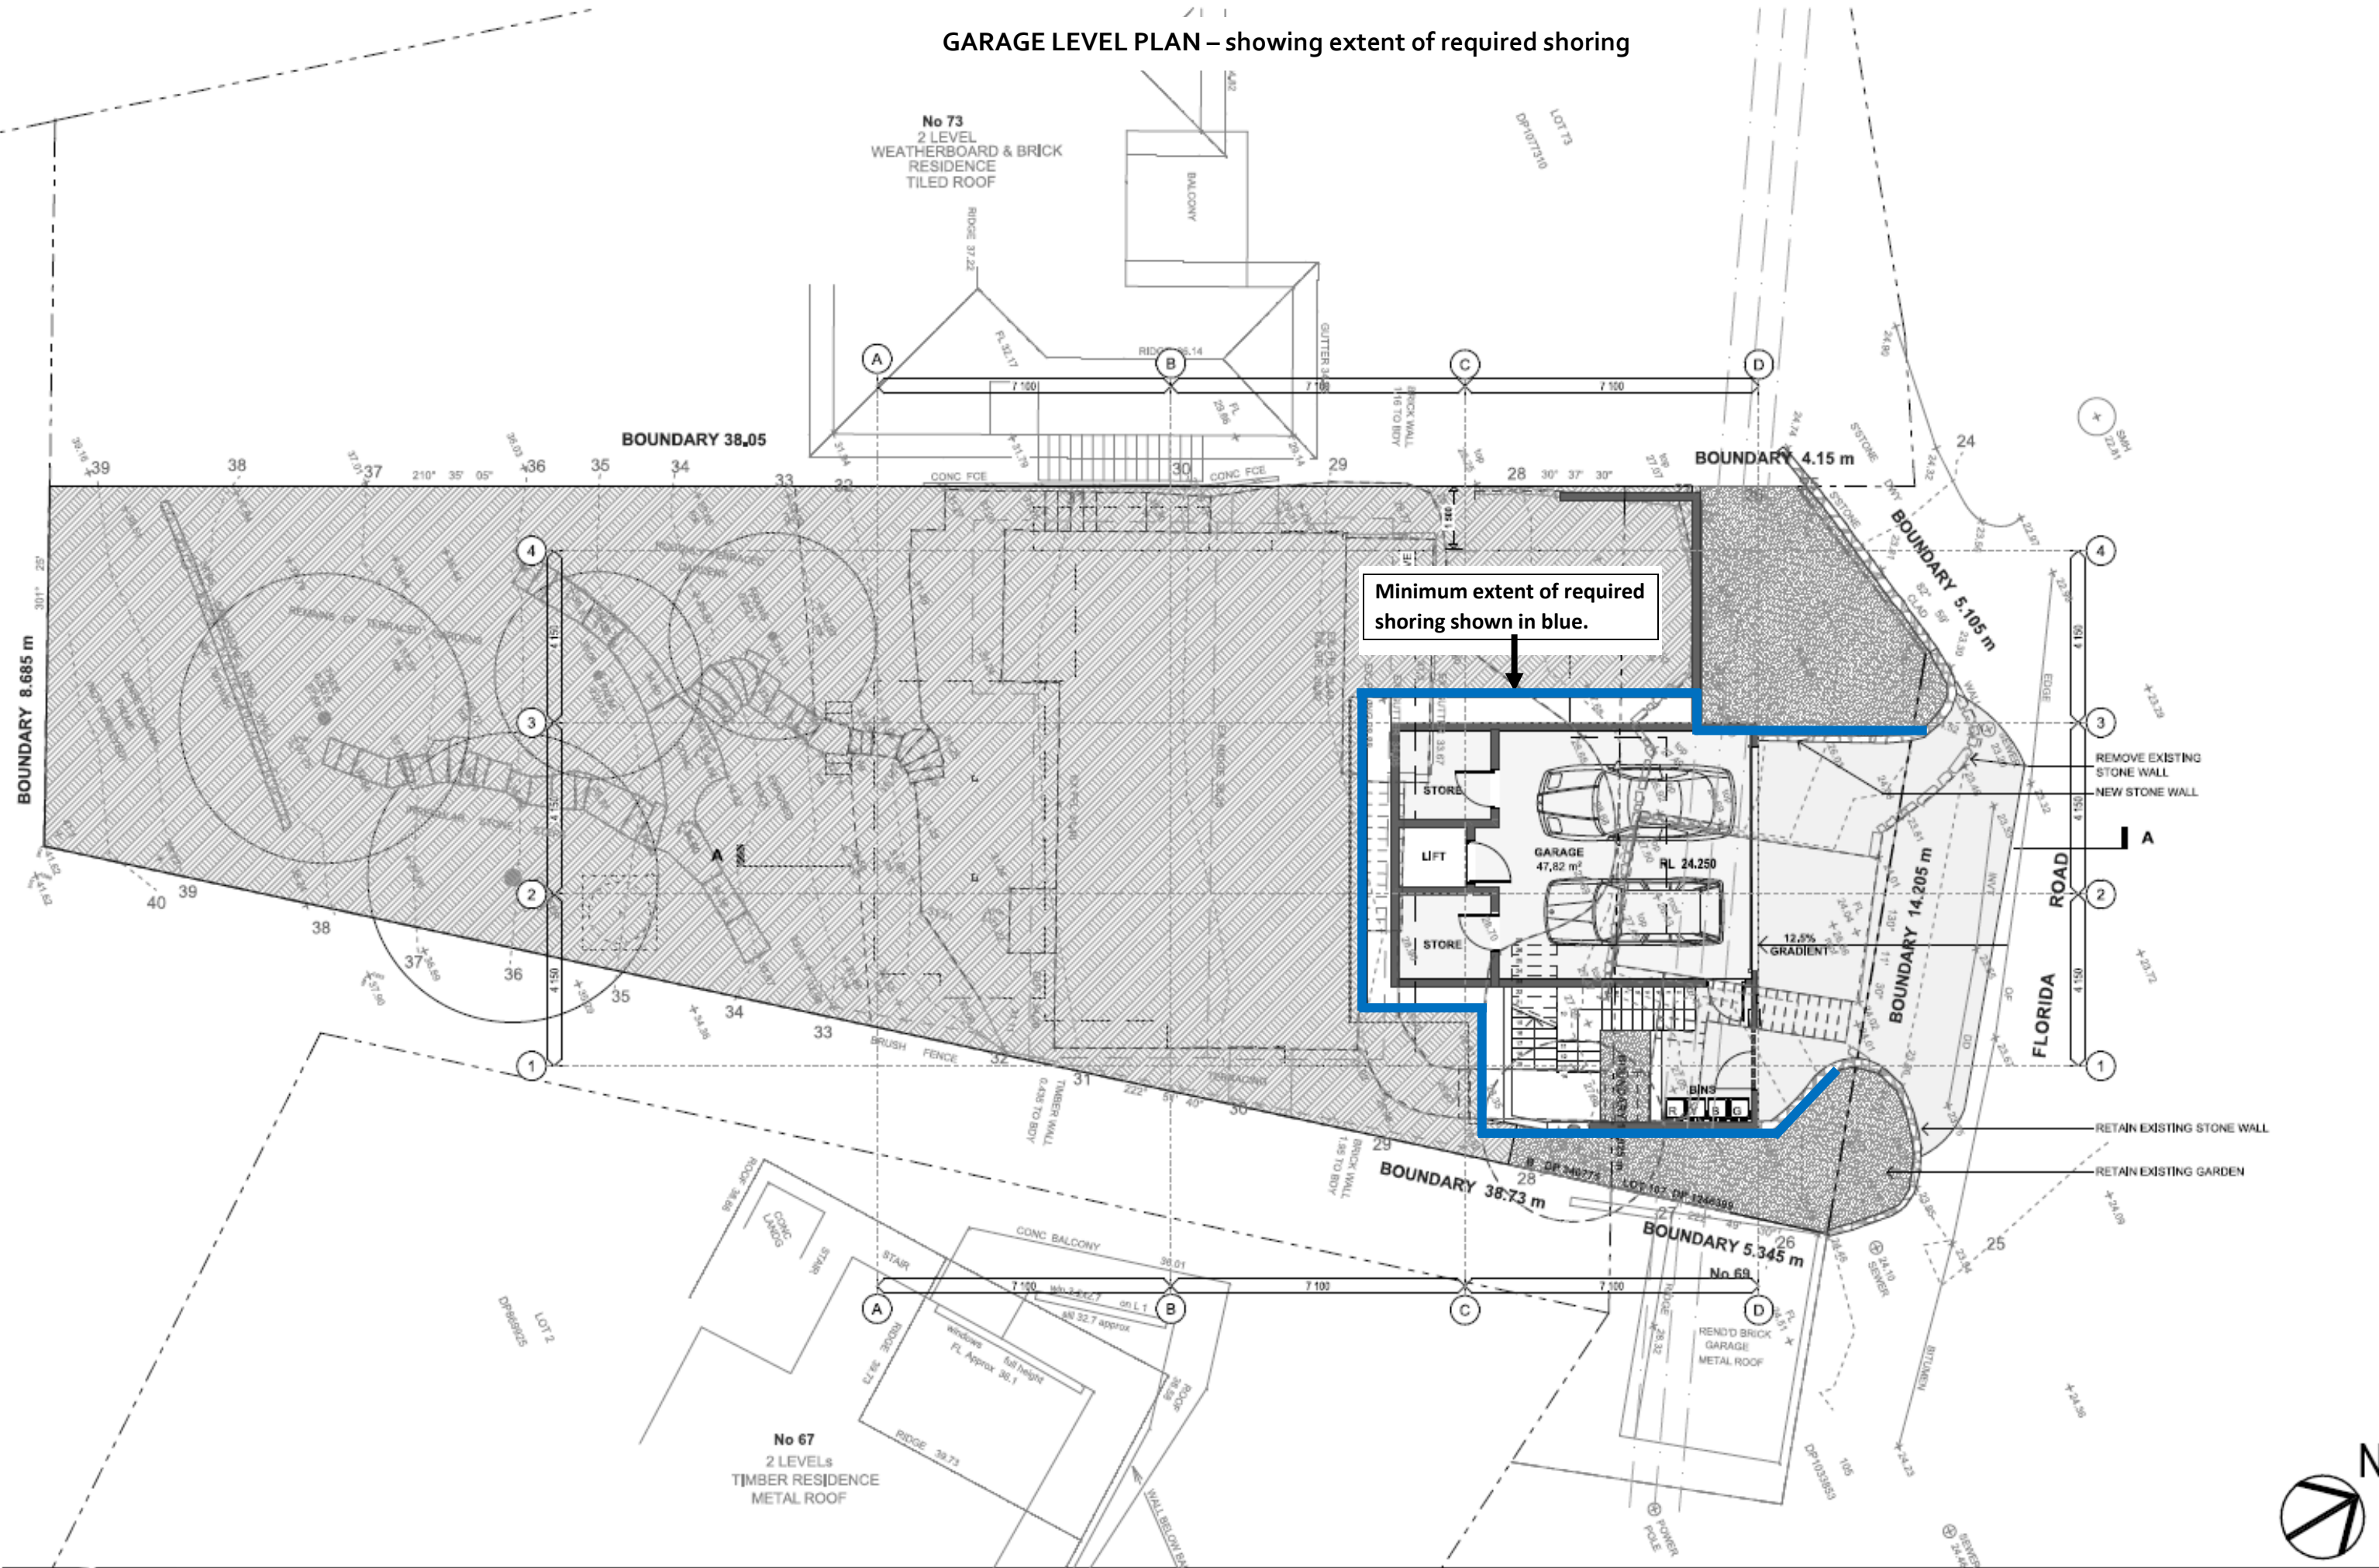
GARAGE LEVEL PLAN – showing extent of required shoring

The E common boundary will be within the zone of influence of the garage and lower ground floor portions of the excavation. The W common boundary will be within the zone of influence of the lower ground floor portion of the excavation

In this instance, the zone of influence is the area above a theoretical 30° line (from horizontal) through fill/soil and a 45° line through clay / weathered rock from the base of the excavation or the top of Medium Strength Rock, whichever comes first, towards the surrounding structures and boundaries.

Due to the depth of the excavation and its proximity to the common boundaries, all sides of the garage and lower ground floor portions of the excavation will require ground support prior to the commencement of the excavation. See the Garage Level and Lower Ground Floor plans attached for the minimum extent of the required shoring shown in blue.

A spaced pile retaining wall is one of the suitable methods of support. Pier spacing is typically ~2.0m but can vary between 1.6 to 2.4m depending on the design. As the excavation is lowered in 1.5m lifts, infill sprayed concrete panels or similar are added between the piers to form the wall. Drainage is to be installed behind the panels. To drill the pier holes for the walls, a pilling rig that can excavate through Medium to High Strength Rock will be required. If a machine of this type is not available, we recommend carrying out core drilling before the

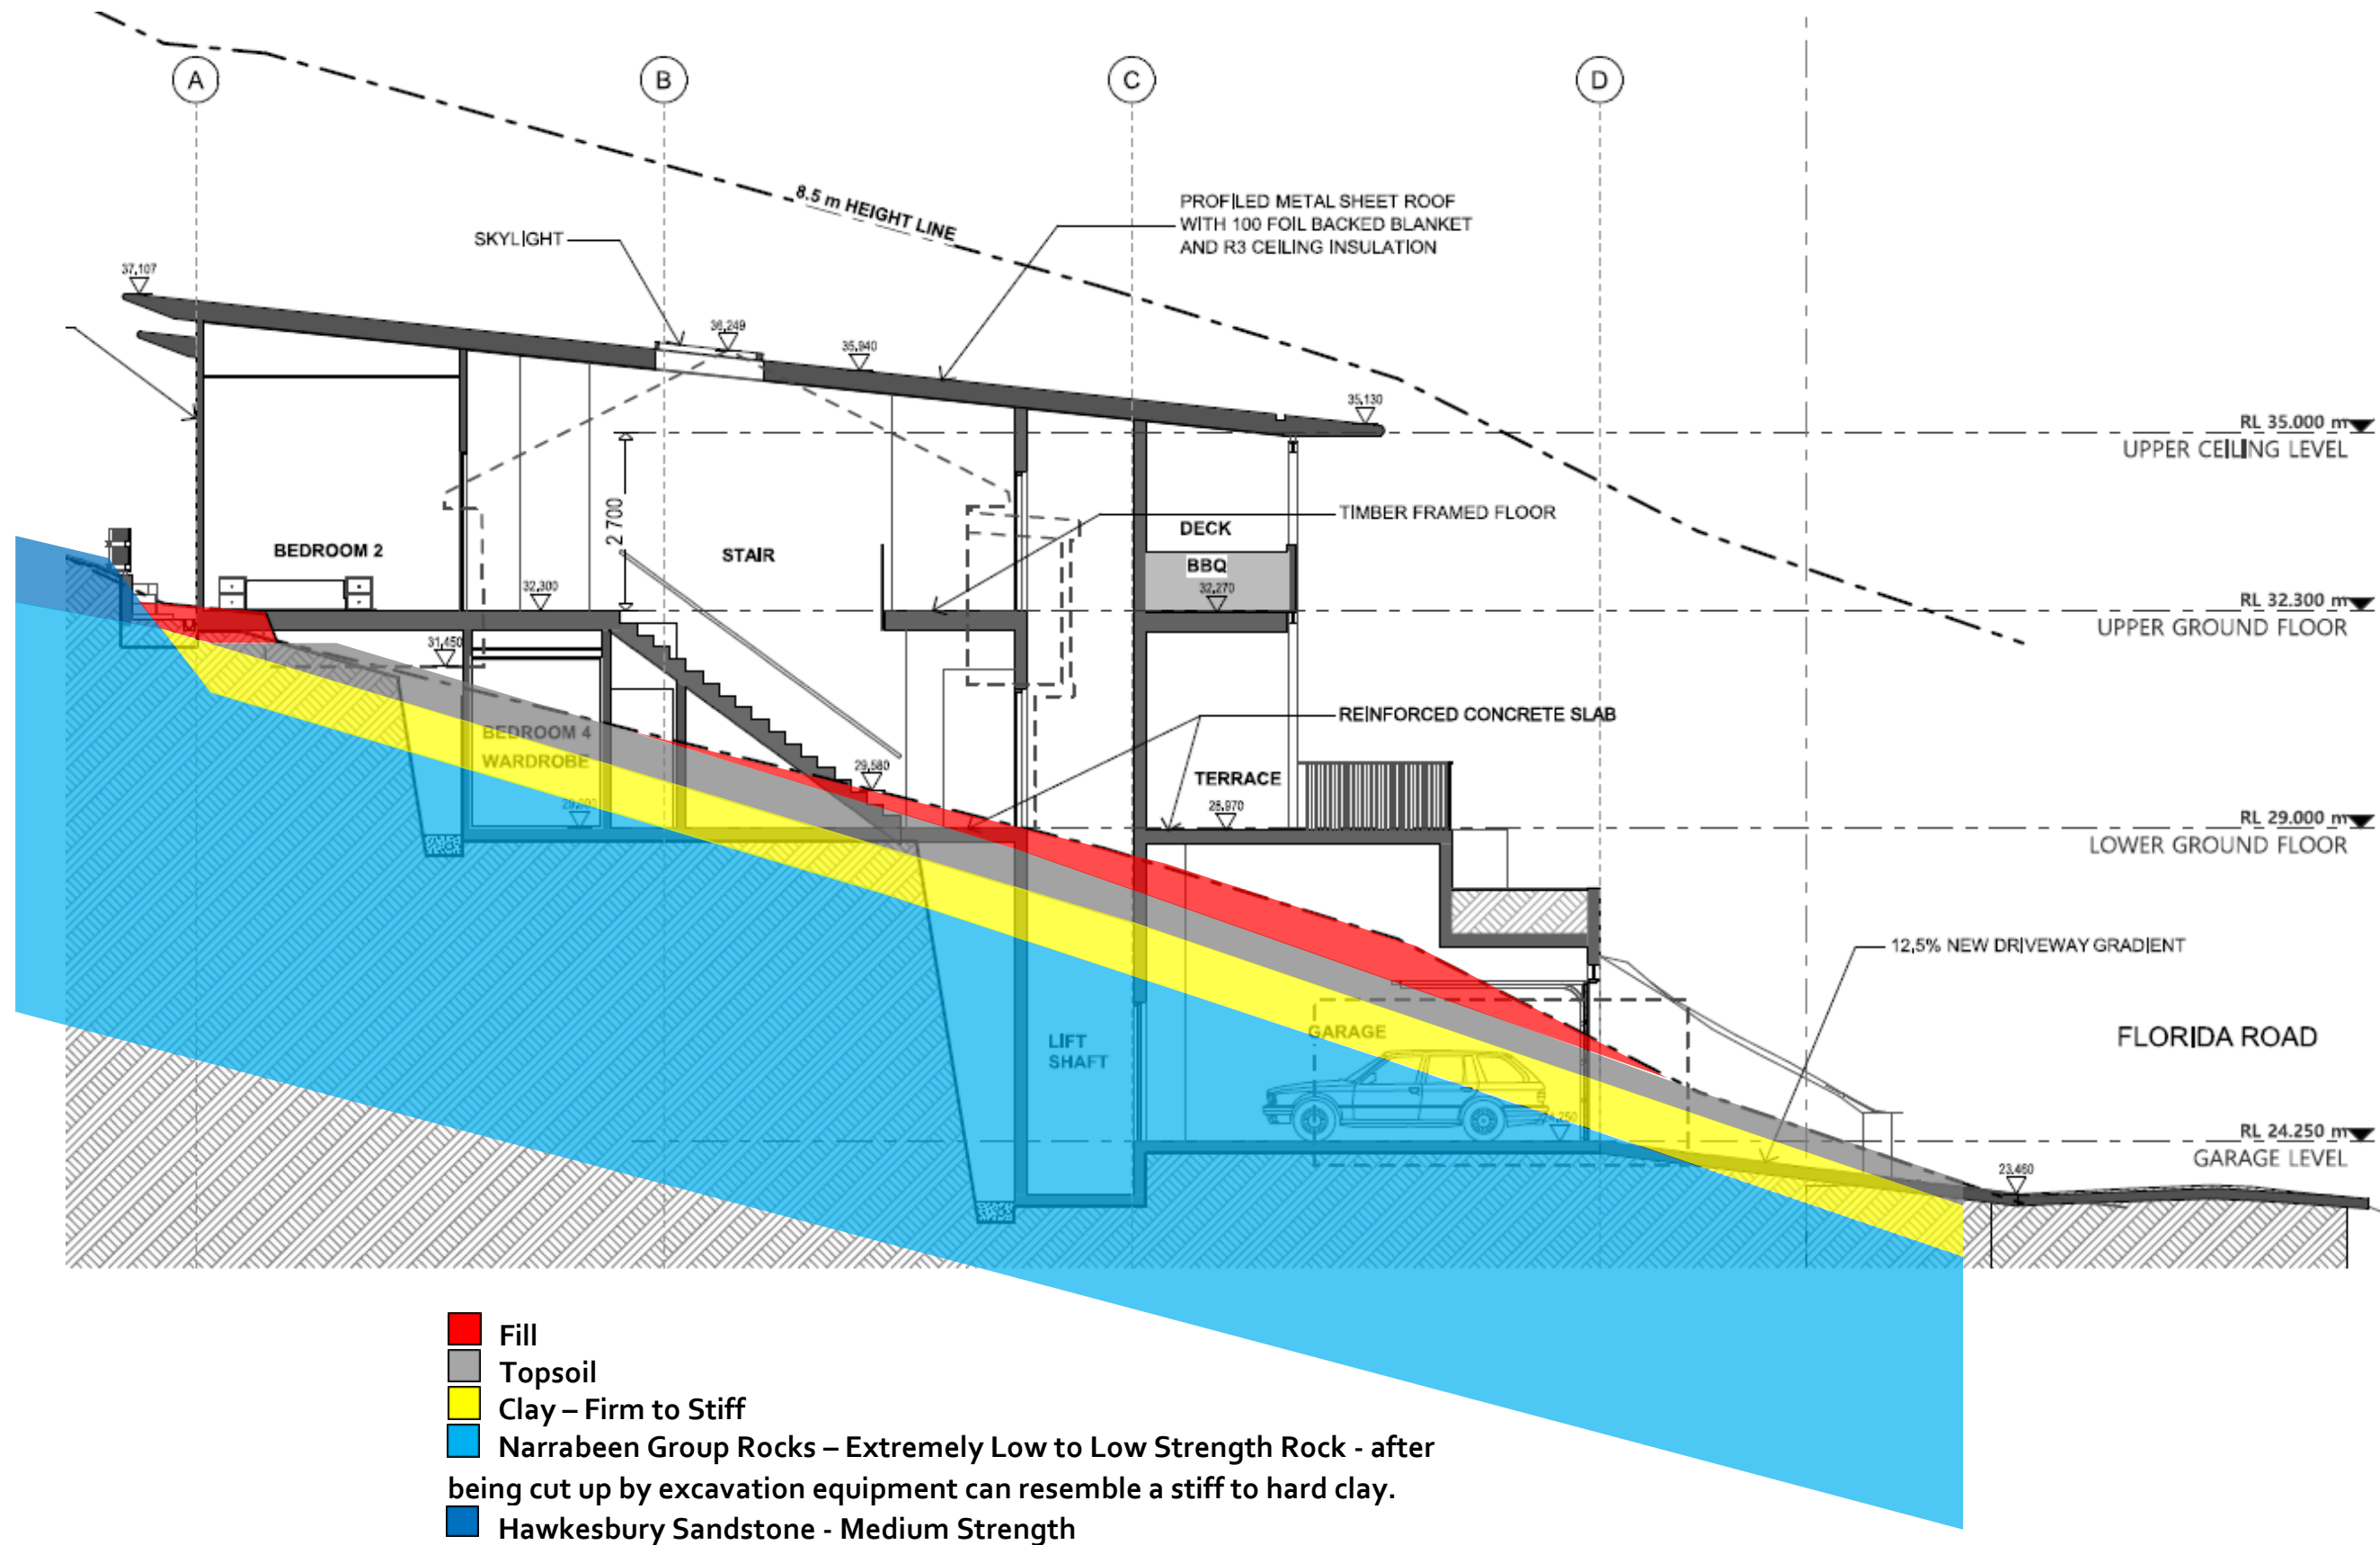
TYPE SECTION – Diagrammatical Interpretation of expected Ground Materials

The upper half of the property is underlain by fill and topsoil over Medium Strength Sandstone bedrock that was exposed at the surface in the locations of DCPs 1 & 2. The contact between Hawkesbury Sandstone and the Narrabeen Group Rocks is interpreted to be near the uphill side of the existing house. The majority of the proposed works are interpreted to be underlain by the Narrabeen Group Rocks. We point out around the contact of two rock types (sandstone & shale) the rock can be variable and associated with higher groundwater seepage.

The lower half of the property is underlain by fill, topsoil, and clay over weathered rock. In DCPs 3 to 5, the clays merge into the weathered zone of the underlying rock at depths of between ~1.0m to ~1.5m below the current surface. The weathered zone of the underlying rock is interpreted as Extremely Low to Low Strength Rock. It is to be noted that this material is a soft rock and can appear as a mottled stiff clay when it is cut up by excavation equipment. See Type Section attached for a diagrammatical representation of the expected ground materials.
