# TREE INSPECTION REPORT.

**On: Tree Specimen**

**Location: 79 Ashworth Avenue  
Belrose NSW 2085**

For. Mr. Luca Mastroianni  
On. 28/4/2025 amended 18/7/2025

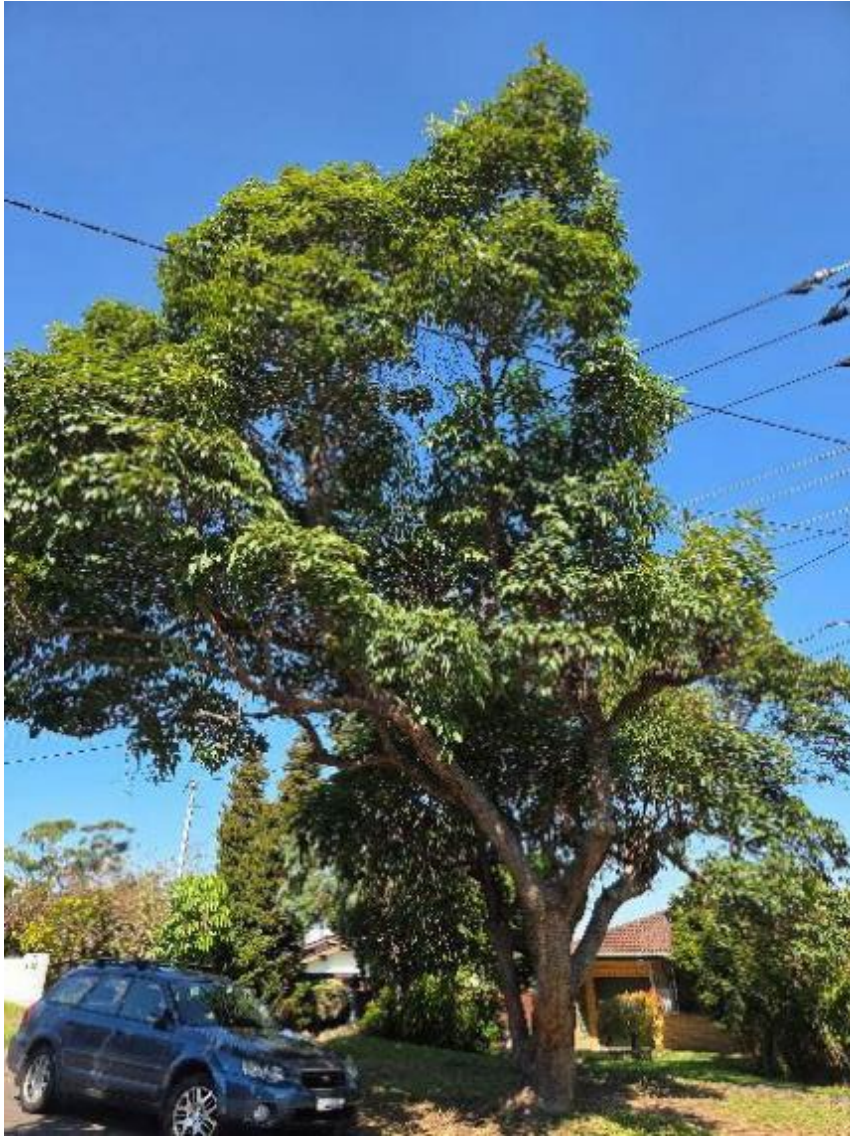
**4.1** Tree **T1** is a *Lophostemon confertus* or 'Queensland Brushbox' which is a native species endemic to Northern NSW and Southern Queensland. The tree has been planted in the nature strip to the North of the Site (see Fig. 2).

The tree was in good health and vigour at the time of inspection and has been subjected to regular pruning to accommodate power lines.

Tree **T1** will now be totally engulfed by the new single driveway and footpath crossover which will service both units.

Fig. 2. Photo of tree T1 a *Lophostemon confertus*

**5.1 T1** will need to be removed and replaced with two small to medium sized trees such as a *Callistemon viminalis* (Weeping Bottlebrush) or a *Tristainiopsus laurina* (Water Gum) to be positioned to the left and right of the new driveway crossover.

- 6.2** Given the constraints posed by Council's street tree **T1** Council has agreed to remove this tree and replace it with an appropriate specimen in keeping with Council's Street Tree strategy (See Appendix 4).  
Further to this it is recommended that the neighbour at 83 Ashworth Avenue be contacted in regard to the removal of tree **T19**, a *Ficus microcarpa* which is an exempt species that can grow into a large specimen with very invasive root system. The reason for its removal is that it can cause damage to both the dwellings at 83 Ashworth and the proposed dwelling at 79 Ashworth.

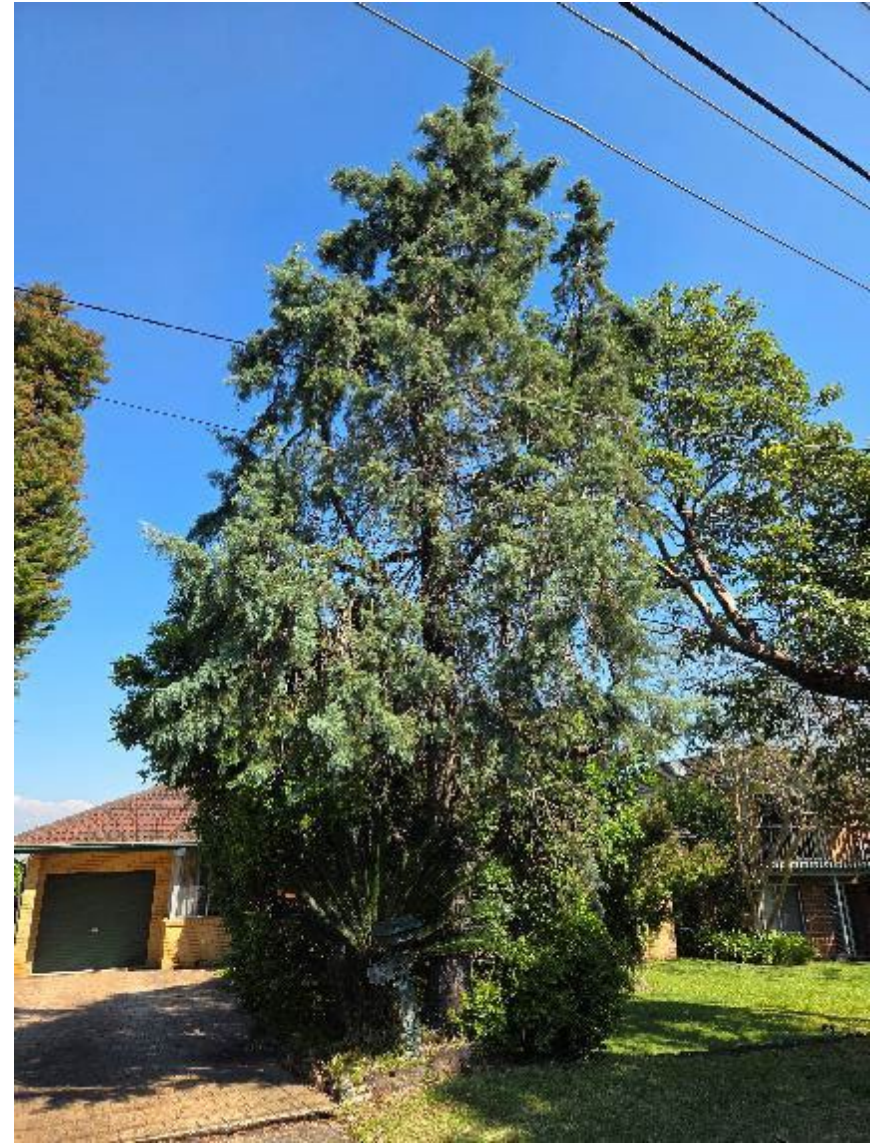
**4.2** Tree **T2** is a *Cupressus lusitanica* or 'Mexican Pine' which is an exotic conifer endemic to Central America. The tree has been planted in the front yard in the Northern portion of the Site to the right hand side of the existing driveway (see Fig. 3).

The tree was in good health and vigour at the time of inspection. Further it is noted that *Cupressus* species are listed in NBC's list of undesirable species and are exempt from protection in the TVP controls.

Fig. 3. Photo of T2 a *Juniperus chinensis*

Tree **T2** is scheduled to be removed in the new landscaping plan for the Site and is proposed to be replaced with new vegetation (See Appendices 2b & 2c).

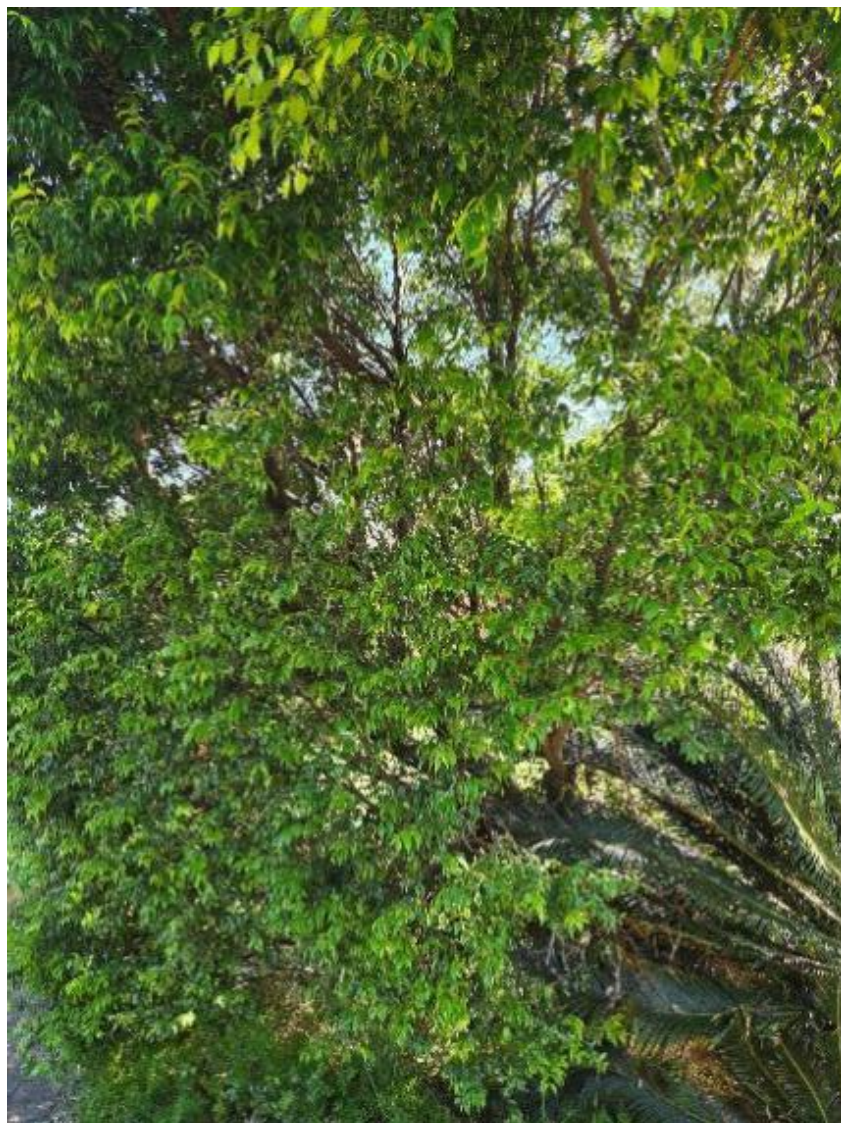
**4.3** Tree **T3 & T6** are both *Syzygium leuhmannii* or 'Riberry' which is a native species which have both been planted in the Northern portion of the Site. The trees were in good health and condition at the time of my inspection and are less than 5m in height and exempt from protection under the TVP controls (See Figs. 4 & 6).

Fig. 4. Photo of tree T3 a *Syzygium* which is under 5m in height

Both of these specimens are proposed to be removed and replaced with new vegetation in the landscape plan for the Site (See Appendix 2b & 2c).

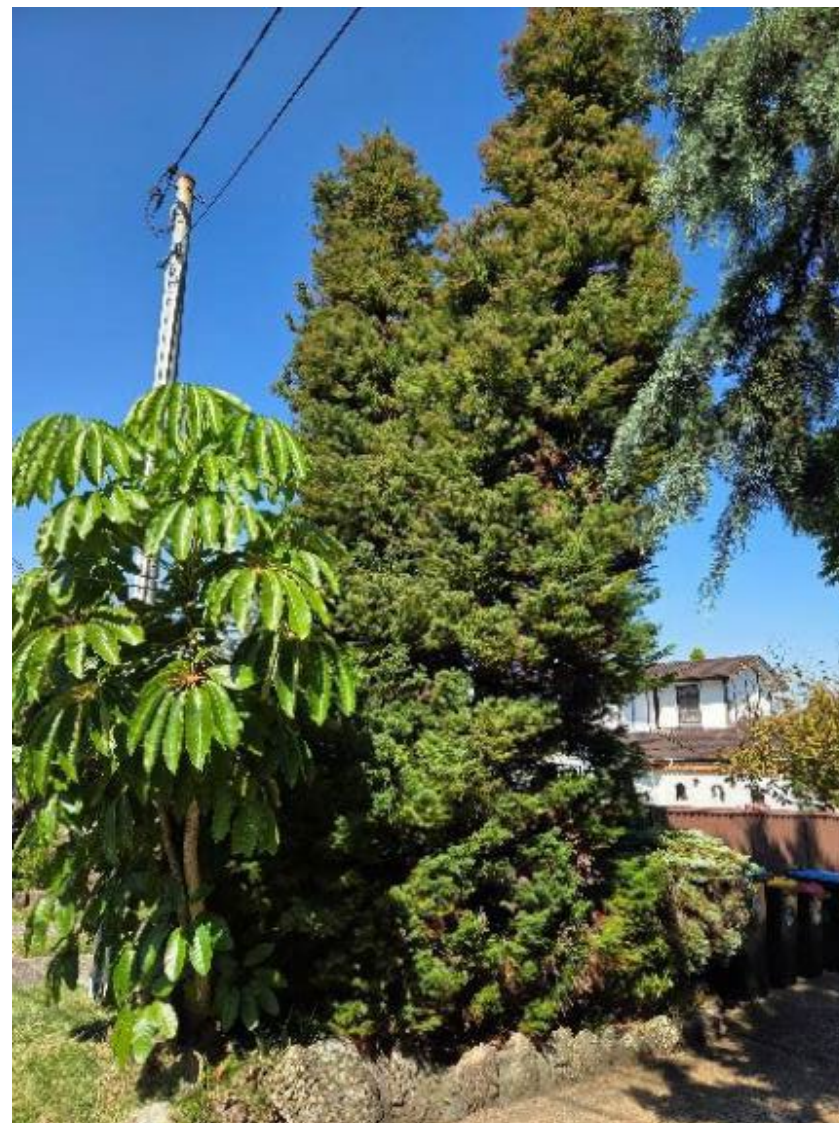
**4.4** Tree **T4** is a *Shefflera actinophylla* or 'Umbrella Tree' which is a native species which has been planted in the front of property in the Northeast portion of the Site and to the left hand side of the existing driveway (See Fig. 6).

The species is listed as exempt from protection in the TVP controls

Fig. 5. Photo of tree T5 a *Cryptomeria japonica* with T4 a *Schefflera actinophylla* to the left of the frame.

The tree is scheduled to be removed and replaced in the new landscaping for the Site (See Appendix 2b & 2c).

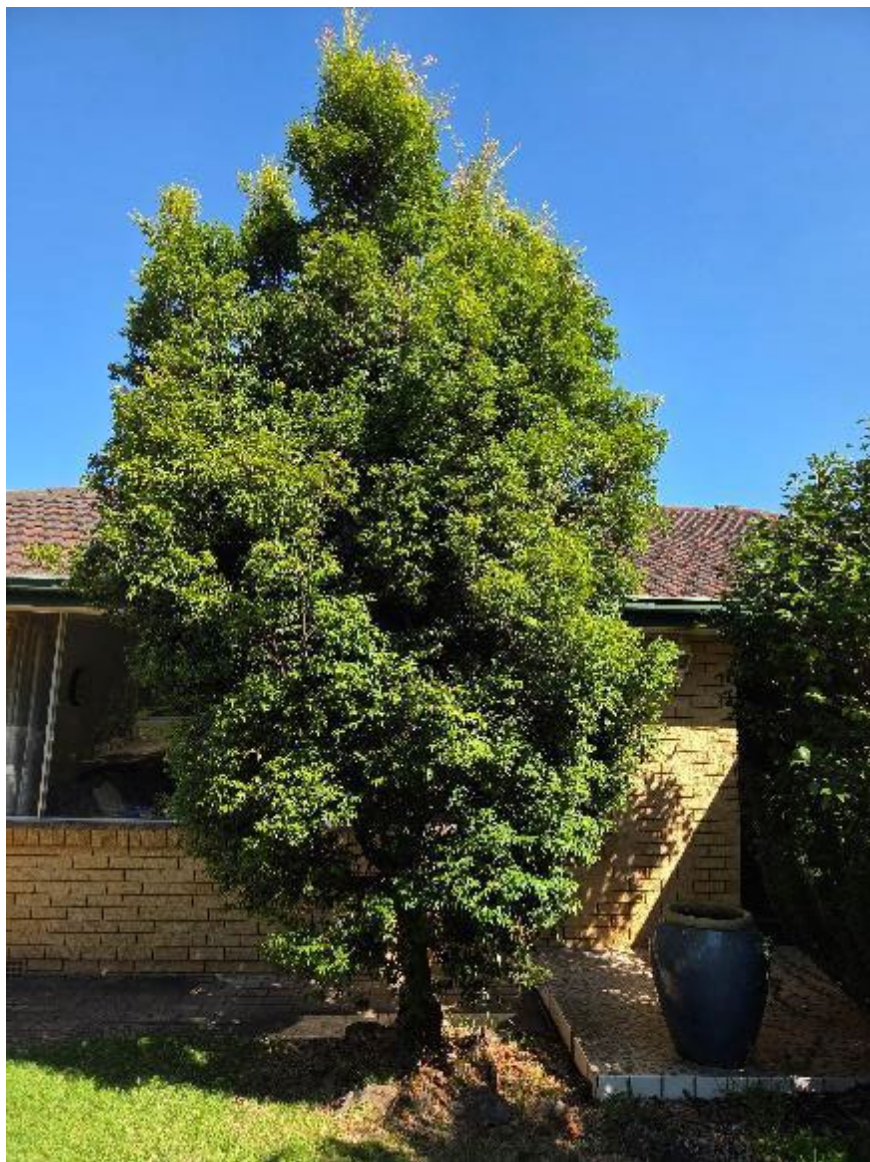
Fig. 6. Photo of tree T6 a *Syzygium* which is just under 5m in height

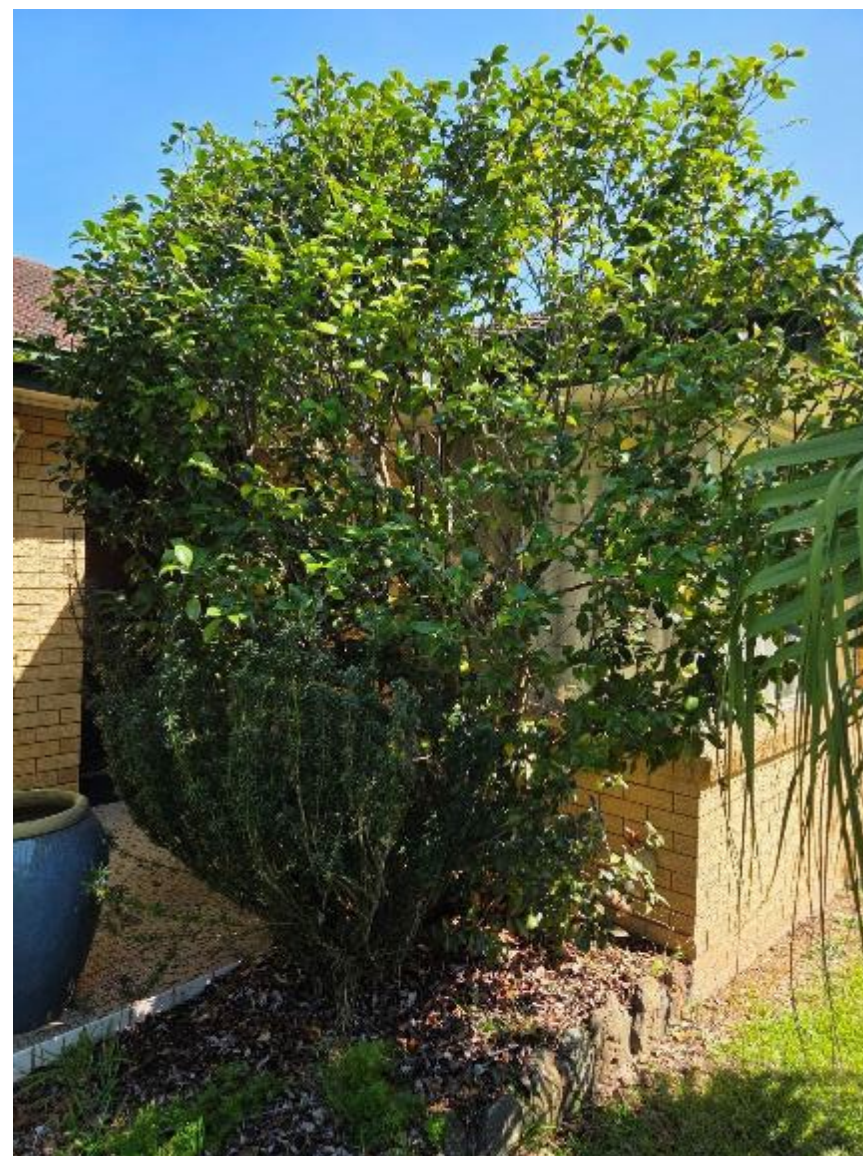
Fig. 7. Photo of tree T7 a *Camelia japonica* under 5m in height.

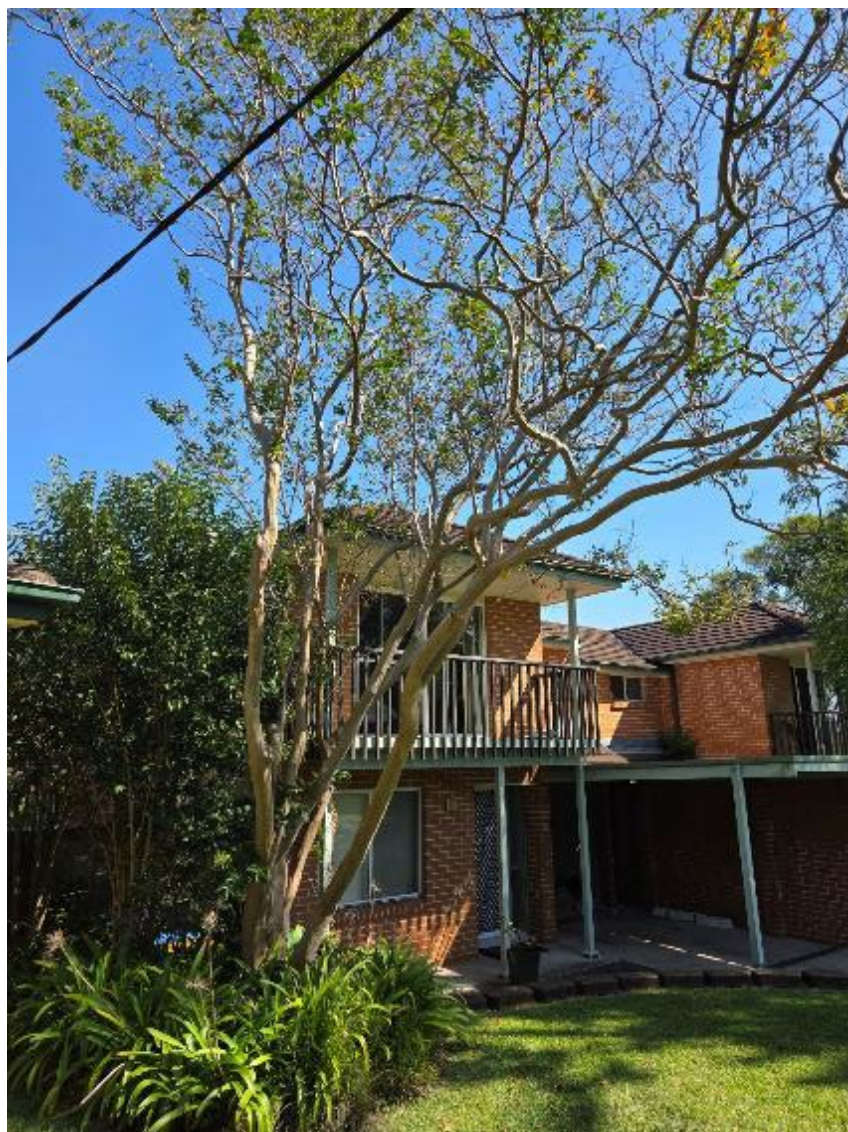
**4.7 Tree T9** is a *Lagerstroemia indica* or 'Crepe Myrtle' which is an exotic species from India. The has been planted in the neighbouring property to the West of the Site. The tree was in good health and condition at the time of my inspection (See Fig. 10). The tree has been planted in close proximity to the dwelling and will have formed an asymmetric rootplate as a result<sup>2</sup>.

Fig. 9. Photo of Tree T9 a *Lagerstroemia indica* in neighbour's land

**5.2** Tree **T7**, the neighbour's *Lagerstroemia* will be subject to a Minor Encroachment of approx. 4% from the driveway and trenching for stormwater pipes (See Appendix 2f). It is recommended that any trenching for plumbing works be conducted using hand tools with the objective of avoiding or minimising damage to tree roots >30mm Ø and under the supervision of the Project Arborist (PA).

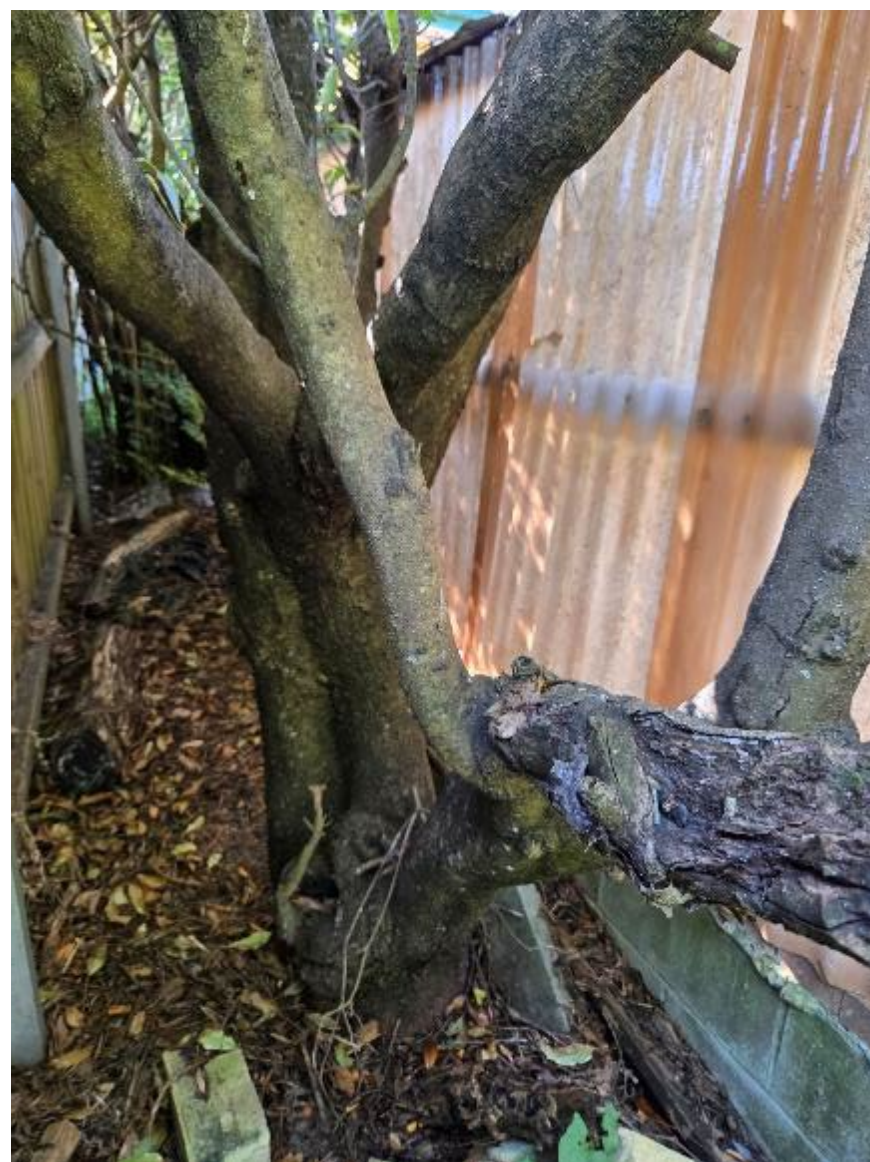
**4.8 Tree T11** is a *Pittosporum eugenioides* 'variegatum' or 'Variegated Pittosporum' which is a hybridised native species which is growing in the rear of the property to the West of the Site. The tree was in poor health and condition at the time of my inspection (See Figs. 12 & 13). The tree is under 5m in height and therefore exempt from the PTV.

Fig. 12. Photo of Tree T11 a *Pittosporum variegatum*.

This tree is scheduled to be removed and replaced in the new landscaping for the development (See Appendices 2b & 2c).

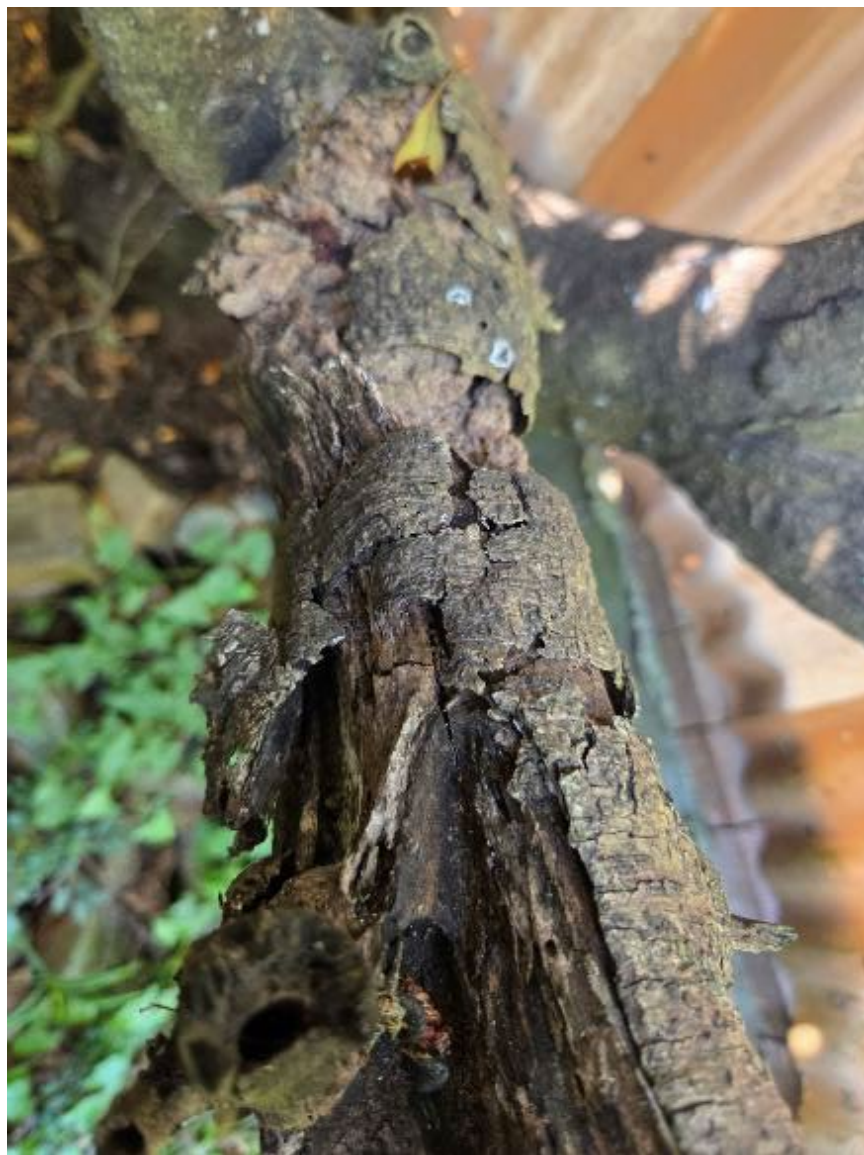
Fig. 13. Photo of borer damage on tree T11

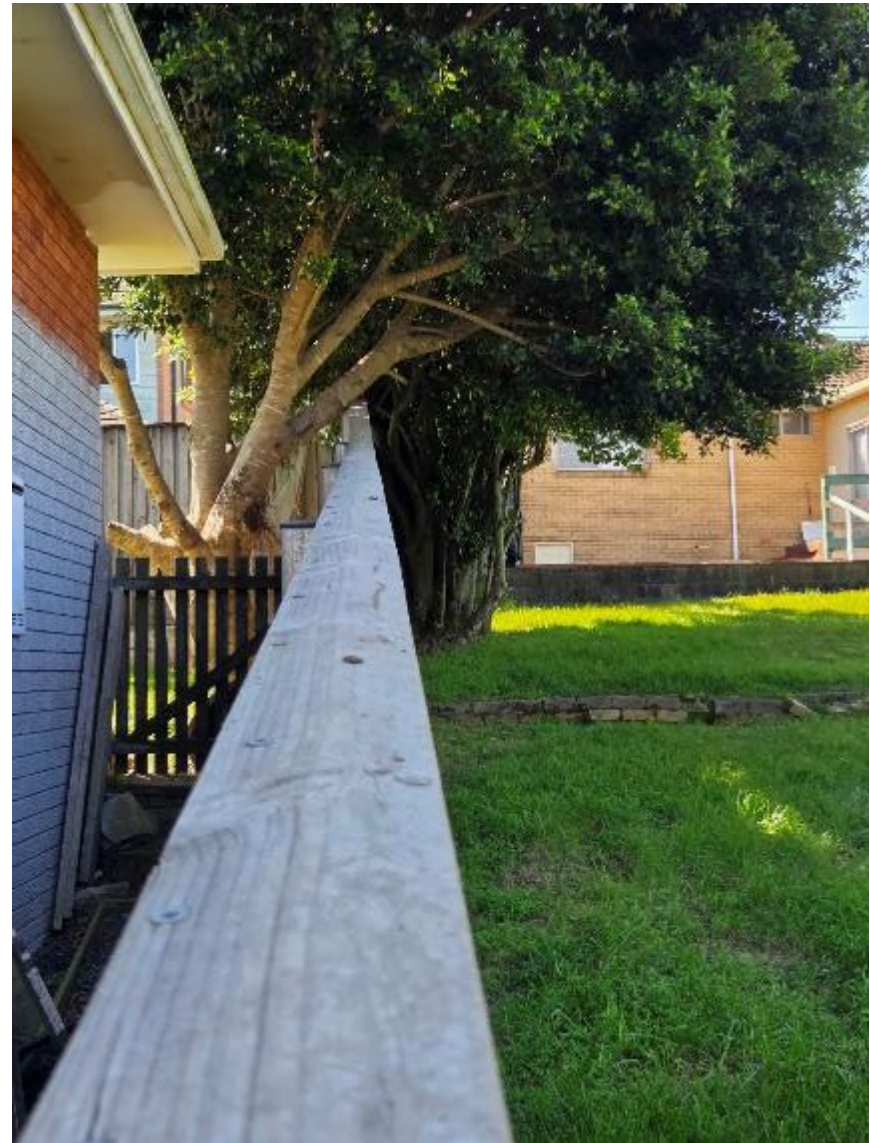
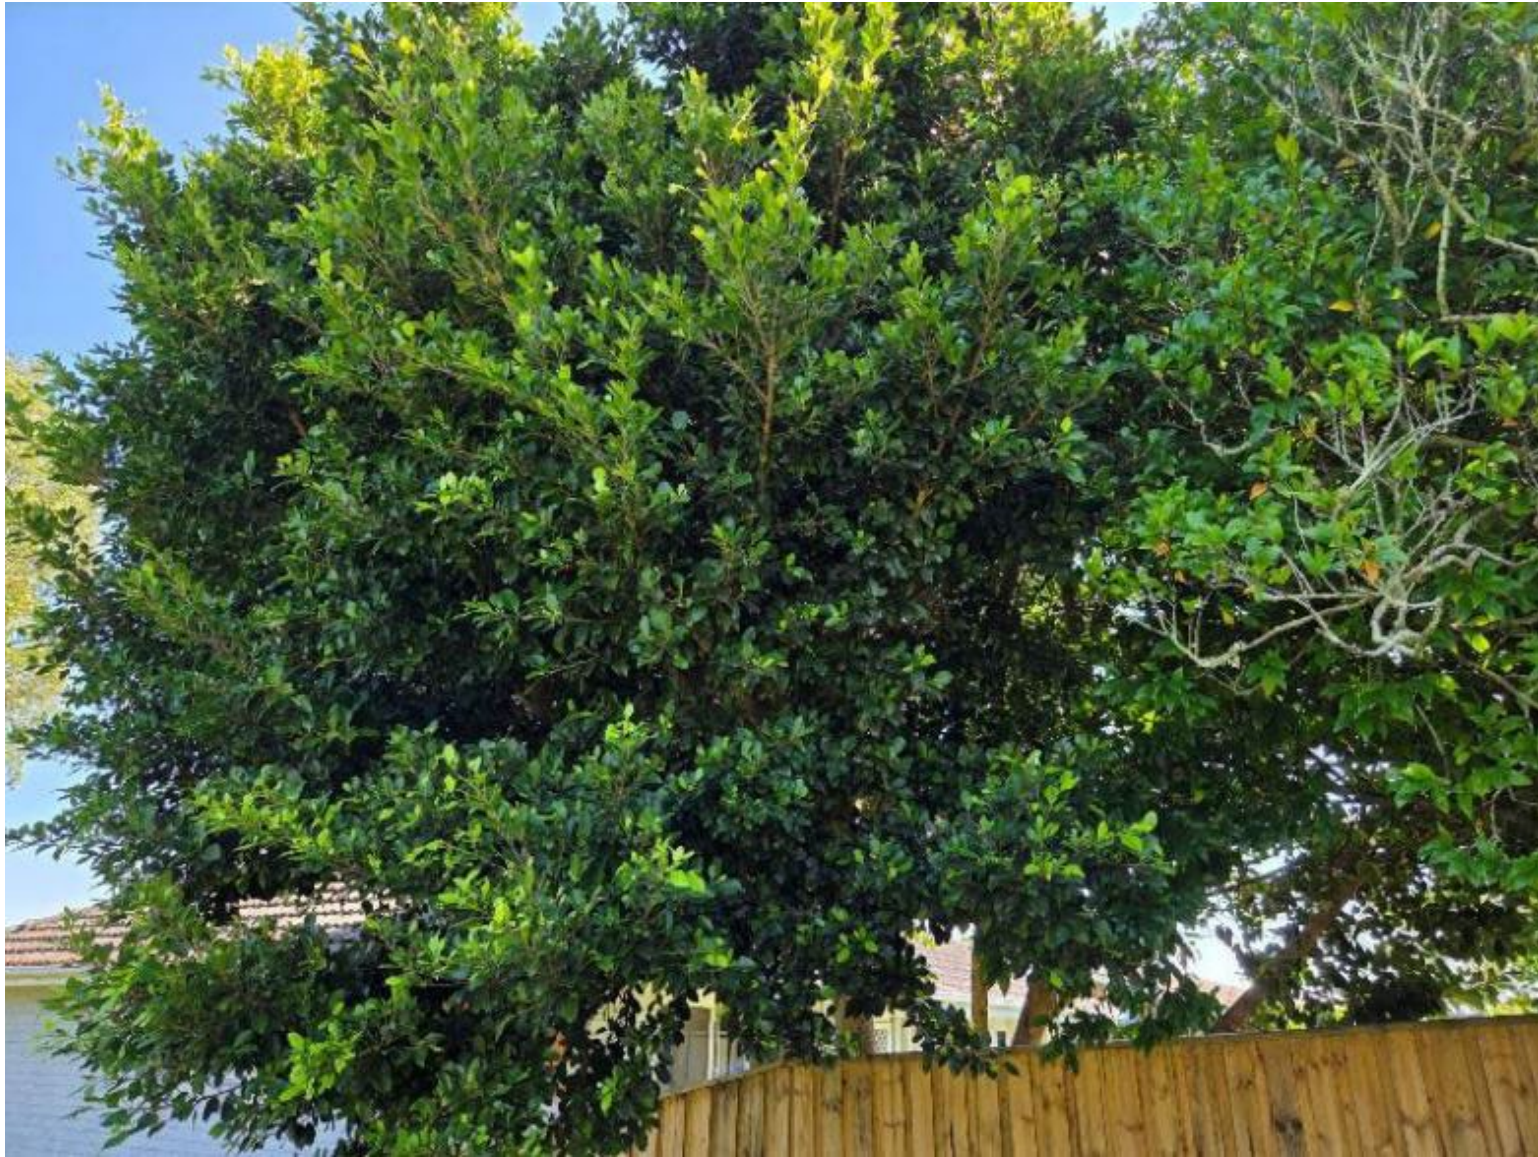
- 4.15 Tree T19** is a *Ficus benjamina* or 'Weeping Fig' which is a native species endemic to Northern Australia and Southeast Asia. The tree is growing in the neighbouring property to the Southwest of the Site. The tree was in good health and condition at the time of my inspection (See Fig. 16). The genus is listed in NBC's list of undesirable species and therefore exempt from the PTV. This specimen has the potential to grow into a very large tree with a highly invasive root system.

Fig. 16. Photo of T19 a *Ficus benjamina* growing adjacent to the border.

Fig. 17. Photo of tree T19 a *Ficus benjamina*

**5.3** Tree **T19** is an exempt species which will grow into a very large tree<sup>3</sup> with a wide spreading and highly invasive root system. Consequently it is recommended to approach the neighbour regarding its removal as this tree would have an adverse impact on his property and services also. Alternatively, at this stage plans for the development indicate a 15% Encroachment into its TPZ (See Appendix 2g) which could be alleviated by design modifications to the OSD and plumbing work. It is recommended that any trenching for plumbing works be conducted using hand tools with the objective of avoiding or minimising damage to tree roots >30mm Ø and under the supervision of the Project Arborist (PA).

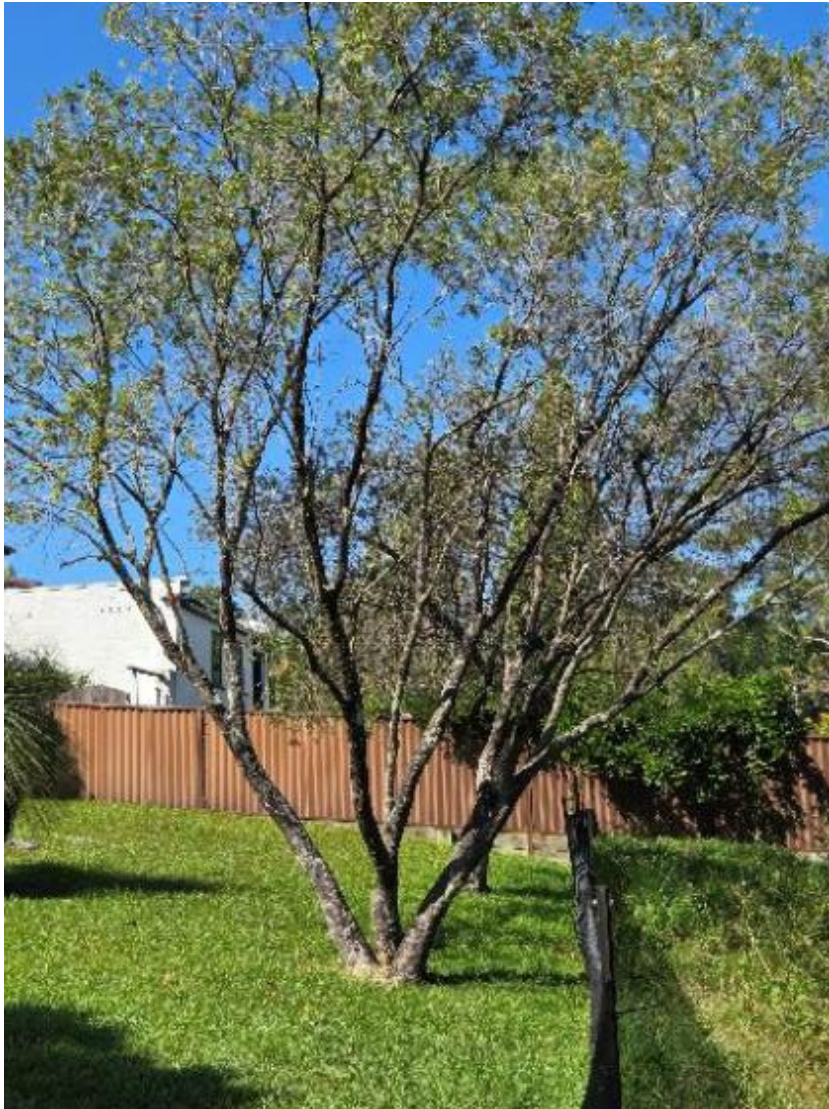
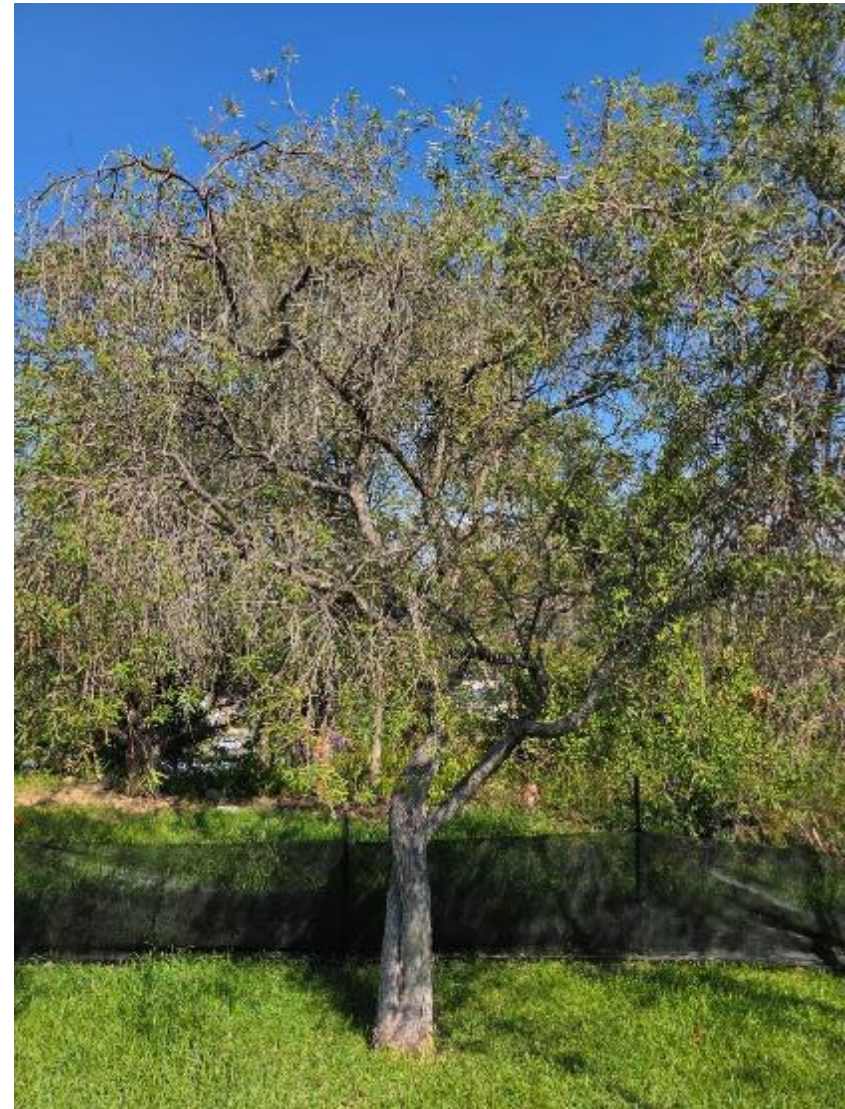
**4.10 Trees T13 & T14** are both *Callistemon viminalis* or 'Weeping Bottlebrush' which is a native species belonging to creeks and rivers in Northeastern NSW. Both of these trees are planted specimens and are located in the Southern portion of the Site. These trees were in good health and condition at the time of my inspection. They are less than 5m in height and exempt from the TVP controls.

Fig. 18. Photo of tree T13 a *Callistemon viminalis*

Fig. 19. Photo of tree T14 all *Callistemon viminalis*

Both of these specimens are scheduled for removal and replacement in the new landscaping for the development (See Appendices 2b and 2c).

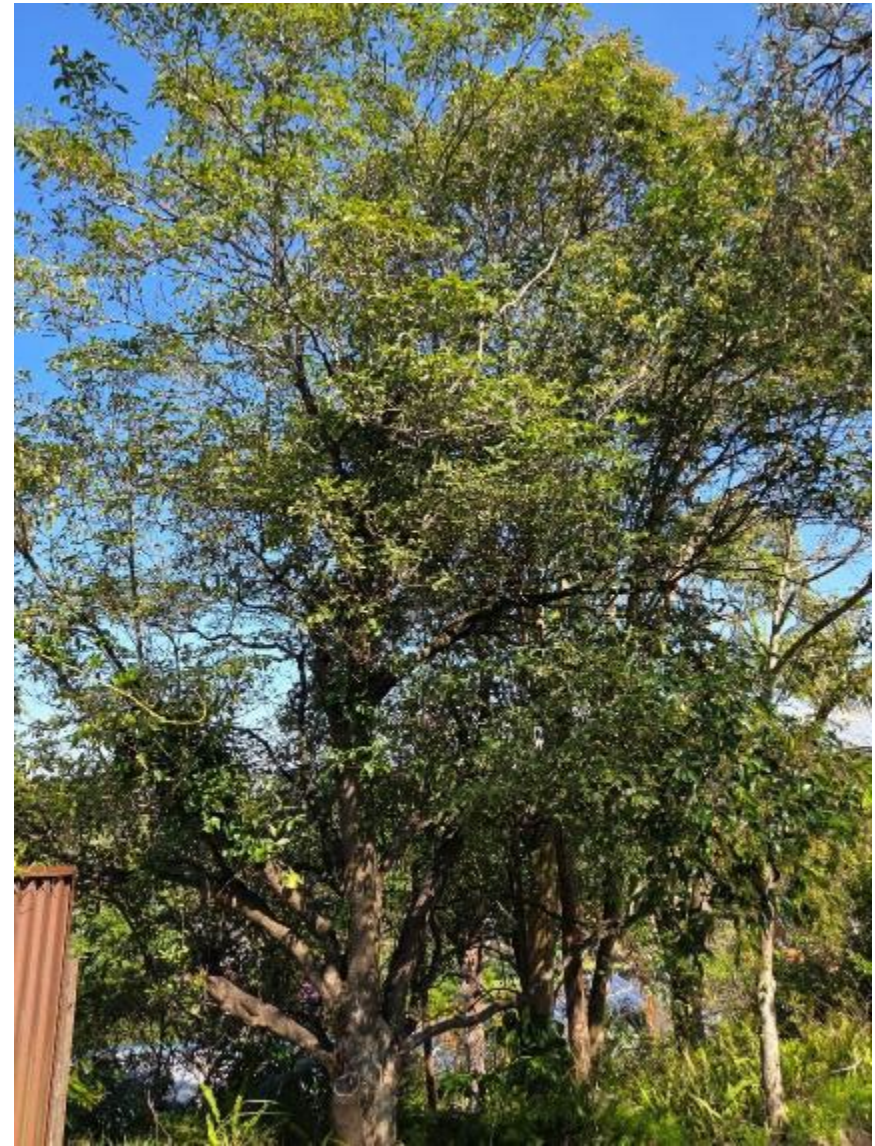
- 4.11 Tree T15** is a *Pittosporum undulatum* or 'Native Daphne' which is an endemic species belonging to the Sydney Region and the NBC's LGA. The tree is growing in the rear of the property to the South of the Site. The tree was in good health and condition at the time of my inspection (See Fig. 21). The tree is listed in NBC's list of undesirable species if under 8m in height. This tree is approx. 6m tall and therefore exempt from the PTV.

Fig. 21. Photo of tree T15 a *Pittosporum undulatum*

This tree located well outside the development site and unlikely to be damaged as a result of Site construction works (See Appendices 2b & 2c).

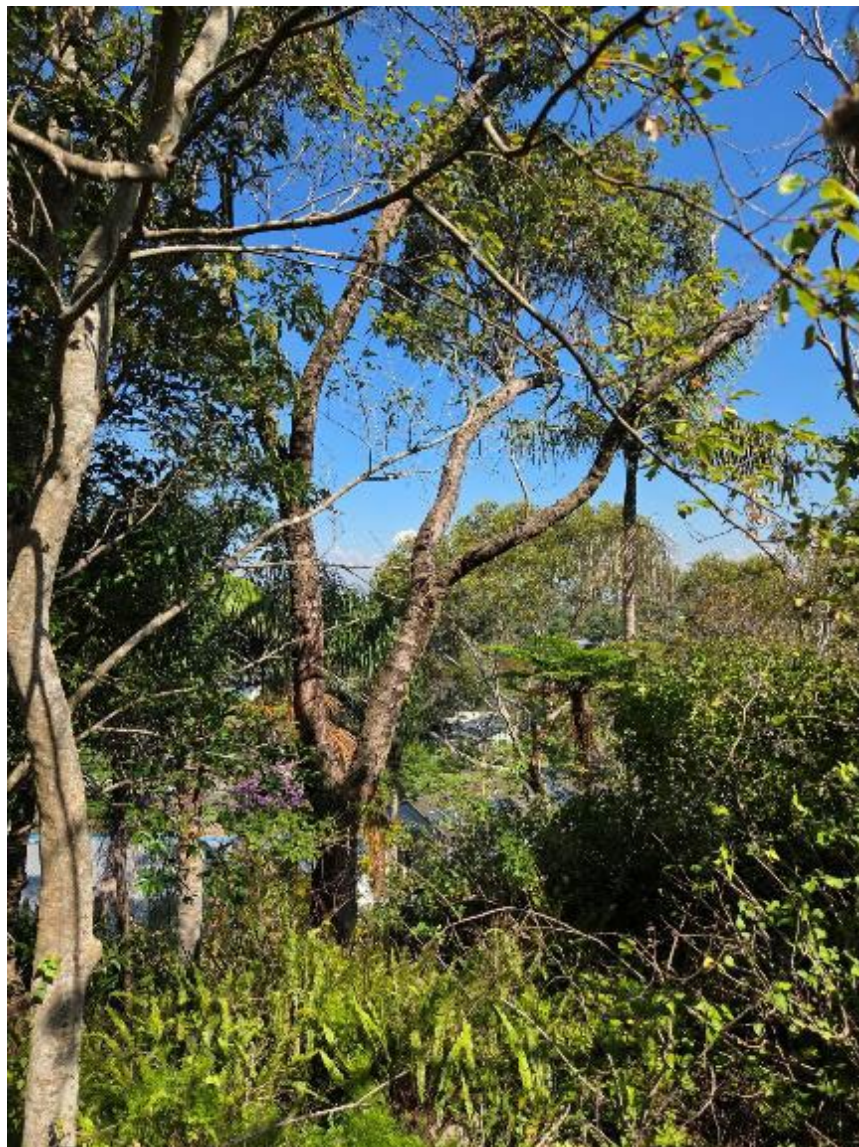
- 4.13 Tree T17** is a *Corymbia gummifera* or 'Red Bloodwood' which is an endemic species belonging to the Sydney Region and the NBC's LGA. The tree is growing in the neighbouring land to the South of the Site. The tree was in good health and condition at the time of my inspection (See Fig. 24).

Fig. 24. Photo of T17 a *Corymbia gummiferum*.

This tree is located well outside the development site and unlikely to be damaged as a result of Site construction works (See Appendices 2b & 2c).

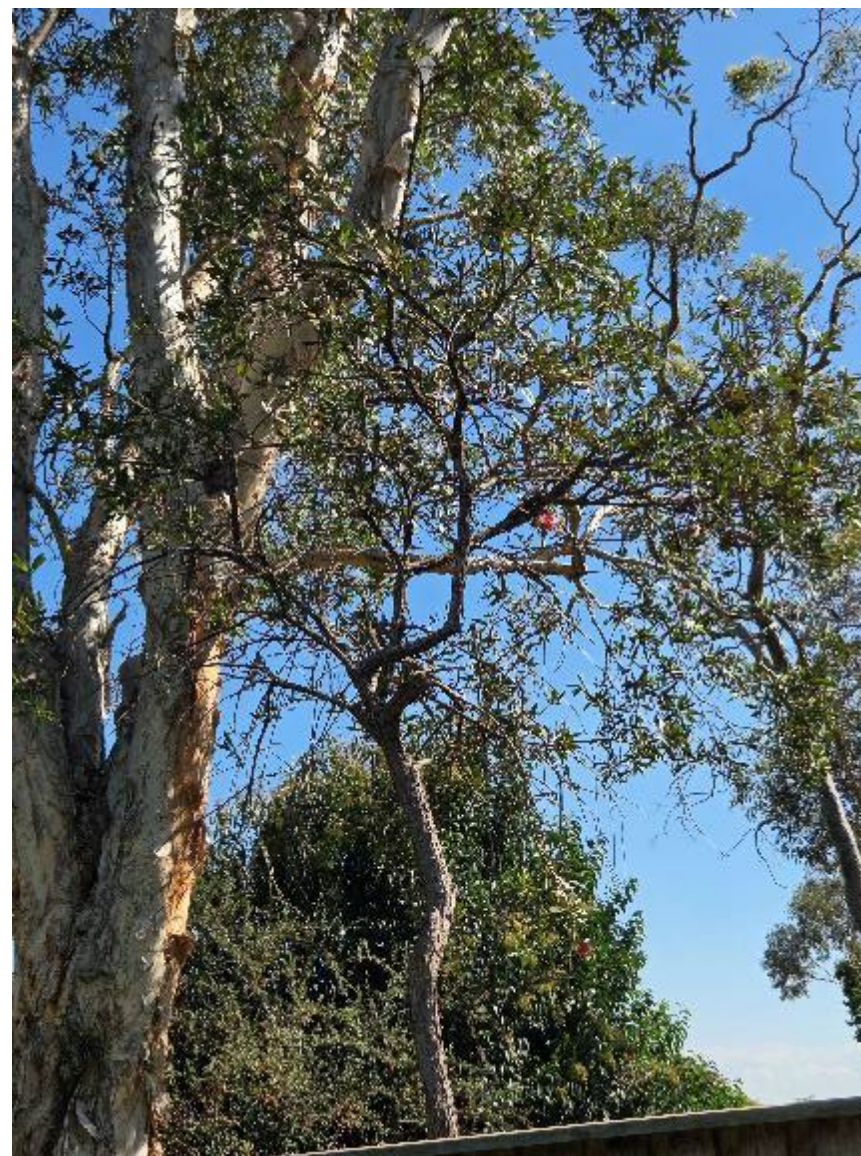
**4.16** Tree **T20** is a *Callistemon citrinus* or 'Red Bottlebrush' is a native species belonging to creeks and rivers in the East coast of Australia. The Tree is a planted specimen that is located in the neighbouring property to the southeast of the Site. The tree was in good health and condition at the time of my inspection. The specimen is less than 5m in height and exempt from the TVP controls.

Fig. 27. Photo of tree T20 a *Callistemon citrinus*.

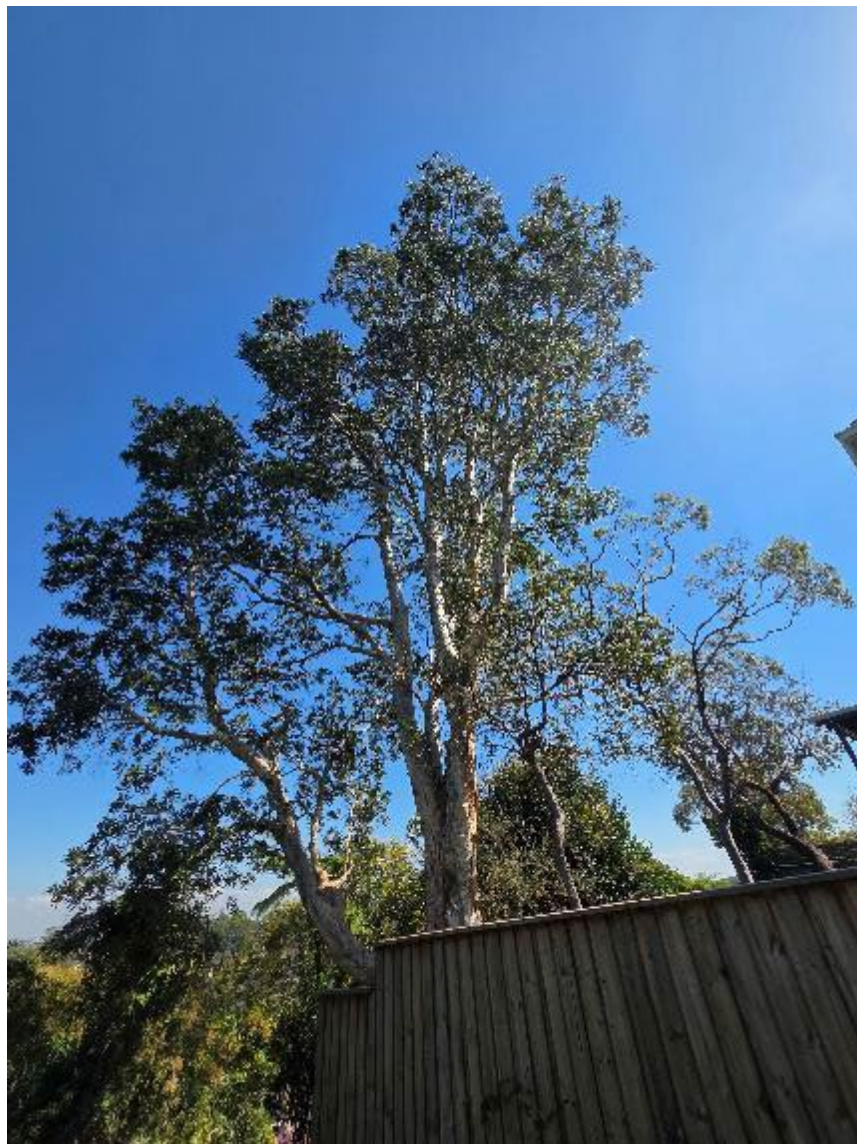
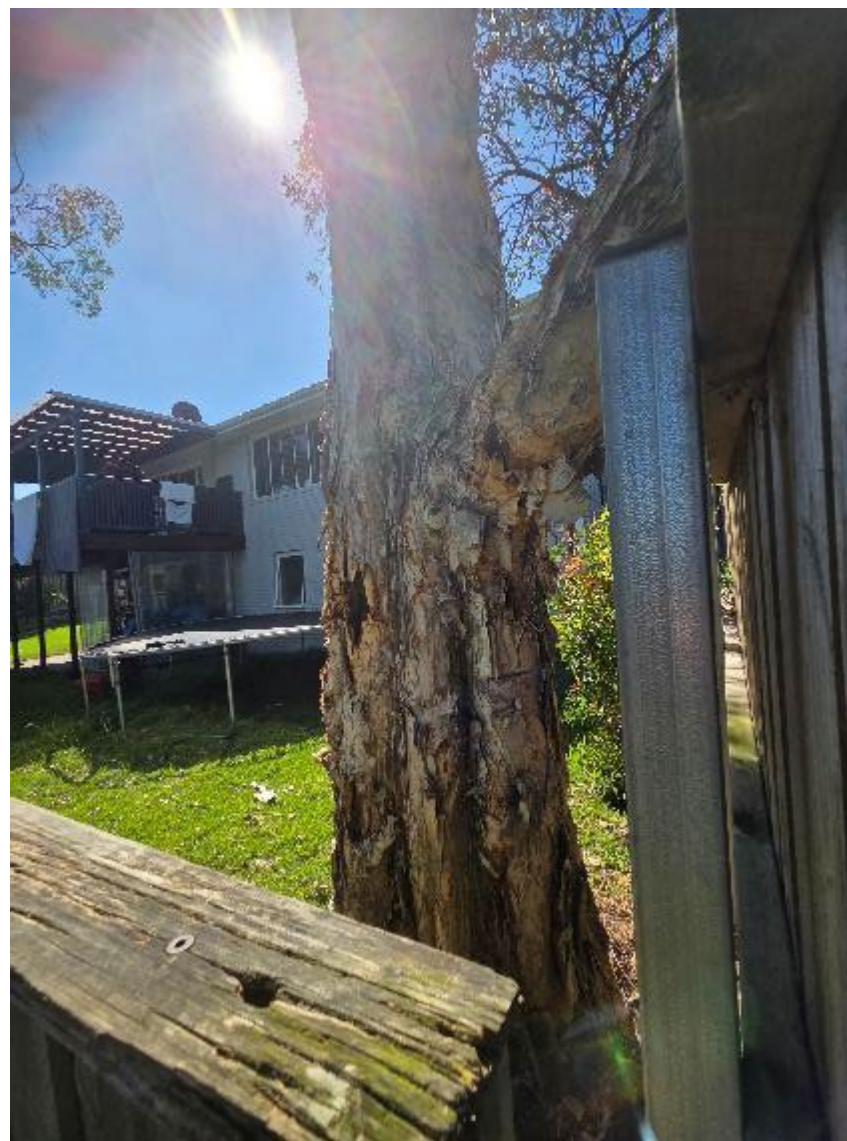
**4.17** Tree **T21** is a *Melaleuca quinquinervia* or 'Broad leaved Paperbark' which is an endemic species common in the Sydney region and the Northern Beaches LGA. The tree is has been planted in the neighbouring property to the Southwest of the Site. The tree was in good health and condition at the time of my inspection (See Fig. 16). The genus is listed in NBC's list of undesirable species and therefore exempt from the PTV. This specimen has the potential to grow into a very large tree with a highly invasive root system.

Fig. 29. Photo of tree T21 a *Melaleuca quinquinervia*.

Fig. 30. Photo of the lower stem of T21.
