J0780. 8th April, 2016. Page 1.

GEOTECHNICAL INVESTIGATION:

Alterations & Additions at 56 Central Road, Avalon

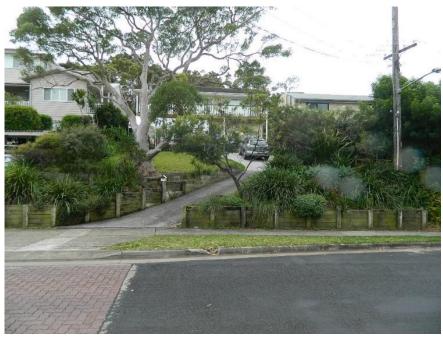
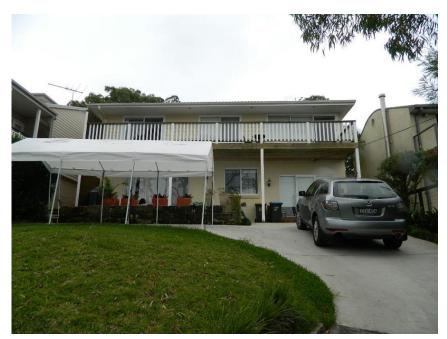
Photo 1

- 2.3 At the road frontage a concrete driveway extends up and across the slope to a car parking area below the house (Photo 1 & 2). The cut batters for the road and driveway are mostly supported by treated pine retaining walls that appear well constructed. A small portion of the cut is supported by concrete block and formed concrete retaining walls that are currently considered stable and will be demolished as part of the proposed works. The two storey brick and timber framed house is in good condition for its age. No signs of movement were observed in its external supporting brick walls. Access to the interior of the house was not available at the time of the inspection. A cut has been made into the slope for the lower ground floor level. A band of competent, medium strength sandstone outcrops in this area and the lower half of the cut has been made through the rock (Photo 3 & 4). The upper portion of the cut has been slightly battered upslope and is covered with Geotextile fabric and wire mesh that is pinned to the rock and soil (Photo 5). From what could be seen the covered ground materials consist of a shallow sandy soil and a low fill from excavations uphill. No significant signs of movement were observed in this area

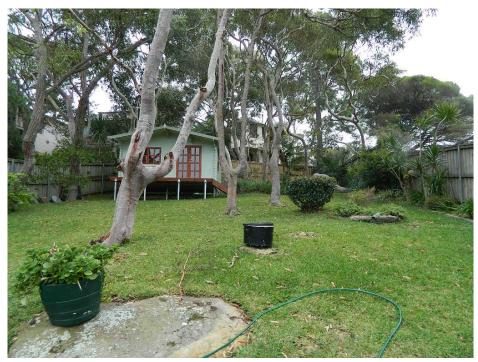
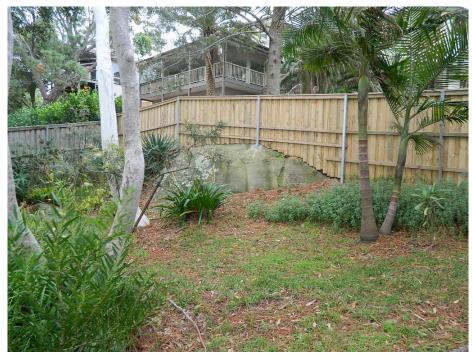
and it is currently considered stable. Another low cut to a maximum height of ~1.0m has been made upslope, above the deck. It is supported by a stable, mortared rock retaining wall. The land surface above is lawn covered with a scattering of sandstone exposed at the surface. A well-constructed timber framed studio is located near the upper boundary of the property and a large sandstone floater is located on the upper boundary (Photo 6 to 8). The floater is partially embedded in the slope and shows no signs of movement.
