## **Geotechnical Assessment**

**Project:** Alterations and Additions  
4 Cabarita Road, Avalon Beach.

**REF: AG 19067**  
16<sup>th</sup> April, 2019

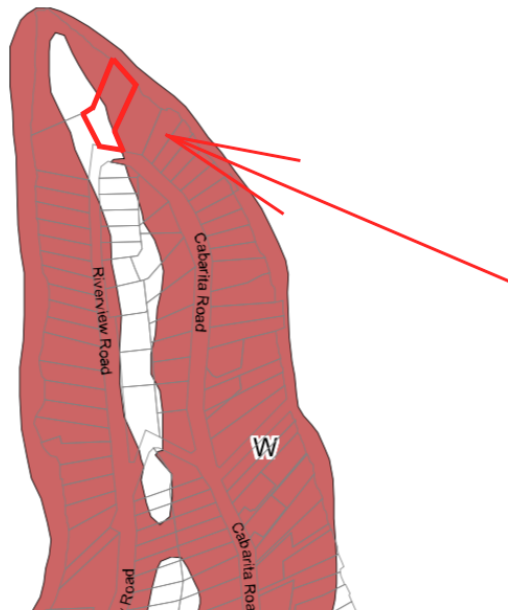
- The property is classified '**Geotechnical Hazard H1**' in Northern Beaches Council PLEP Geotechnical Hazard Map Sheet GTH\_015 (PLEP Geotechnical Hazard Map **Image 2** below).

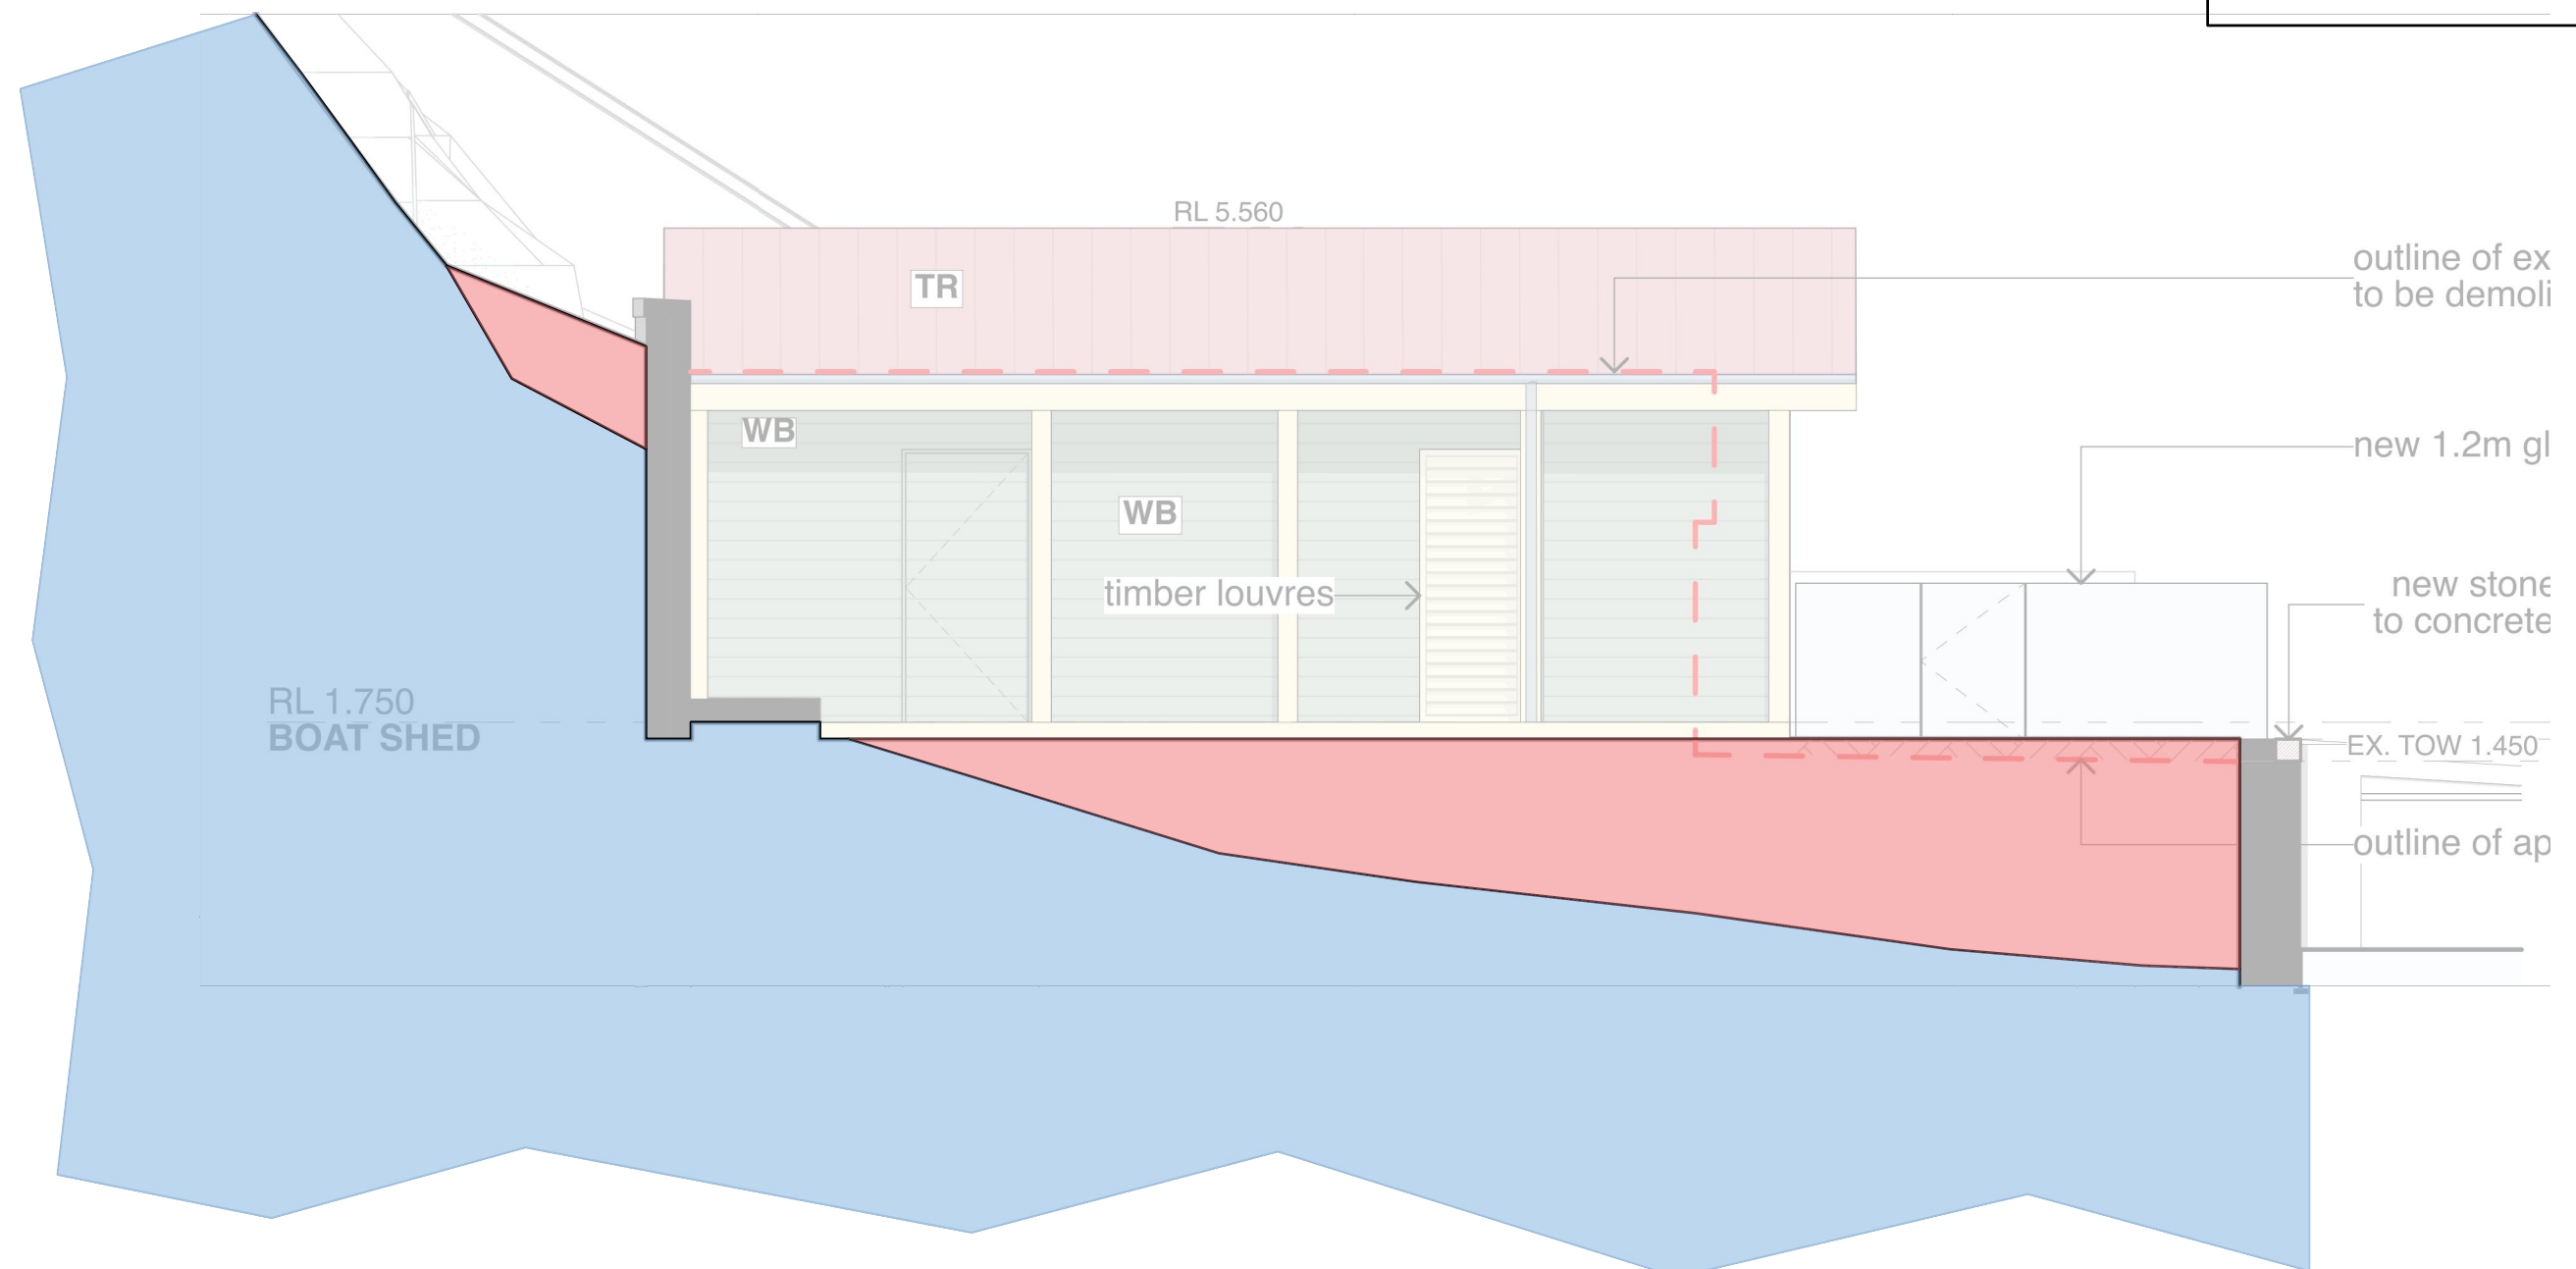
## INFERRED GEOLOGICAL SECTION

INTERPRETED SUBSURFACE SECTION ONLY.  
ACTUAL GROUND CONDITIONS MAY VARY.
