Address of site 98 Bungan Head Road, Newport

Report Title: RISK ANALYSIS & MANAGEMENT FOR PROPOSED PROPOSED GRANNY FLAT AT 98 BUNGAN HEAD ROAD, NEWPORT– PX 00042

**RISK ANALYSIS & MANAGEMENT  
FOR  
PROPOSED GRANNY FLAT  
AT  
98 BUNGAN HEAD ROAD, NEWPORT**

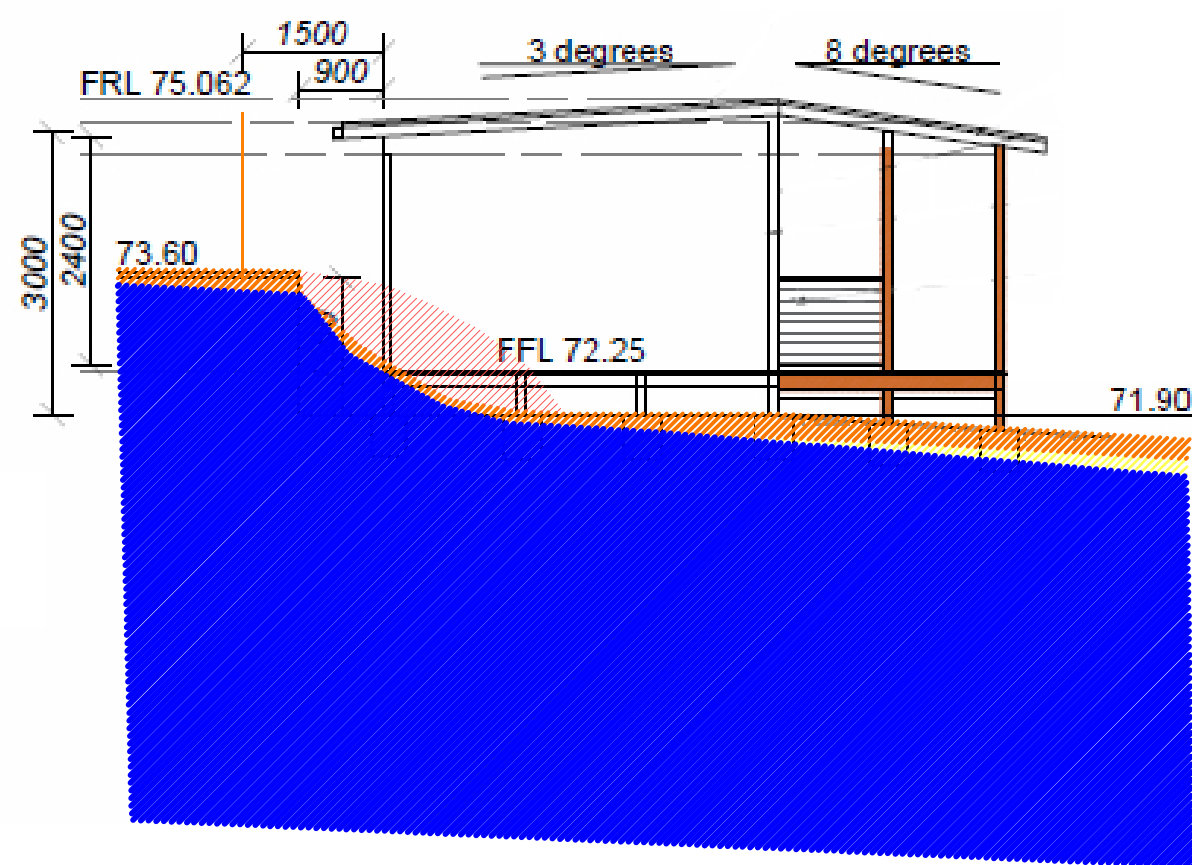
NOTE  
INTERPRETED SUB SURFACE SECTION ONLY.  
ACTUAL GROUND CONDITIONS MAY VARY.
