Consulting & Building Construction

Date: 26.03.2023

Our Ref: 22/23

Subject: Alterations and additions -13 Gardere Avenue, Curl Curl NSW 2096

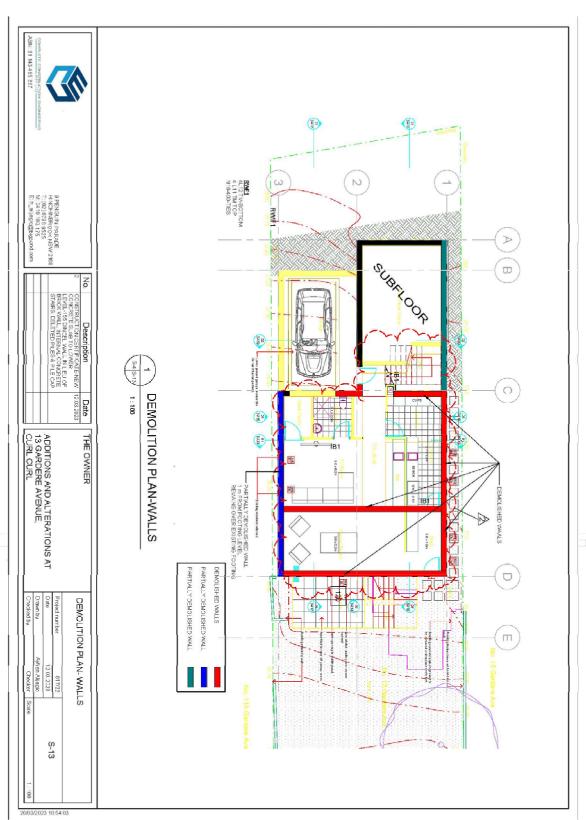
Appendix A-Plan S-13

Furthermore, it has been recorded that upon initial excavation of the basement pad, the western double brick wall, between internal stairs and the living room, has no footing and as such is deemed structurally unfit to support proposed additional loads of upper levels.

This report is to be read in conjunction with the structural engineering plan S-13, dated 12.03.2023, and photographic record, which are attached to this report.

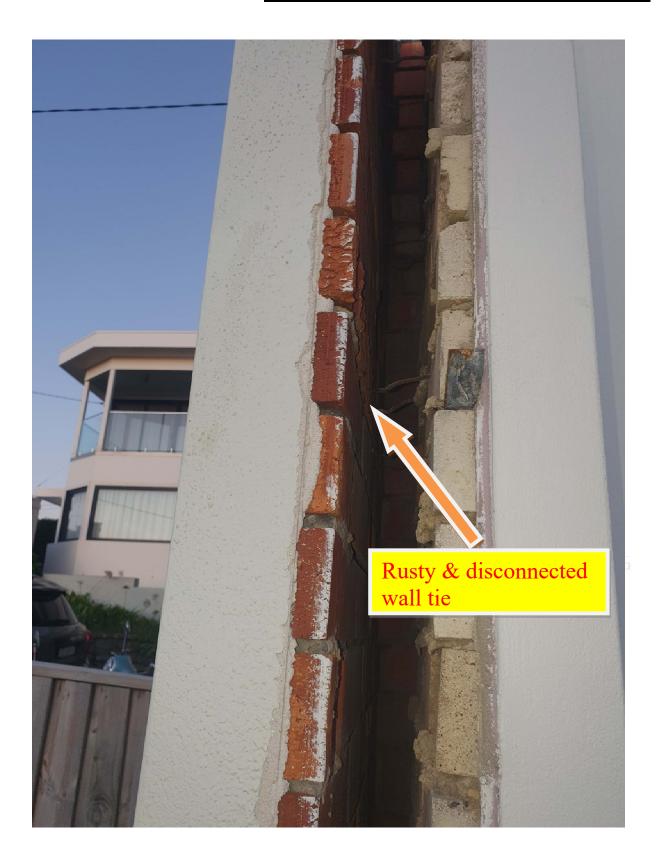
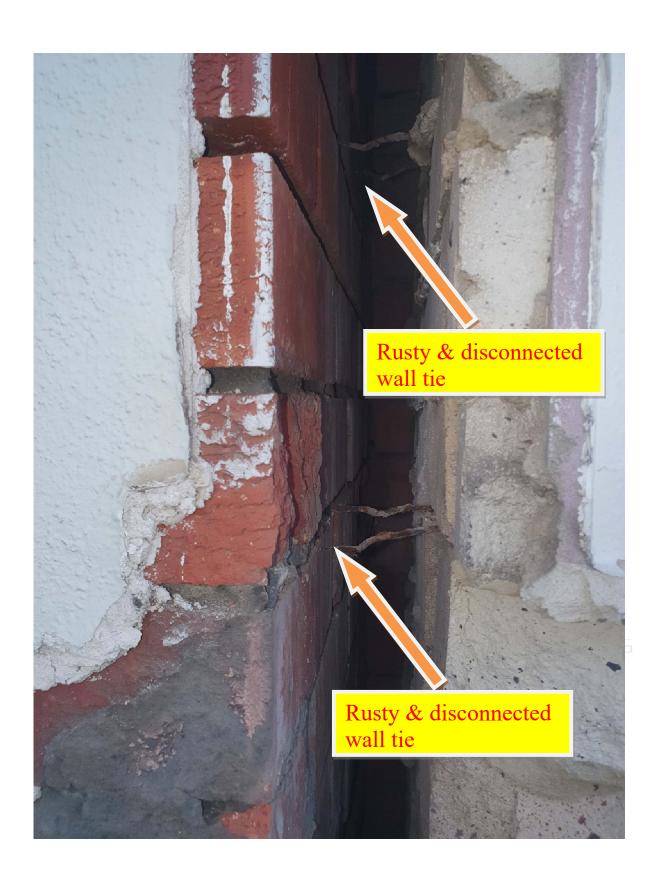
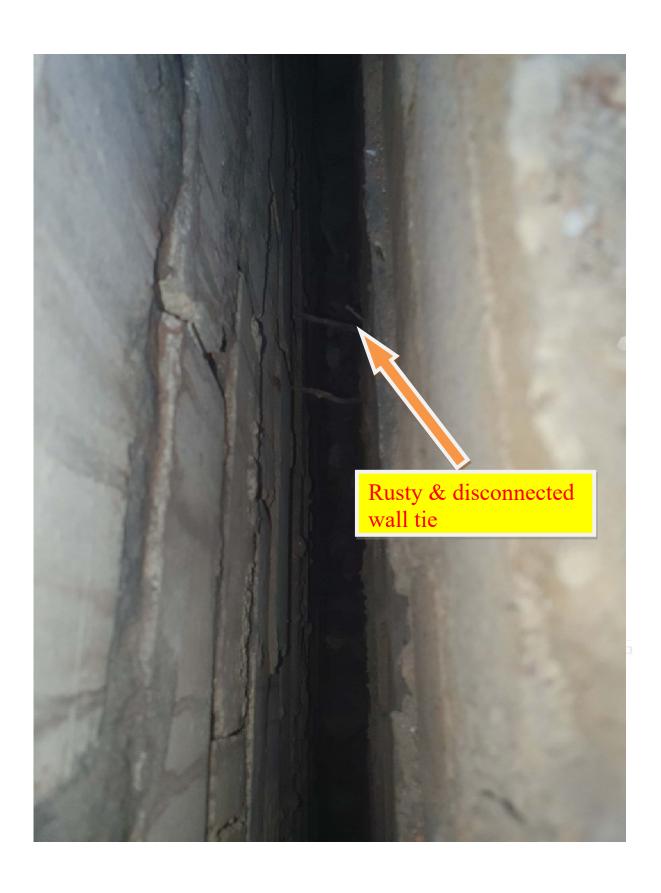
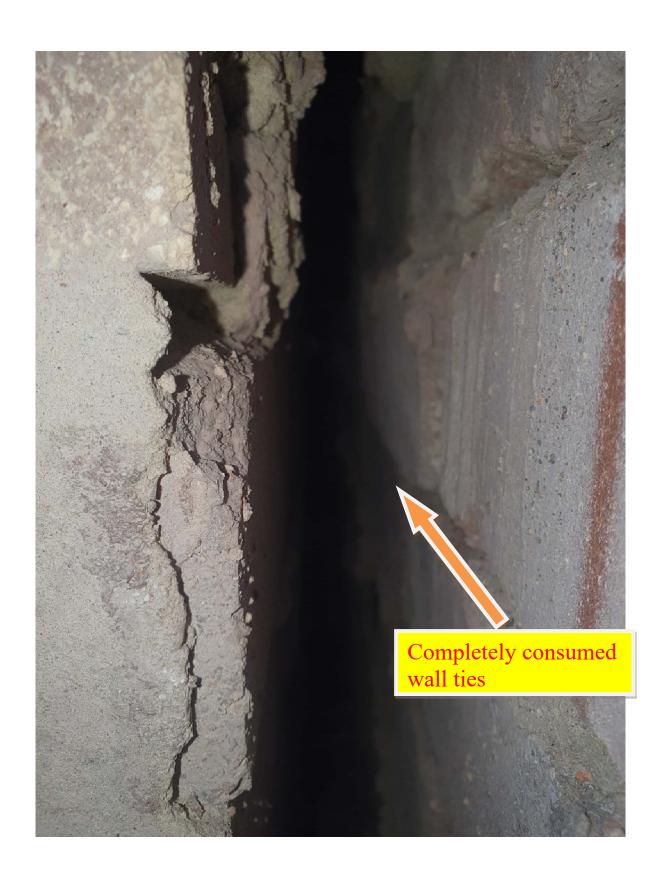
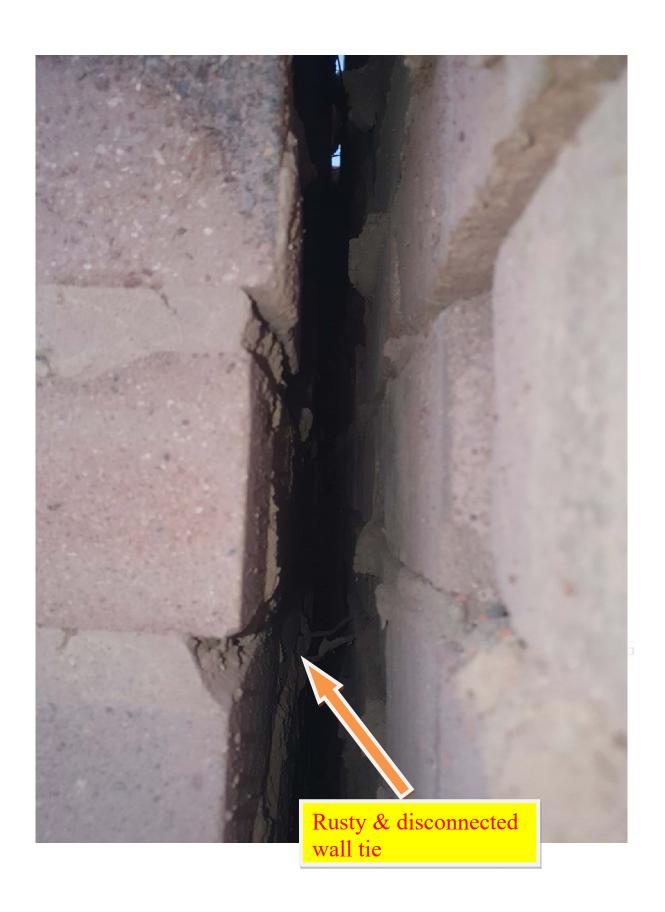
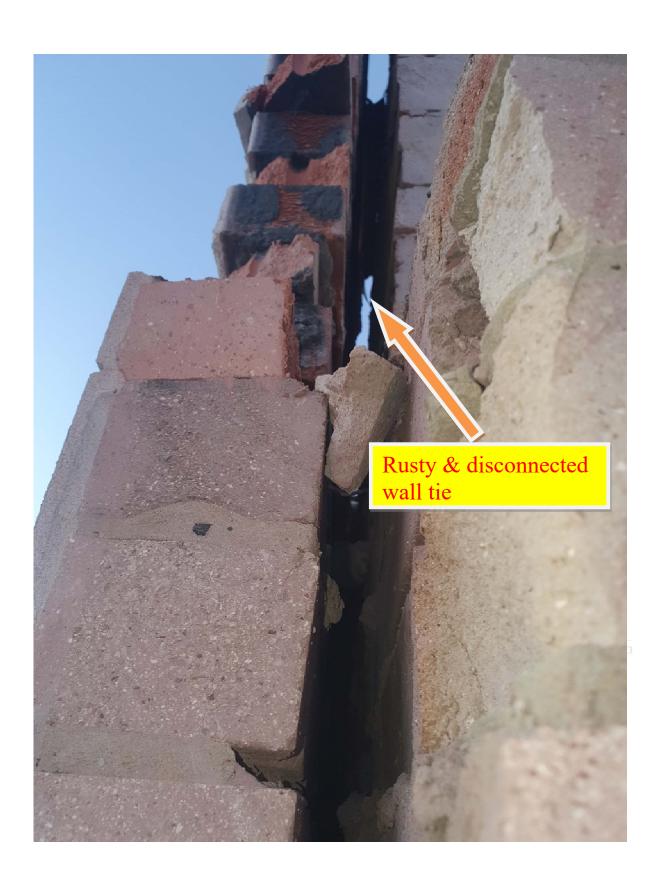
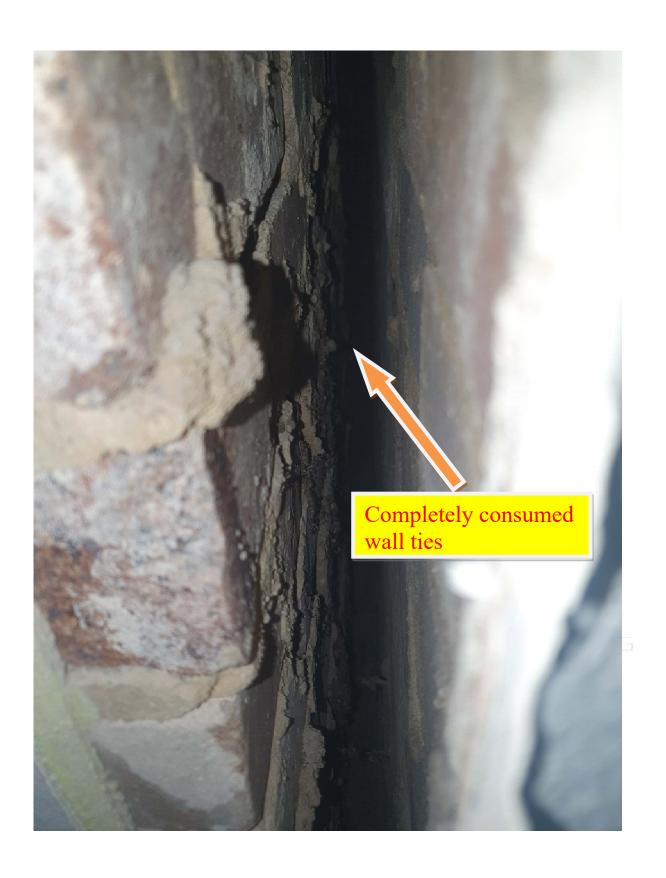
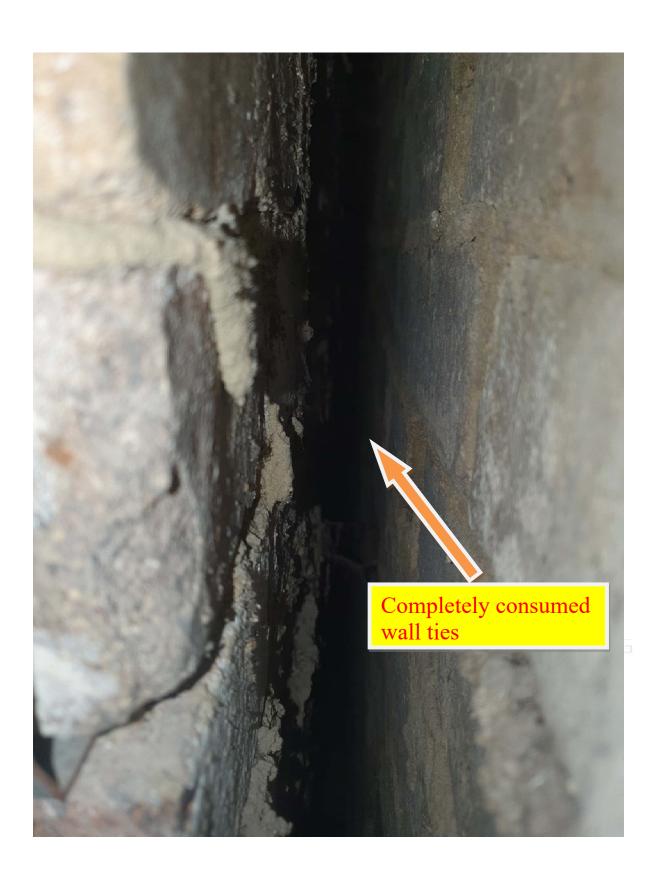
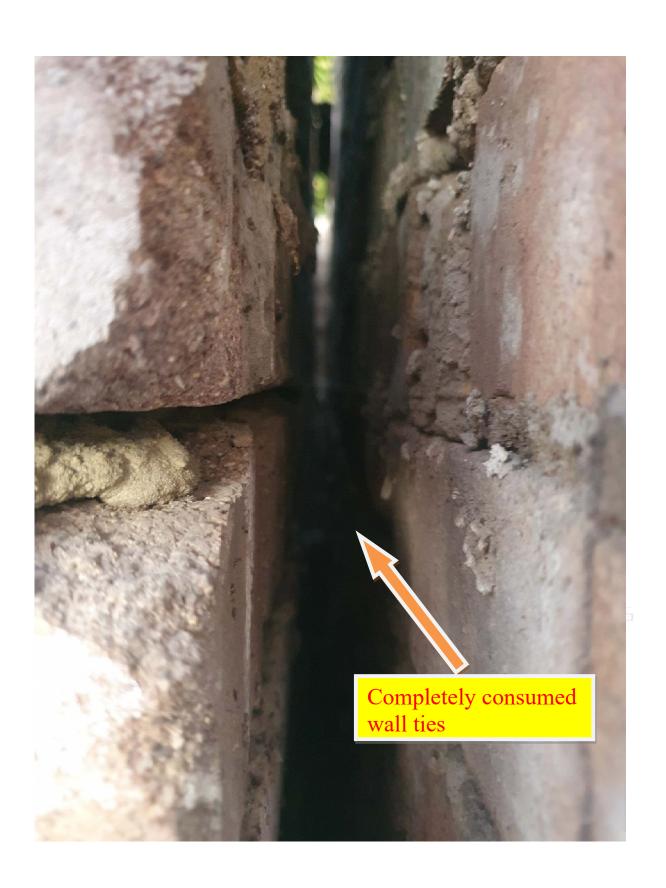
Appendix B-Photographic record

It has been recorded that all double brick walls have suffered extensive dilapidation to wall ties with majority of them being broken down and disconnected due to the rusting process, which in some cases had consumed entire wall tie within the wall's cavity.

It has been recorded that the existing brick walls, both skins, have developed softness (dusting effect when exposed to surface rubbing and no drilling resistance to hammering effect), in particular the external skin.

Similar condition is recorded alongside the remaining western external wall between proposed bedroom 4 and the internal stairs.

This condition eliminates installation of remedial type of walls ties and therefore removal of all walls impacted by the above-described conditions is recommended.

Level of wall ties deterioration/rusting/disconnection within this wall is directly proportional to the wall height and it is recommended that the double brick wall below floor joists be remediated with stainless steel remedial type of wall ties as per plan S-5, section 5, dated 12.03.2023 and the remaining portion of wall above the existing floor level be removed and rebricked.
