**Date:** 22nd January 2024  
**No. Pages:** 4  
**Project No.:** 2023-019

Sean Dew,  
213 Tooronga Road,  
Terrey Hills NSW 2084

### **Preliminary Landslip Risk Assessment for 213 Tooronga Road, Terrey Hills**

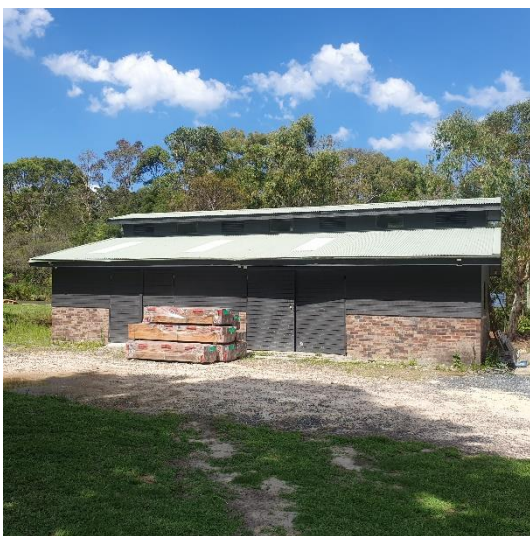
Within the eastern grass lawn is a single storey brick and timber 'barn' surrounded by a gravelled forecourt along the western side, a garden along the northern and eastern sides. The garden along the northern side of the building extends north approximately  $\leq 3.0\text{m}$  to an east-west striking sandstone vertical cut (Photograph-2) which is approximately 1.5m high and reduces its level down to the same level as the garden towards the east. The ground along the southern side of the barn (Photograph-1) exposes excavated sandstone bedrock. The barn area has been excavated into the slope exposing sandstone bedrock to the north which contains sandstone bedrock. The sandstone bedrock is classified as medium strength (based on tactile assessment), fine to medium grained and contains gently east dipping cross beddings and appeared stable (Photograph-2). The barn and surrounding ground appeared in good condition with no signs of excessive ground movement or underlying geotechnical issues.

*Photograph-1: The barn. View looking east.*

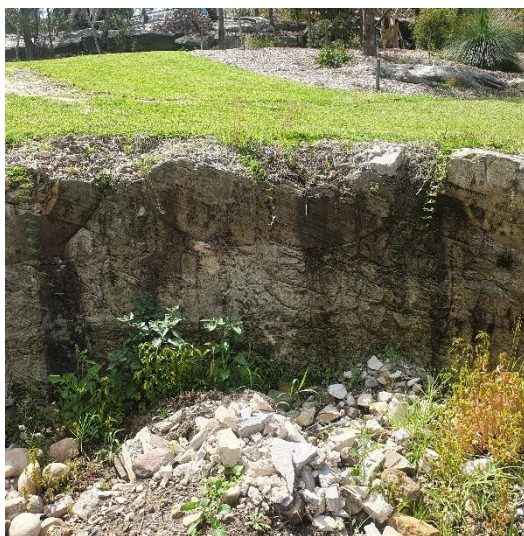
*Photograph-2: Excavated bedrock. View looking north.*

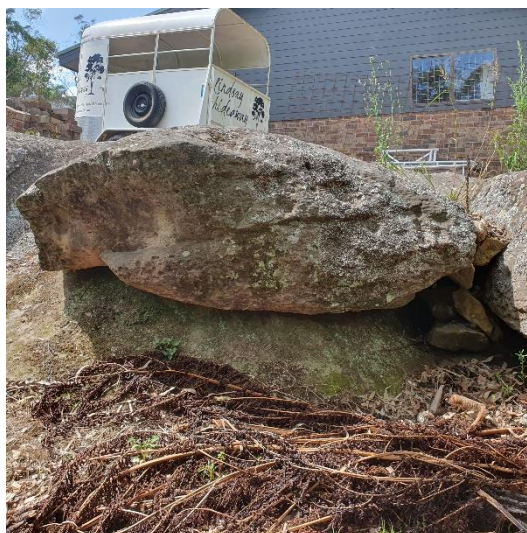
Approximately 5.0m south from the barn, the bedrock steeply ( $-30^\circ$ ) dips south and contains relatively large boulders on the top. An approximately 2.0m wide x 1.50m high x 2.0m long boulder was observed to be marginally stable (Photograph-3) and is located on the higher northern side of the eastern front lawn with medium sized trees (approximately 5.0m tall trees, 0.50m diameter trunk) between the front eastern grass lawn and boulder.

*Photograph-3: Marginally stable sandstone boulder.*

It is considered that a detailed Landslip Risk Assessment for this S4.55 Application is not required. However, it is recommended that the marginally stable boulder identified to the south of the barn (Photograph-3) be supported via the construction of a piers (down to bedrock) below the southern end of the boulder to prevent it from rolling. Additionally, it is recommended that the tree located directly adjacent to the driveway excavation (Photograph-5) be supported or removed to prevent this from falling to the nearby structure.

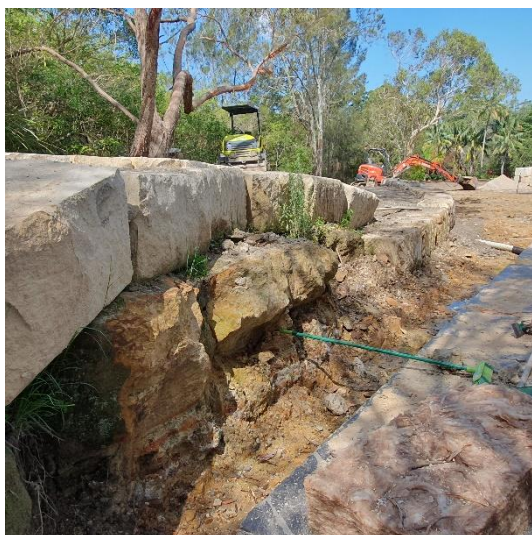
The northern portion of the block also contains open grass lawns which are gently south dipping ( $<5^\circ$ ) and within the centre rear of the site is a single storey timer building which is currently under renovation. The building is surrounded by a concrete slab and contains a gravel driveway to the north (approximately 1.50m higher than the concrete driveway). The concrete driveway and building have been excavated (approximately 1.50m deep) into the slope and exposes residual natural material/extremely weathered bedrock to the north (supporting the gravel higher driveway) (Photograph-4). To the north-west of the concrete driveway, the excavation exposes silty sandy fill and tree roots of an approximately 5m high tree located directly adjacent to the excavation (Photograph-4). The driveways and building appeared in good condition, however the tree appeared marginally stable.

*Photograph-4: Residual material/EW bedrock. View looking east.*

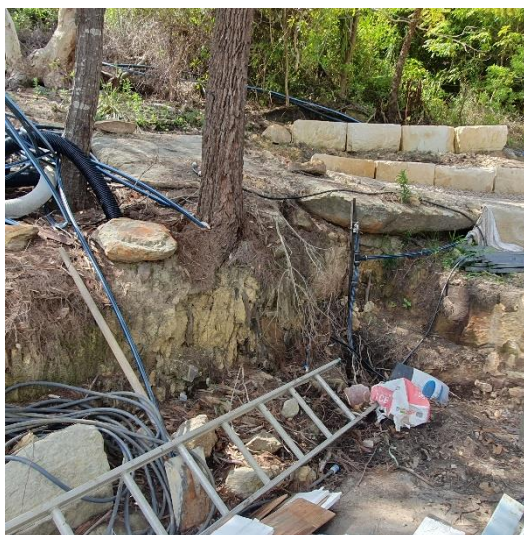
*Photograph-5: Tree located directly adjacent to the excavation. View looking north.*
