Report Title: Geotechnical Report 57 Mona Vale Road, Mona Vale  
Report Date: 28/6/21

## **GEOTECHNICAL INVESTIGATION:**

### **New Pool and Landscaping at 57 Mona Vale Road, Mona Vale**

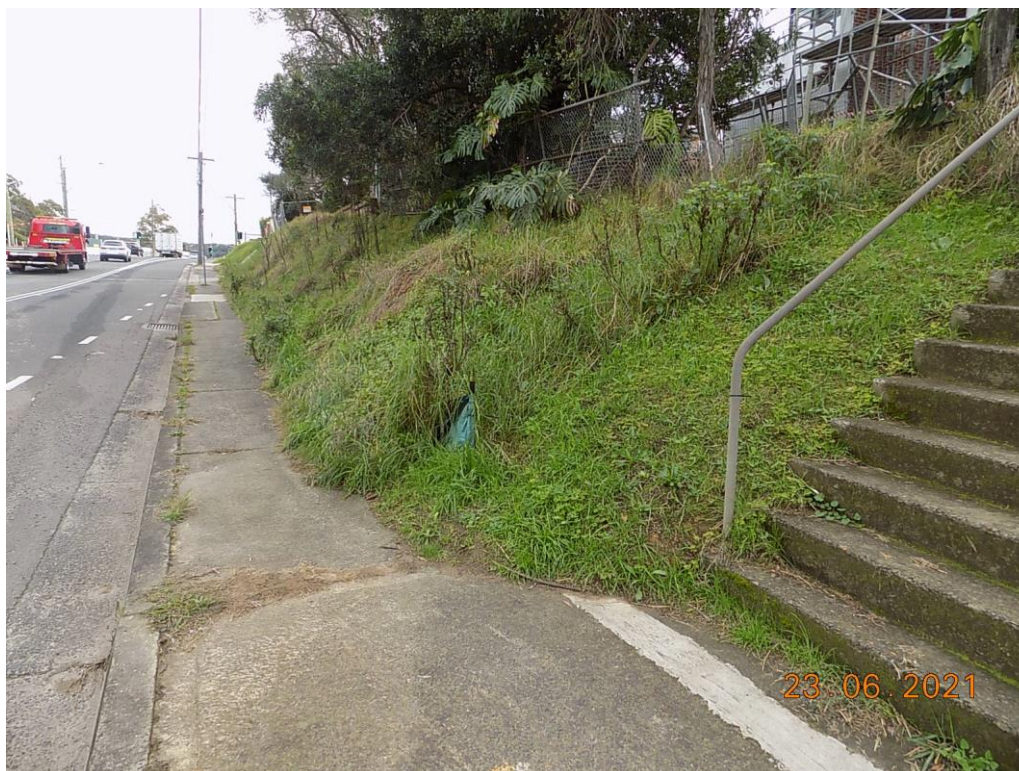
Photo 1

- 2.3** The cut for Mona Vale Road is lawn-covered and battered to stable angles (Photo 1). Between the cut batter and the house is a gently sloping garden area (Photo 2). The house is currently under construction as part of a separate application (Photo 3). Currently, an unsupported excavation has been made in the slope to a maximum depth of ~1.2m to create a level platform for the house (Photo 4). The excavation is proposed to be extended as part of the proposed works for the pool area. We recommend the cut batter be temporarily supported until the retaining wall

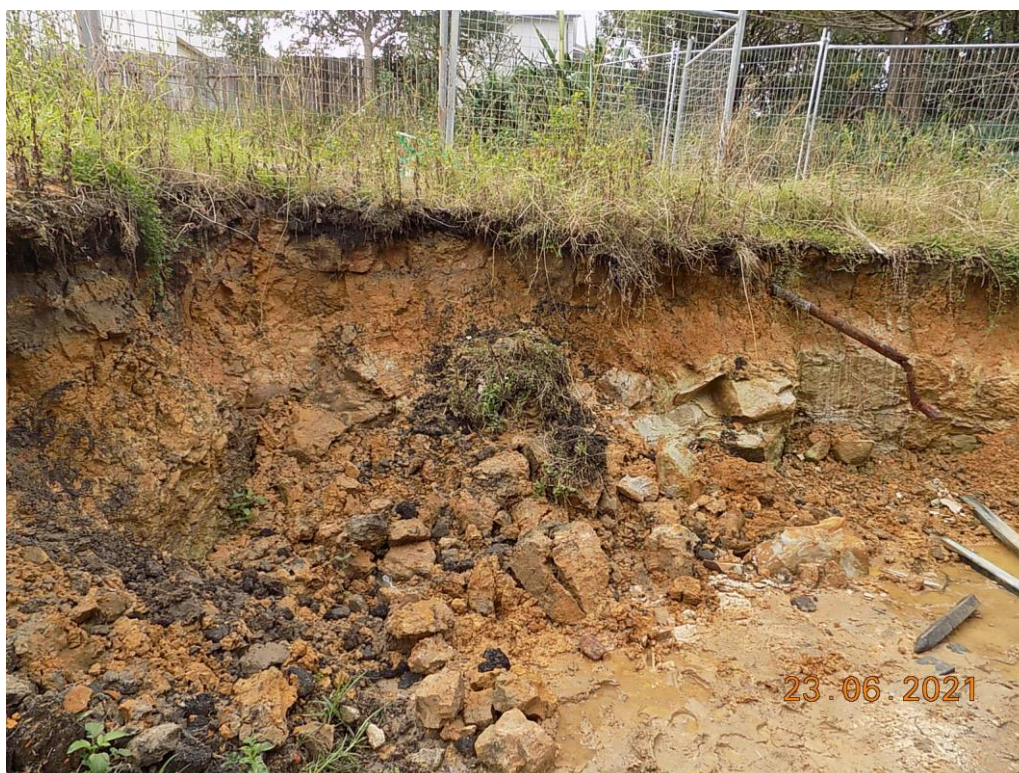
Photo 4

| HAZARDS | Hazard Three | Hazard Four |
|---|---|---|
| TYPE | The proposed fill failing and impacting on the subject property before the retaining walls are in place. | The as-dug excavation for the house collapsing onto the work site before retaining walls are in place (Photo 4). |
| RISK TO PROPERTY | 'Moderate' ( $2 \times 10^{-4}$ ) | 'Moderate' ( $5 \times 10^{-5}$ ) |
| RISK TO LIFE | $6.6 \times 10^{-5}$ /annum | $8.3 \times 10^{-7}$ /annum |
| COMMENTS | This level of risk to life and property is 'UNACCEPTABLE'. To move risk to 'ACCEPTABLE' levels the recommendations in <b>Section 14</b> are to be followed. | This level of risk to property is 'TOLERABLE'. To move risk to 'ACCEPTABLE' levels, the recommendations in <b>Section 2.3</b> are to be followed. |

is constructed or until the proposed excavation works commence, whichever occurs first.

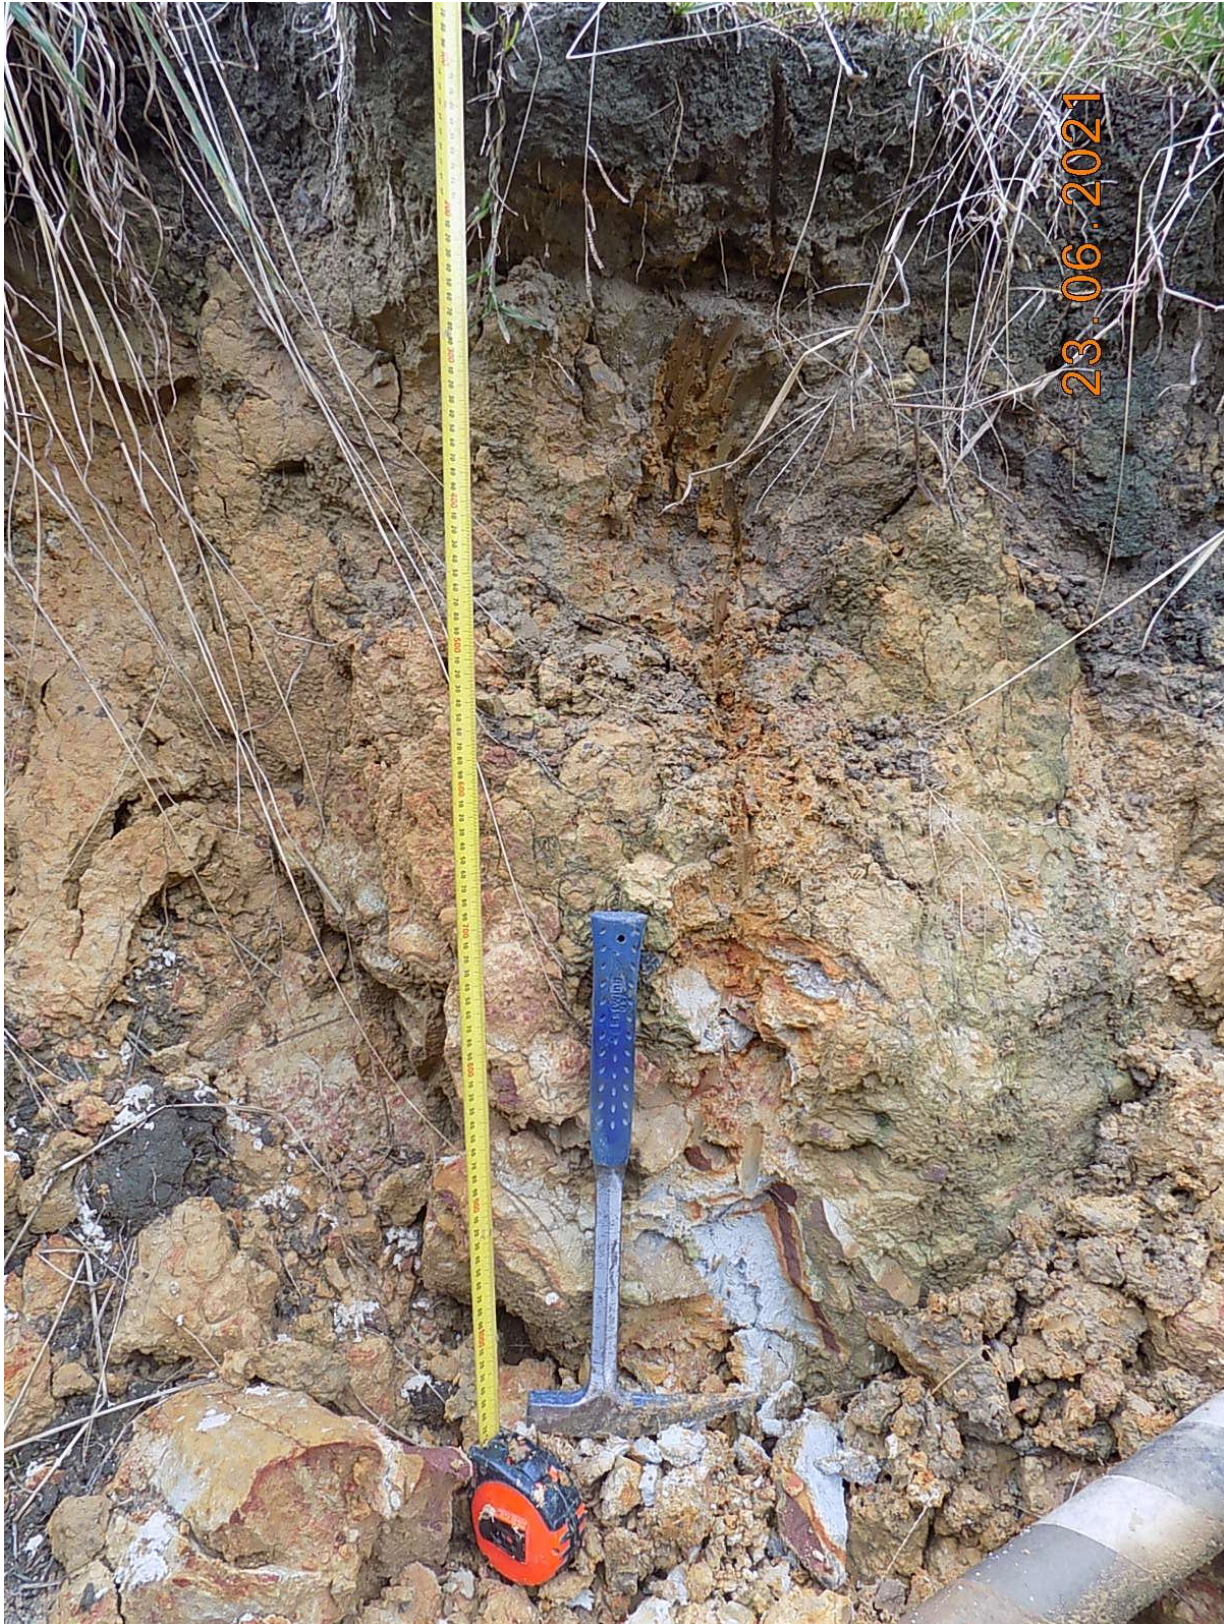
#### EXCAVATION 1 (~RL41.6) – EXC1 (Photo 5)

| Depth (m) | Material Observed |
| 0.0 to 0.2 | <b>CLAYEY SOIL</b> , dark brown, dense, damp, fine to medium grained with fine trace organic matter. |
| 0.2 to 0.5 | <b>CLAY</b> , brown, firm, damp, fine grained. |
| 0.5 to 1.1 | <b>EXTREMELY LOW TO LOW STRENGTH SHALE</b> , grey and mottled orange and maroon, damp, fine grained. |

Base of excavation @ 1.1m in Low Strength Shale.

Photo 5: EXC1 – Downhole is from top to bottom
