GEOTECHNICAL RISK MANAGEMENT POLICY FOR PITTWATER
FORM NO. 1 – To be submitted with Development Application

GEOTECHNICAL INVESTIGATION:

New House at **3 Alexandra Crescent, Bayview**

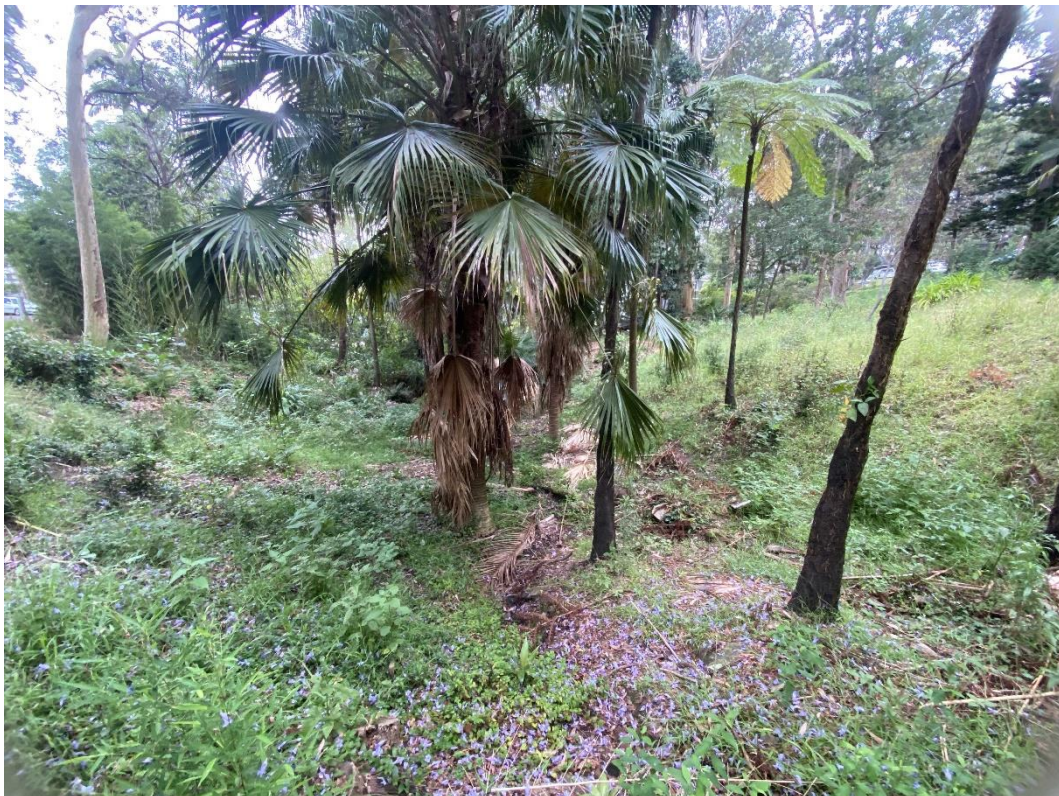
Photo 4

- 2.1** The site was inspected on the 29th November, 2024.
- 2.2** This vacant property is on the low side of the road. The property encompasses the moderately graded N and S banks of a drainage path that falls to the E. The natural slope falls towards the channel at an average angle of $\sim 12^\circ$. The slope above and below the property continues at similar angles.
- 2.3** At the road frontage, undeveloped bushland falls to a drainage path that enters the property from a stormwater culvert headwall at the upper boundary (Photos 1 & 2). The council stormwater map indicates a conduit continues through this property. However, the termination point is visible above the surface. The watercourse runs to the E and continues beyond the E boundary (Photo 3). The undeveloped bushland rises from the S side of this water channel to the S common boundary (Photo 4).

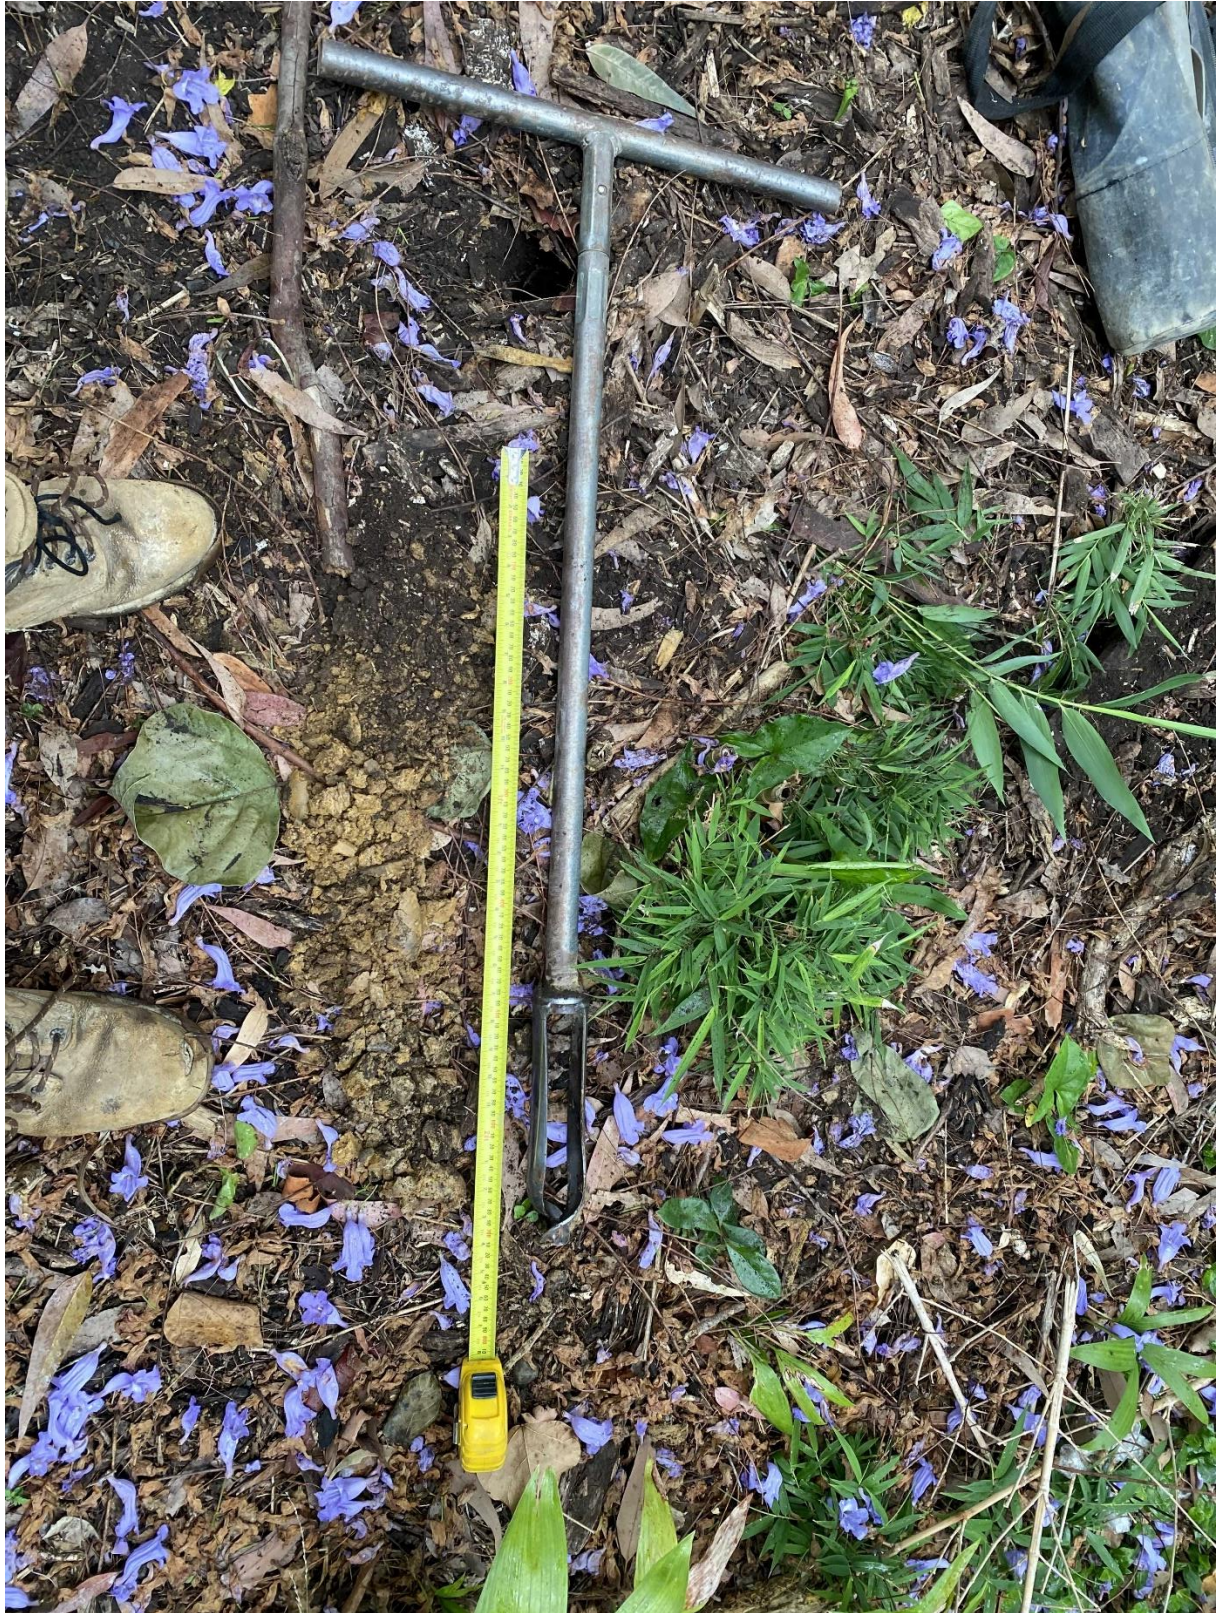
Photo 5 (Top to Bottom)

AUGER HOLE 1 (~RL24.5) – AH1 (Photo 5)

Depth (m)	Material Encountered
0.0 to 0.2	TOPSOIL , dark brown clayey soil, medium grained, loose, fine trace of organic matter, dry.
0.2 to 0.7	CLAY , orange, fine grained, stiff, dry.

Refusal @ 0.7m. No water table encountered.

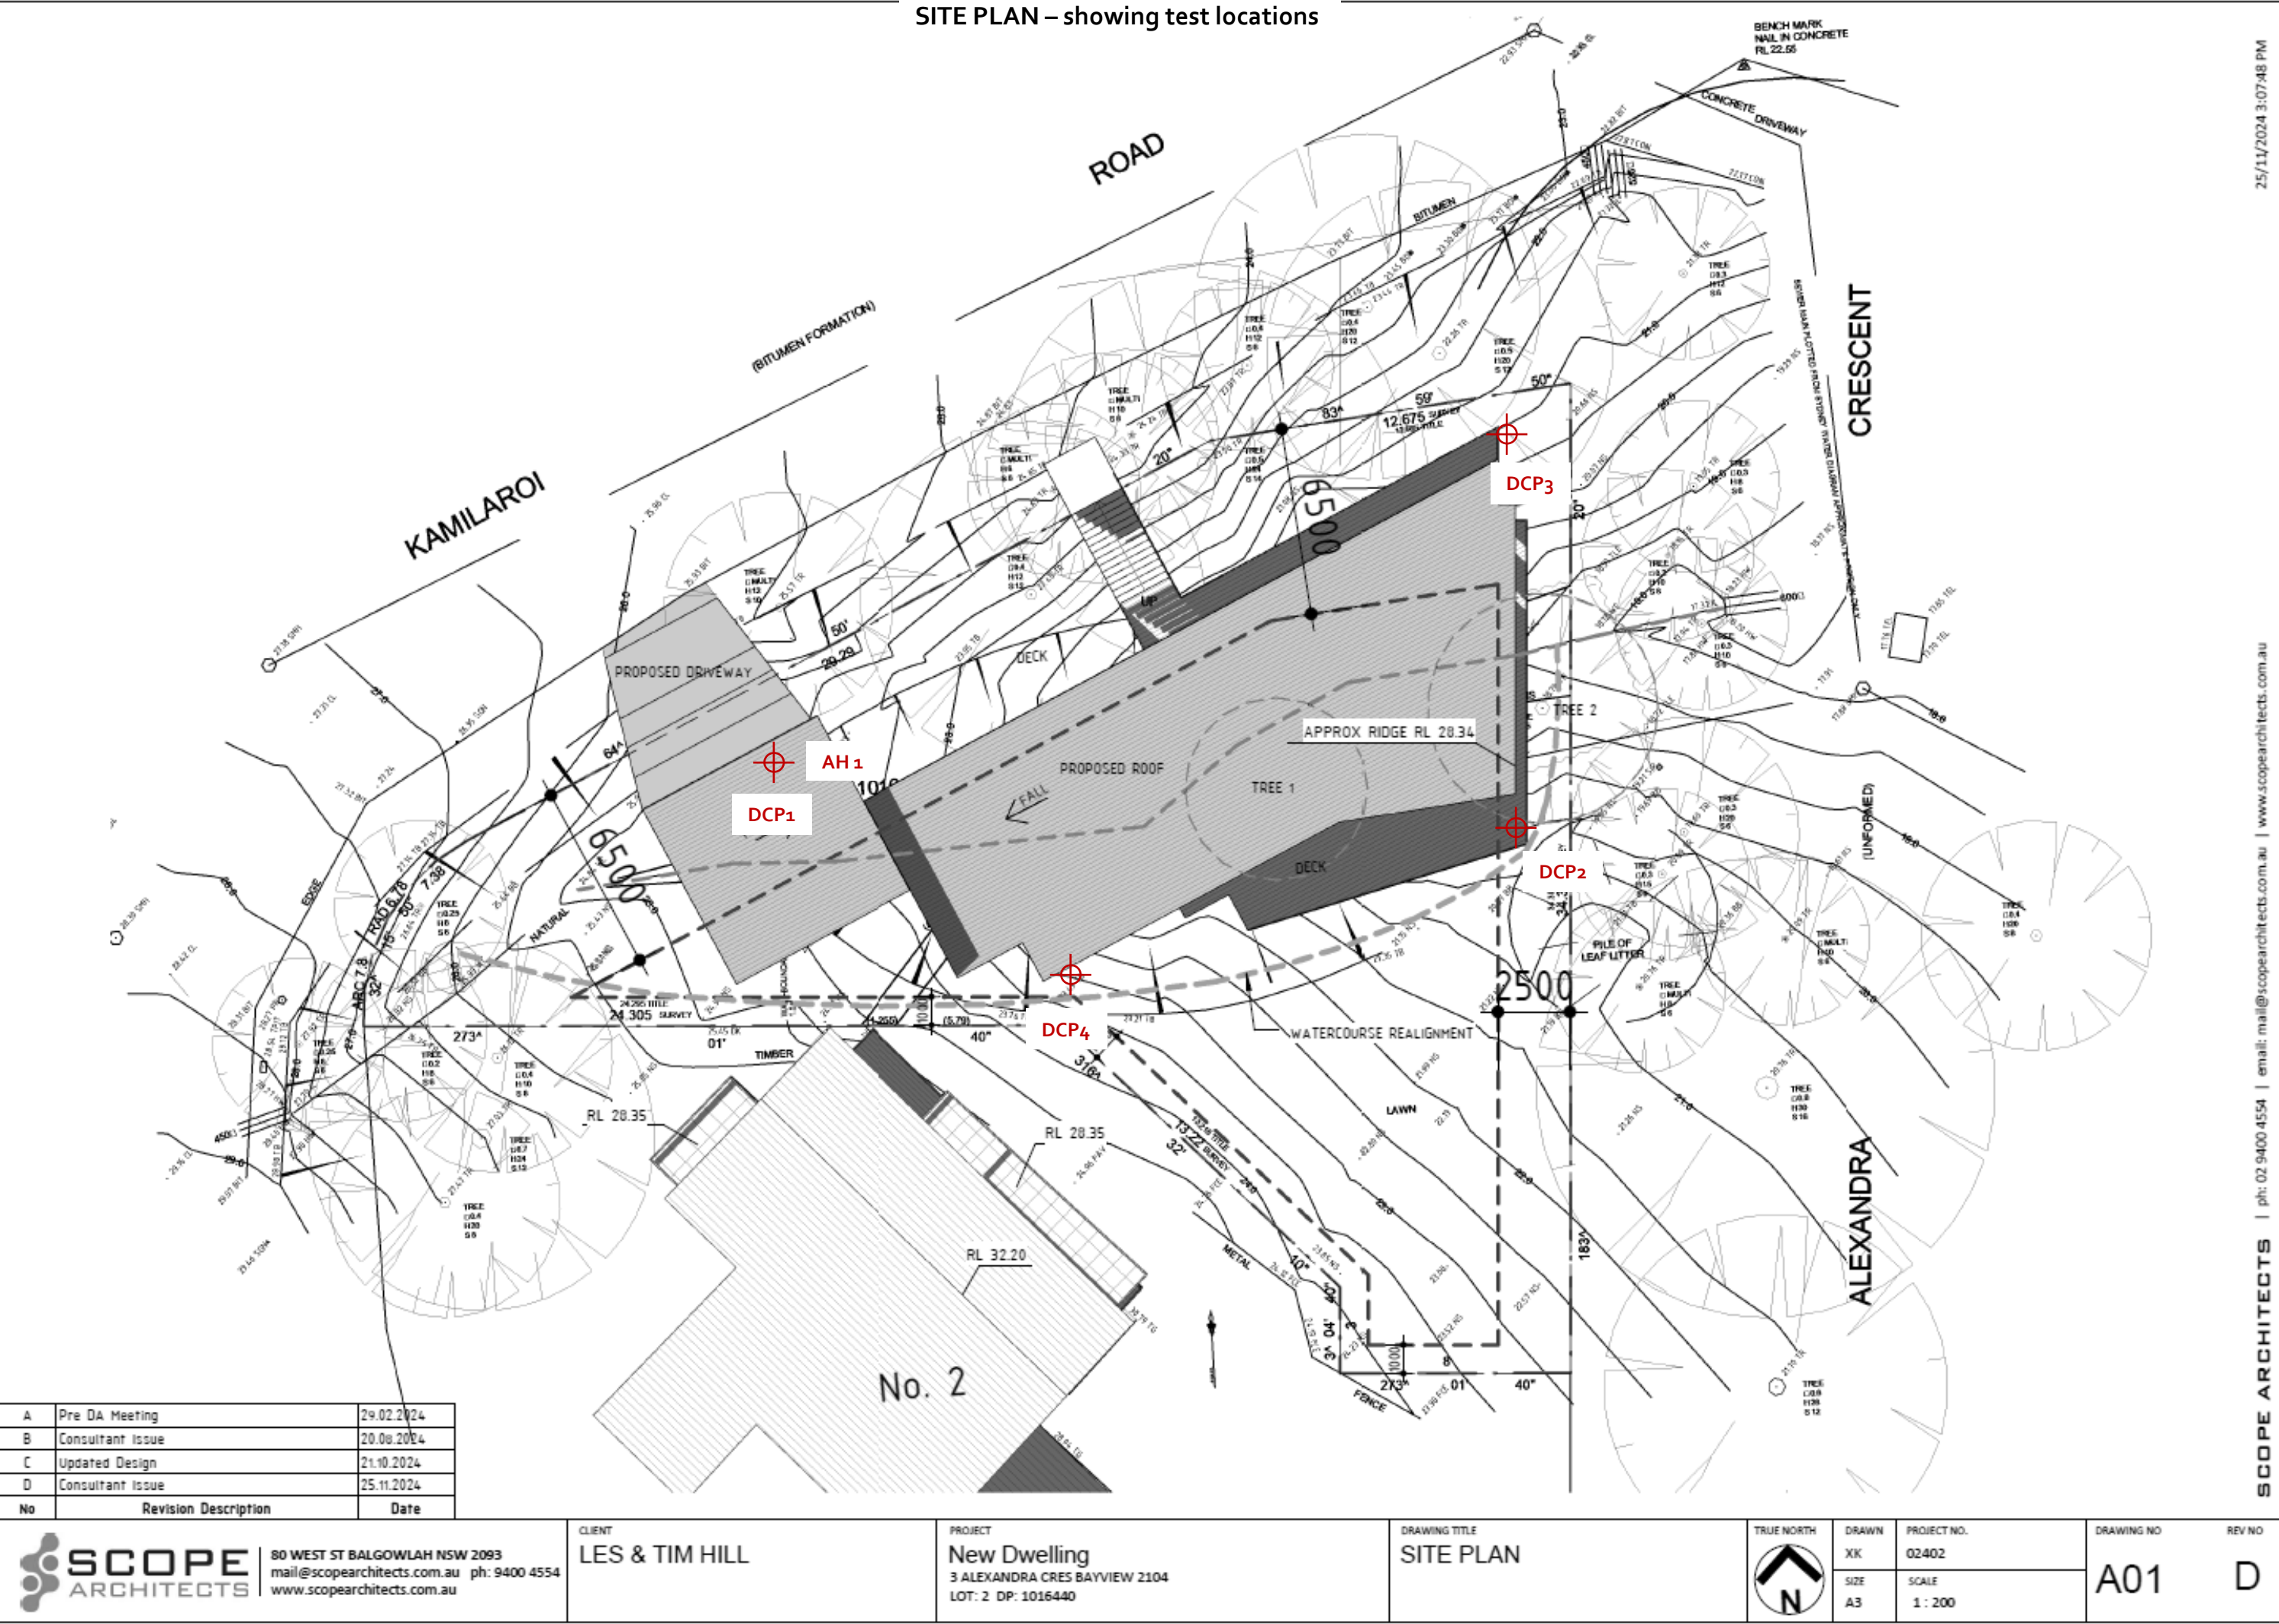
SITE PLAN – showing test locations

One hand Auger Hole (AH) was put down to identify soil materials. Four Dynamic Cone Penetrometer (DCP) tests were put down to determine the relative density of the overlying soil and the depth to weathered rock. The locations of the tests are shown on the site plan attached. It should be noted that a level of caution should be applied when interpreting DCP test results. The test will not pass through hard buried objects so in some instances it can be difficult to determine whether refusal has occurred on an obstruction in the profile or on the natural rock surface. This is not expected to be an issue for the testing on this site. However, excavation and foundation budgets should always allow for the possibility that the interpreted ground conditions in this report vary from those encountered during excavations. See the appended "Important information about your report" for a more comprehensive explanation. The results are as follows:

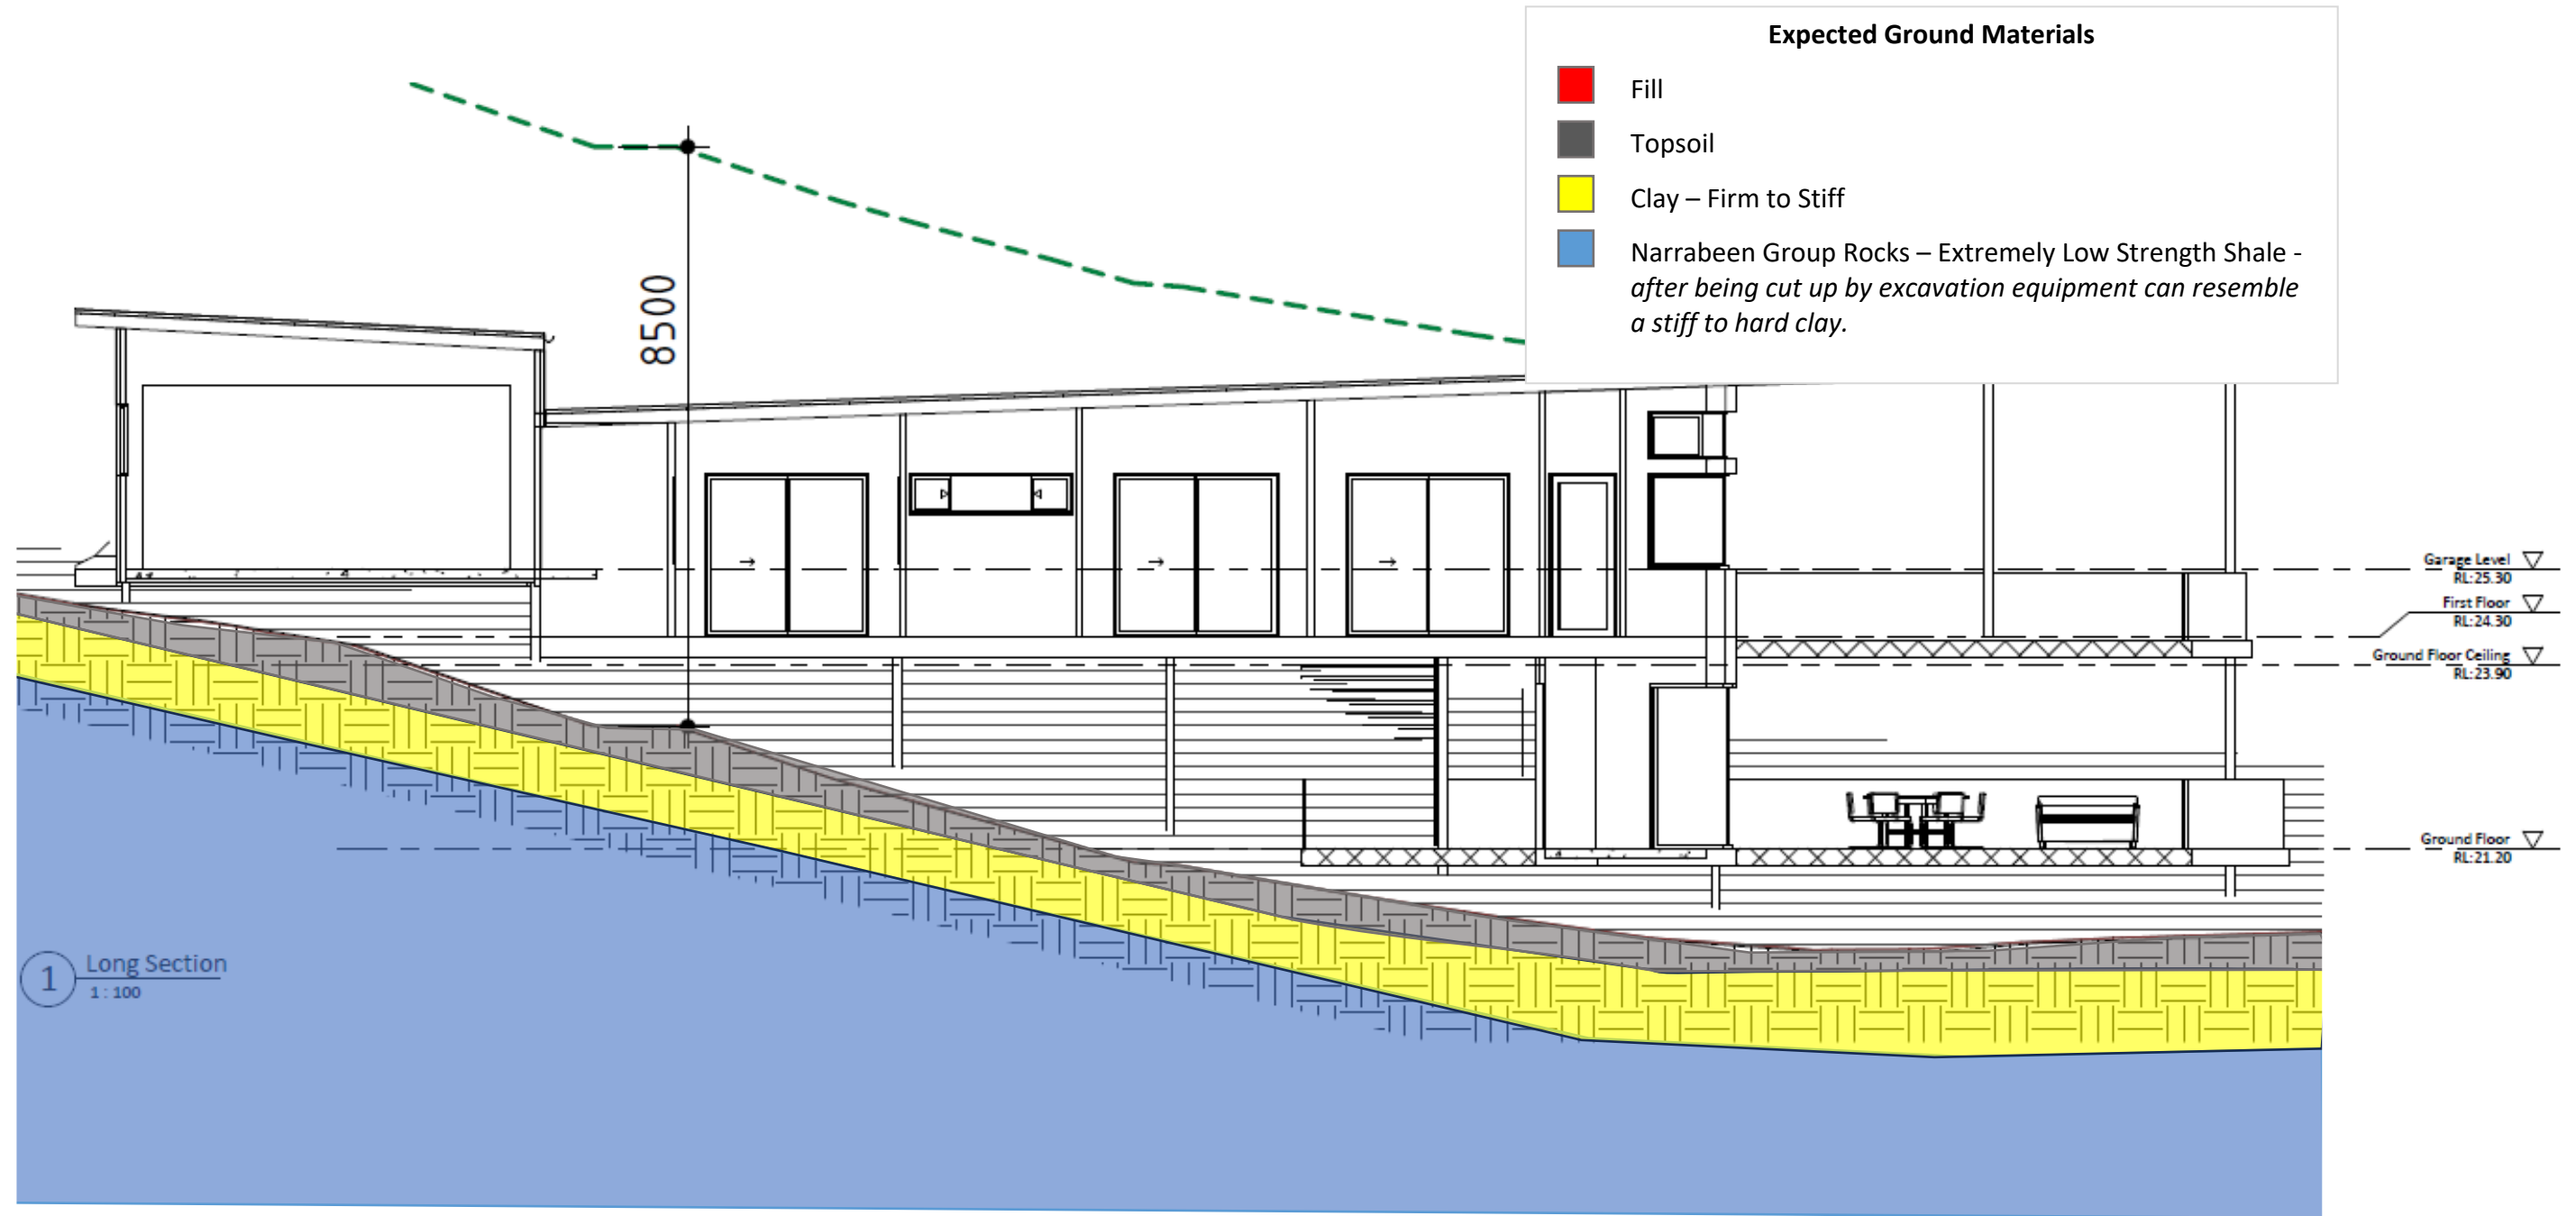
TYPE SECTION – Diagrammatical Interpretation of expected Ground Materials

The slope materials are colluvial at the near surface and residual at depth. In the test locations, the ground materials consist of shallow soils over clays. The clay merges into the underlying weathered rock at depths of between ~0.9m to ~1.2m below the current surface. The weathered zone is interpreted to be Extremely Low Strength Shale. See Type Section attached for a diagrammatical representation of the expected ground materials.

Due to the presence of the water course that runs across the property, the proposed house is to be supported off piers taken to and embedded 0.6m into the underlying Extremely Low Strength Shale. This ground material is expected to be encountered at depths of between ~0.9m and ~1.2m. As such, the required depths of the piered foundations are expected to be between ~1.5m and 1.8m below the current surface measured from the downhill side of each pier hole. See Type Section appended.
