# Geotechnical Assessment

**Project:** Proposed Duplex Development  
46 Pitt Road, North Curl Curl NSW

**Ref:** AG 25408  
4 September 2025

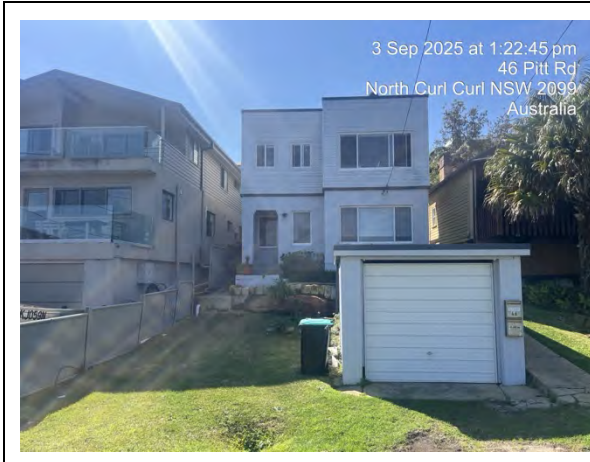
**Photo 1:** Site frontage.

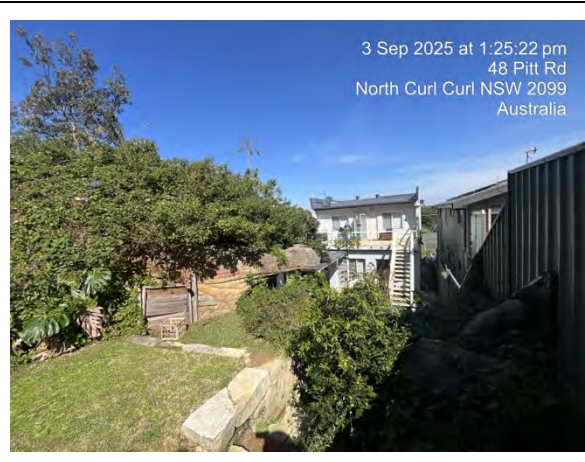
**Photo 2:** Residence rear.

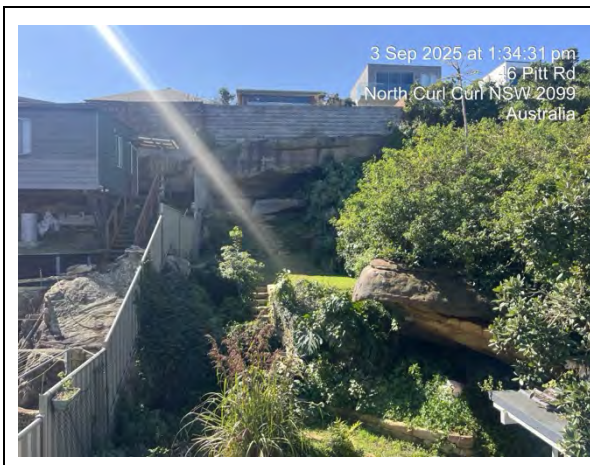
**Photo 3:** Looking from residence rear towards rear boundary.

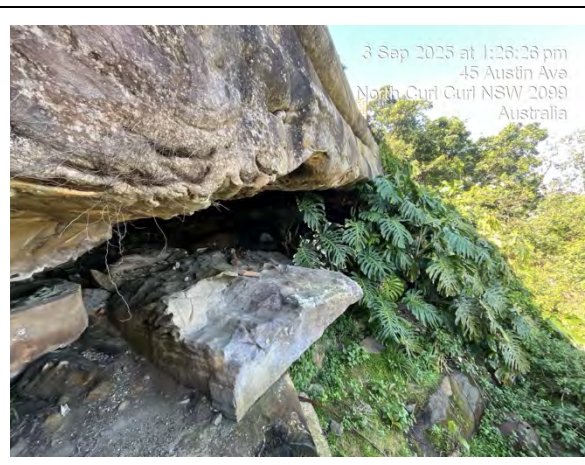
There are failed joint blocks located at the base of the undercut, having settled in the position from which they fell from the undercut (e.g. Photo 4). Localised, freshly exposed sandstone faces, indicative of more recent minor failures (i.e. ~last 10 years) were observed (Photo 5 & 6).

**Photo 4:** Undercut bedrock near rear boundary and historical block failure.

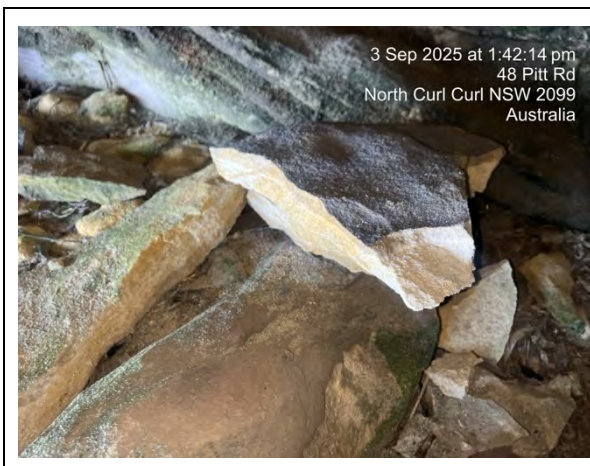
**Photo 5:** Evidence of recent localised failure.

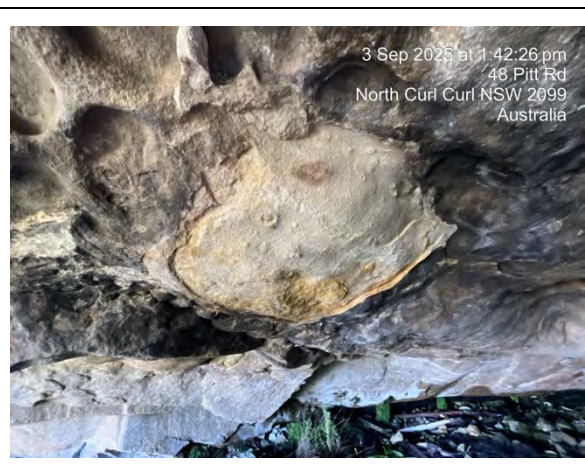
**Photo 6:** Evidence of recent localised failure.

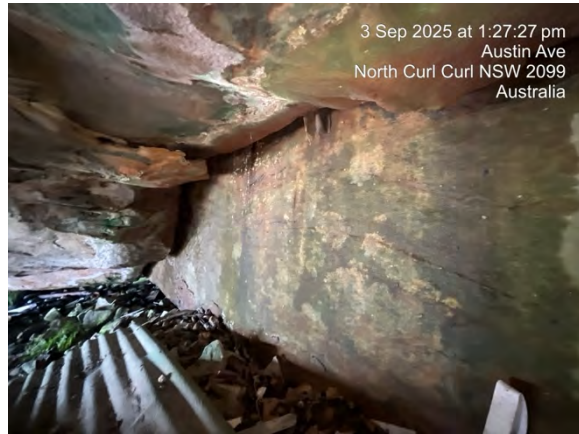
A significant vertical joint, approximately 100mm wide, was observed running ~E–W across the rear of the undercut section of rock. The rock in the area of the joint was noticeably wet, and dripping water was observed falling from the joint (Photo 7 & 8). A smaller vertical joint running ~N–S was observed running approximately in line with the eastern boundary of the site; this joint was dry (Photo 9).

- A significant vertical joint, of approx. 100mm wide, was observed running ~E-W across the rear of the undercut section of rock. The rock in the area if the joint was noticeably wet, and dripping water was observed falling from the joint. (i.e. an active erosional process occurring at the rear wall of the undercut rock).

**Photo 7:** Significant vertical joint at the rear of the undercut bedrock running ~E-.

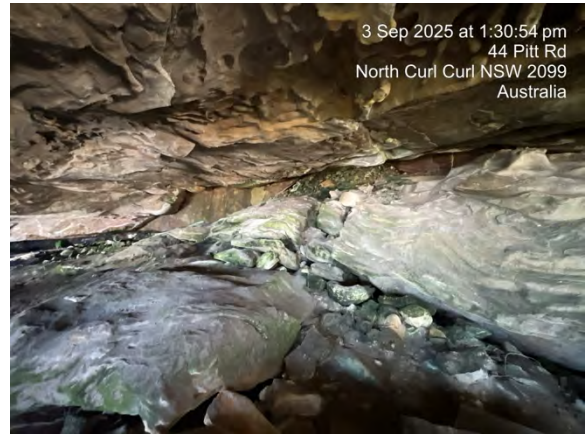
**Photo 8:** Significant vertical joint at the rear of the undercut bedrock running ~E-W – wider angle.

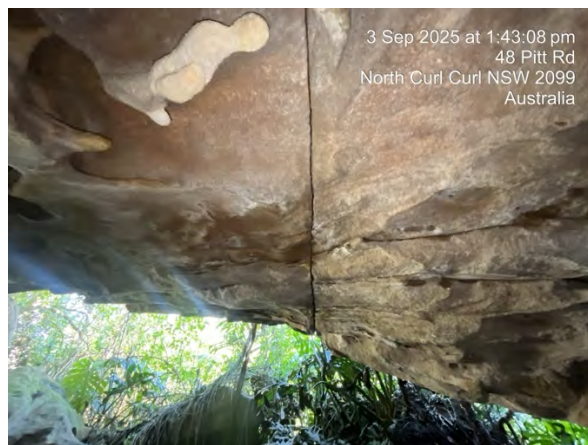
**Photo 9:** Vertical joint running ~N-S, approximately in line with the eastern boundary of the subject site.

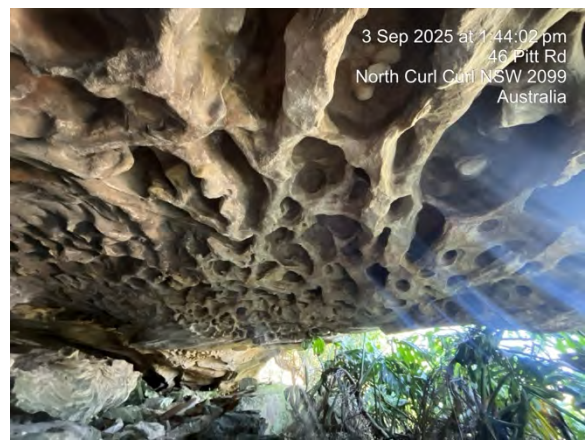
- The extremely weathered underside of the undercut indicated the formation has been in its current state for a significant time period, however there is evidence of recent localised minor failures.

**Photo 10:** Underside of the undercut is extremely weathered, indicates the formation has been in its current state for a significant period of time.
