# Geotechnical Assessment

**Project:** Alterations & Additions  
48 Annam Road, Bayview NSW

**Prepared for:**  
Nikki Hardy & Sven Amman, c/- Rapid Plans

**Ref:** AG 25436  
2 October 2025

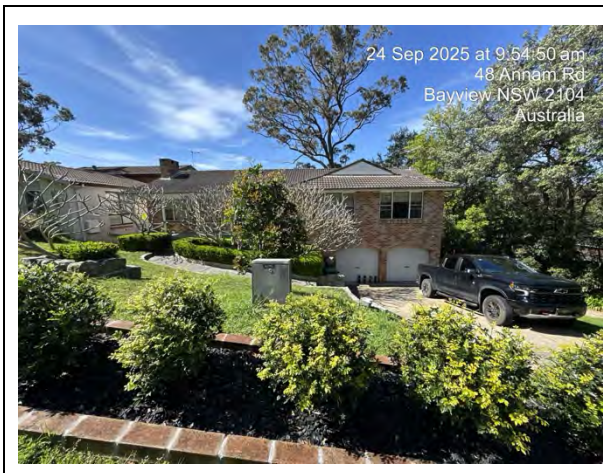
**Photo 1:** Site frontage, looking south-east.

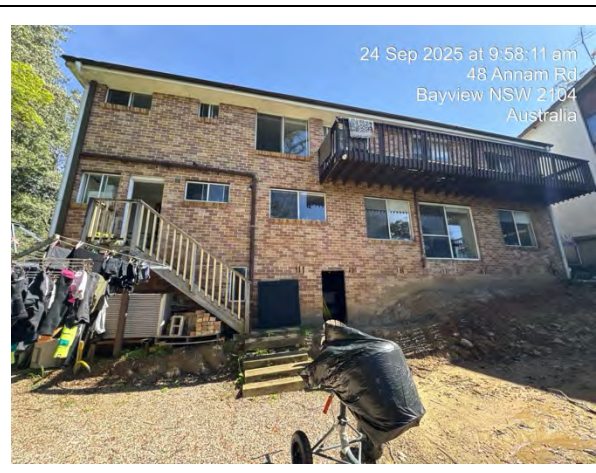
**Photo 2:** Photo taken at the rear of the dwelling, looking north-west.

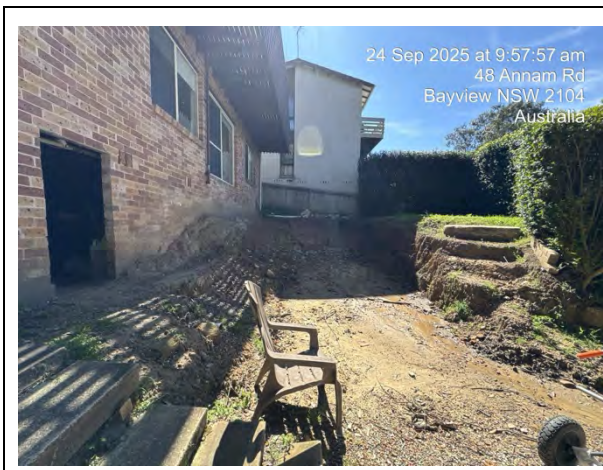
**Photo 3:** Photo taken at the rear of the dwelling, looking north-east.

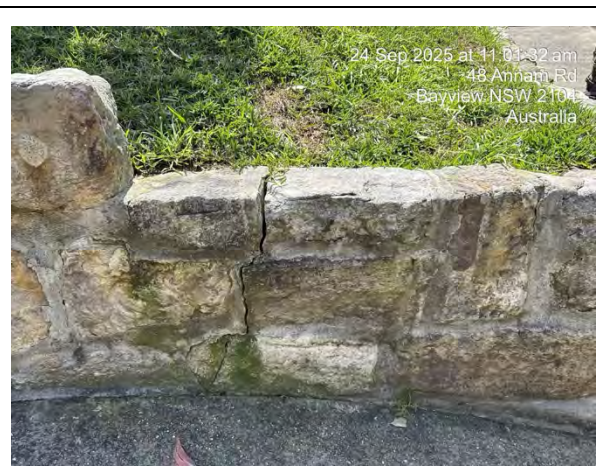
| Parameter | Description |
|---|---|
| Retaining structures | Mortared stone walls appear in fair condition but there is a crack on the wall at the front of the dwelling. |

**Photo 4:** Mortared stone walls at the front of the dwelling, looking north-east.

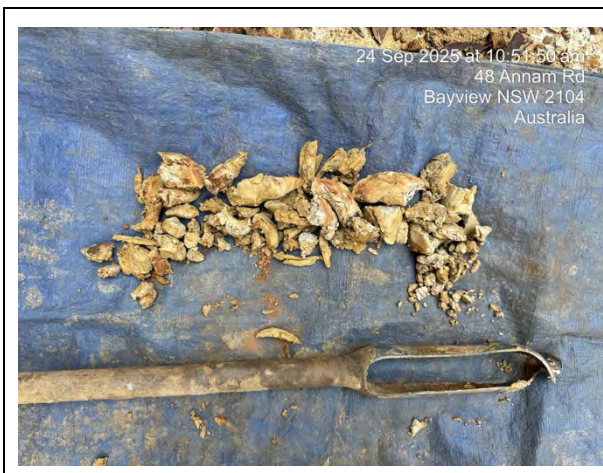
**Photo 5:** Subsurface soil profile of BH1.

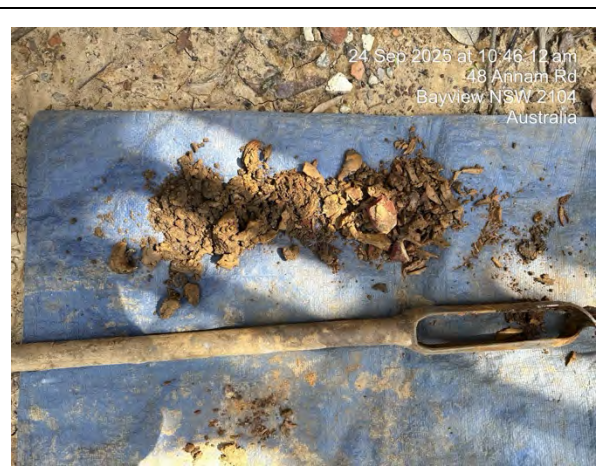
**Photo 6:** Subsurface soil profile of BH2.
