## **PRELIMINARY GEOTECHNICAL ASSESSMENT:** **14 Ocean Road, Manly**

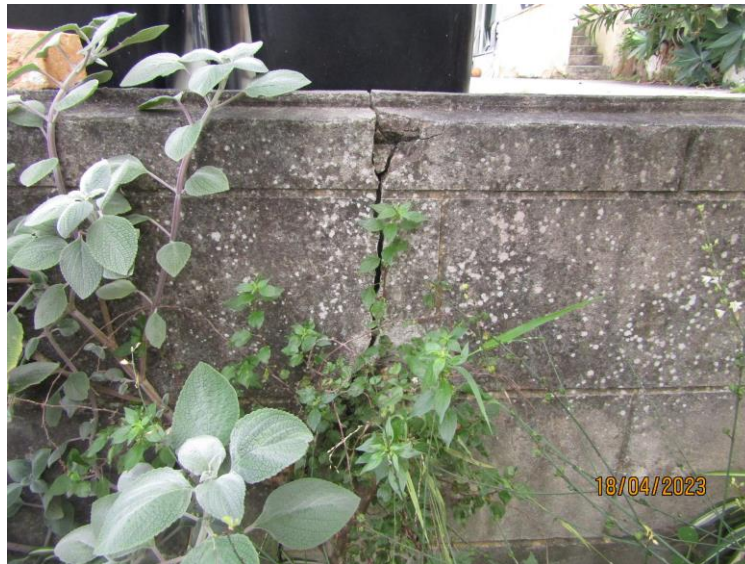
Photo 1

The cracked concrete block retaining wall (Photos 1 & 2) is to be monitored by the owners on an annual basis or after heavy and prolonged rainfall events, whichever occurs first. A photographic record of these inspections is to be kept. Should further movement occur the

wall is to be remediated so it meets current engineering standards. We can carry out these inspections upon request.
