Report Title: Geotechnical Report 47 Elaine Avenue, Avalon Beach  
Report Date: 7/12/21

## **GEOTECHNICAL INVESTIGATION:**

New Pool at **47 Elaine Avenue, Avalon Beach**

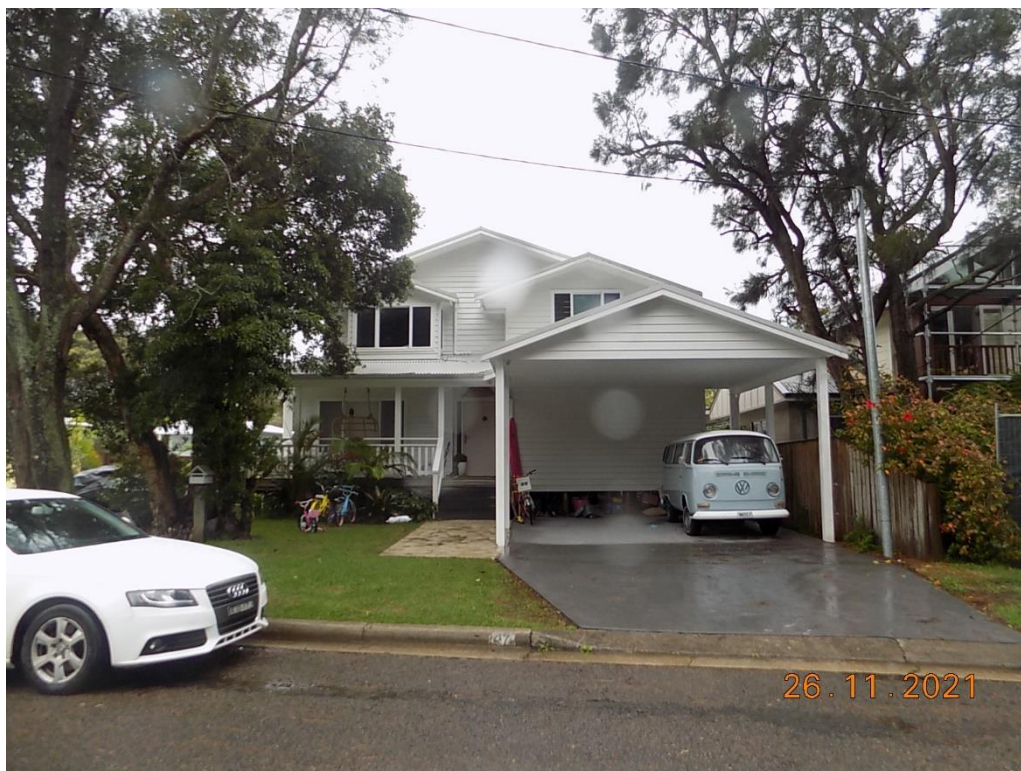
Photo 1

- 2.3** At the road frontage, a concrete driveway runs to a carport attached to the W side of the house (Photo 1). In between the road frontage and the house is a level lawn area. The part two storey timber framed and clad house is supported on timber posts (Photos 2 & 3). The timber posts appear to stand vertical. A gently sloping lawn area extends from the E side of the house to the lower boundary (Photo 4). A concrete retaining wall supports the cut for a concrete-lined drainage channel immediately beyond the lower boundary (Photo 5).

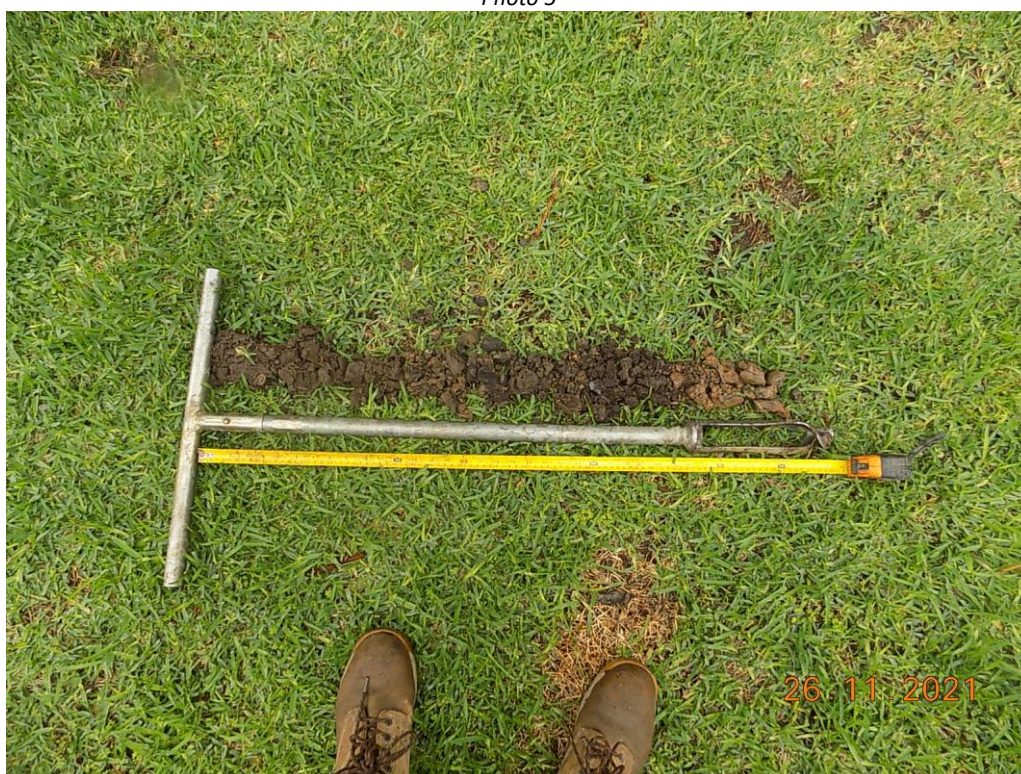
Photo 6 (Left to right)

#### AUGER HOLE 1 (~RL2.75) – AH1 (Photo 6)

| Depth (m) | Material Encountered |
|---|---|
| 0.0 to 0.3 | <b>FILL</b> , dark brown clayey soil, fine to medium grained, loose, fine trace of organic matter, dry. |
| 0.3 to 0.6 | <b>FILL</b> , yellow and brown, fine grained, stiff, dry. |
| 0.6 to 0.8 | <b>CLAY</b> , black and yellow, fine grain, stiff to hard, dry. |
| 0.8 to 0.9 | <b>CLAY</b> , mottled yellow and maroon, hard, dry. |

End of test @ 0.9m. No water table encountered.
