## **REPORT ON GEOTECHNICAL SITE INVESTIGATION**

### **PROPOSED ALTERATIONS AND ADDITIONS**

**28 ETHEL STREET, BALGOWLAH, NSW**

**Project No.: 2021-198**

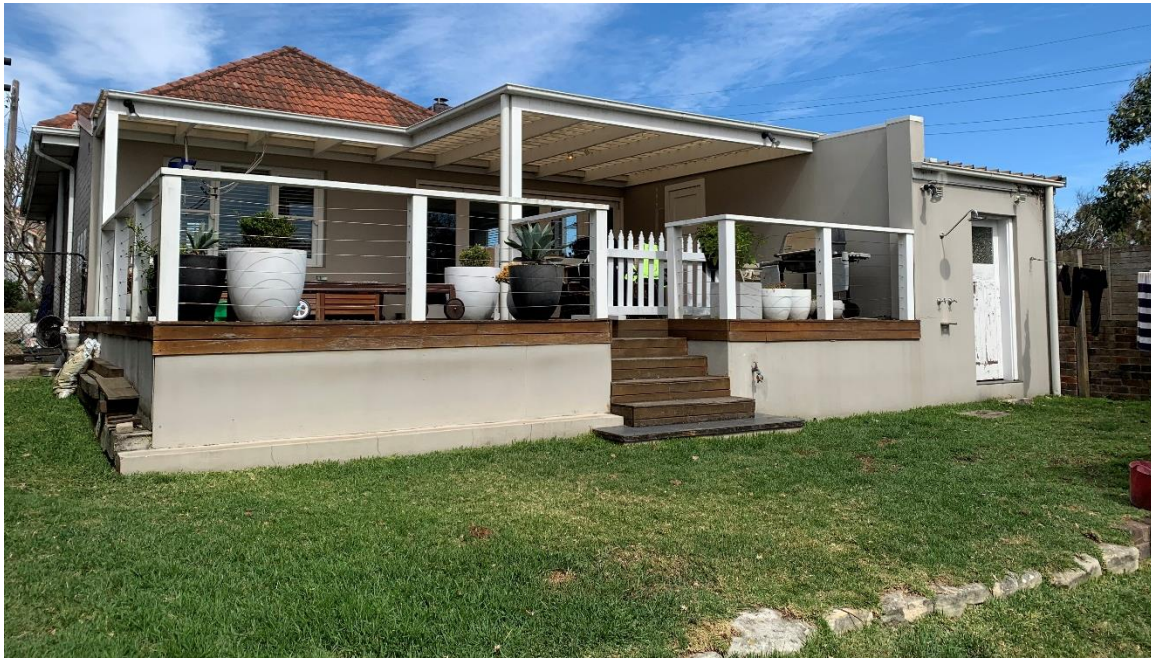
*Photograph 2. View of the rear of the main structure, facing south*

The site contains a one storey brick cottage positioned towards the front of the site which appears to be in good condition with only minor horizontal cracking identified within the rear wall of the structure. Vehicle access is provided along the western boundary via a concrete stripped driveway from Ethel Street. The front of the block contains a small grassed lawn and surrounding gardens, with a rendered brick and timber boundary wall extending around the southern and western boundary within the front of the site.

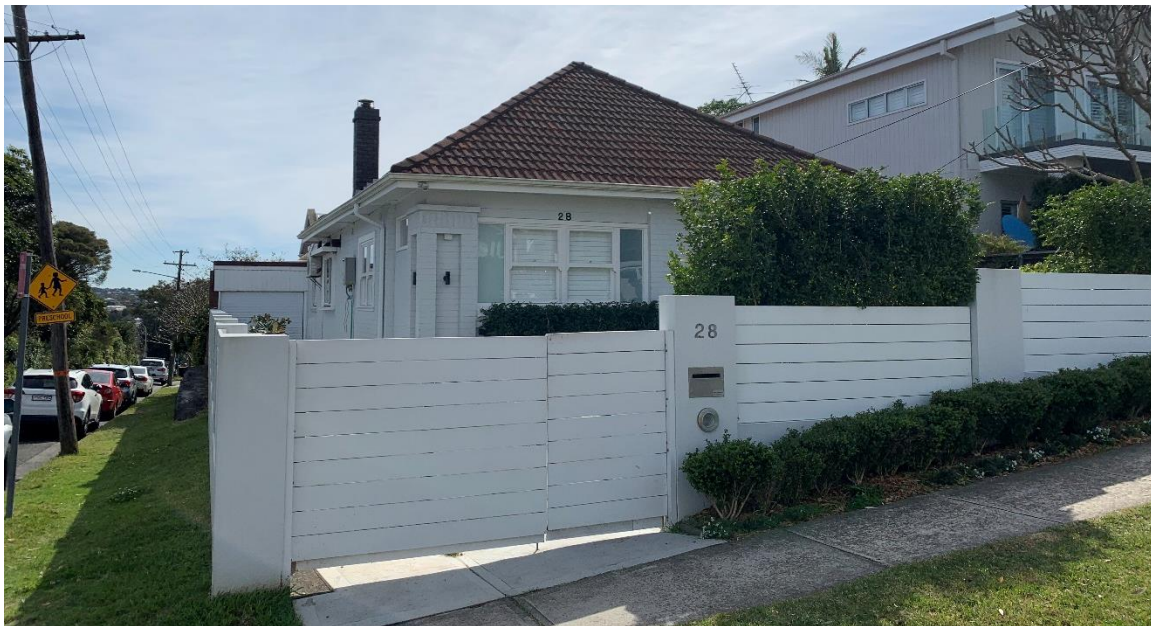
*Photograph 3. View of the front of the site, facing north*

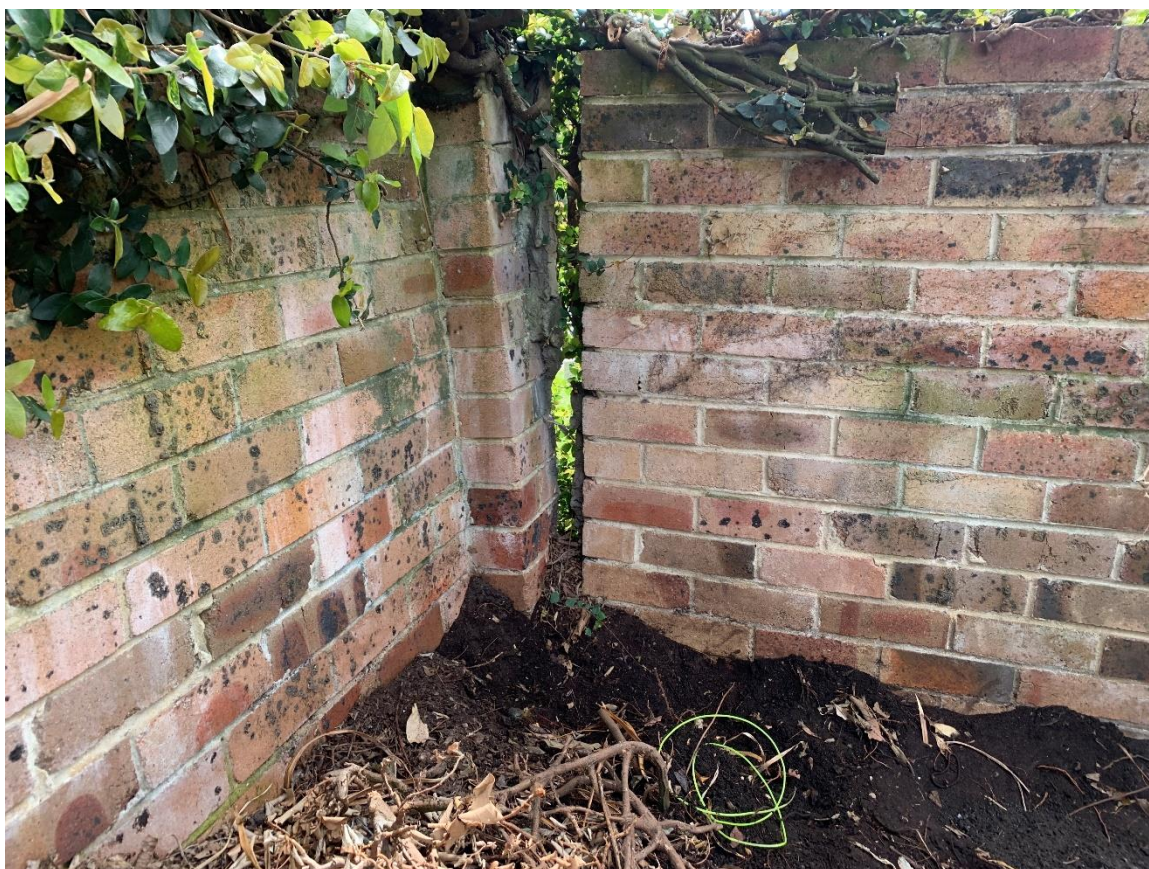
the upper southern region of the rear, as vertical brick walls are positioned adjacent to the western boundary and appear to underlie portions of the grass. A single skin brick 1.55m high boundary wall is positioned along the western and northern boundaries within the rear and has undergone significant deflection and settlement within western portions. The north western corner of the wall has a  $\leq 150\text{mm}$  deflection and significant outward rotation as shown in Photograph 4.

*Photograph 4: Outward rotation within the western boundary wall within the rear of the site, with significant deflection and  $\leq 150\text{mm}$  separation from adjacent northern boundary wall, facing north.*

Existing landslip hazards were not identified however the excavation will create potential stability hazards though these are not expected to impact adjacent properties but will need to be considered during construction. The existing northern boundary wall is in an unstable condition and should be removed or reconstructed as part of or prior to demolition and excavation works.

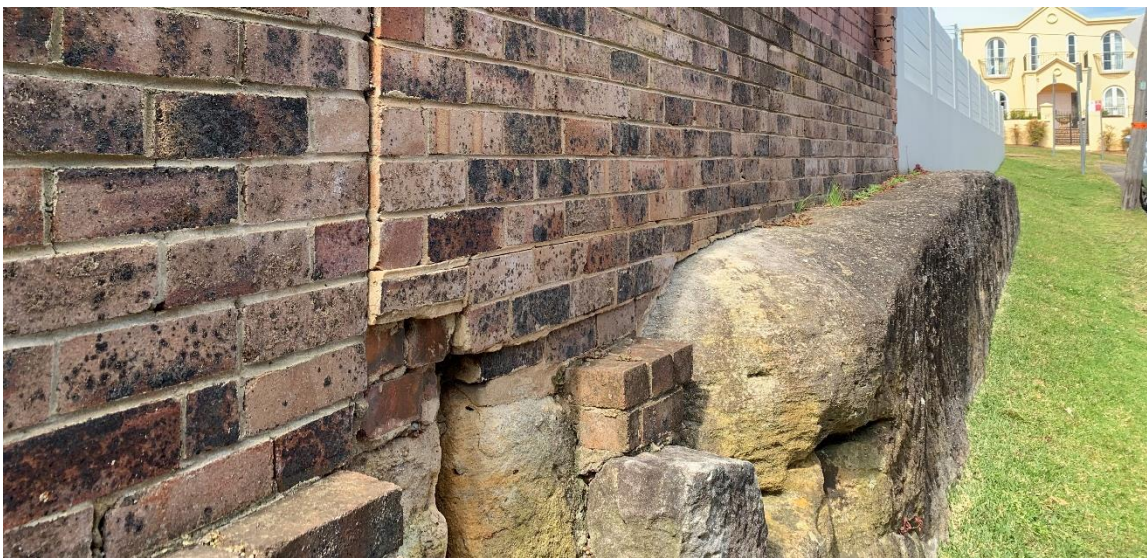
Exposed sandstone bedrock was identified within the site and surrounding areas. A  $\approx 10\text{m}$  long section of outcropping bedrock was observed below the western boundary fence, with the rendered boundary wall, brick wall and north western portion of the main structure all bearing on the exposed bedrock. This outcrop is shown in Photograph 5. Exposed sandstone bedrock was also identified within the rear lower northern portion of the site.

*Photograph 5: Exposed sandstone bedrock along the western boundary of the site, with brick wall of main structure and western boundary wall formed on outcrop.*
