## **PRELIMINARY GEOTECHNICAL ASSESSMENT:**

### **12 Collaroy Street, Collaroy**

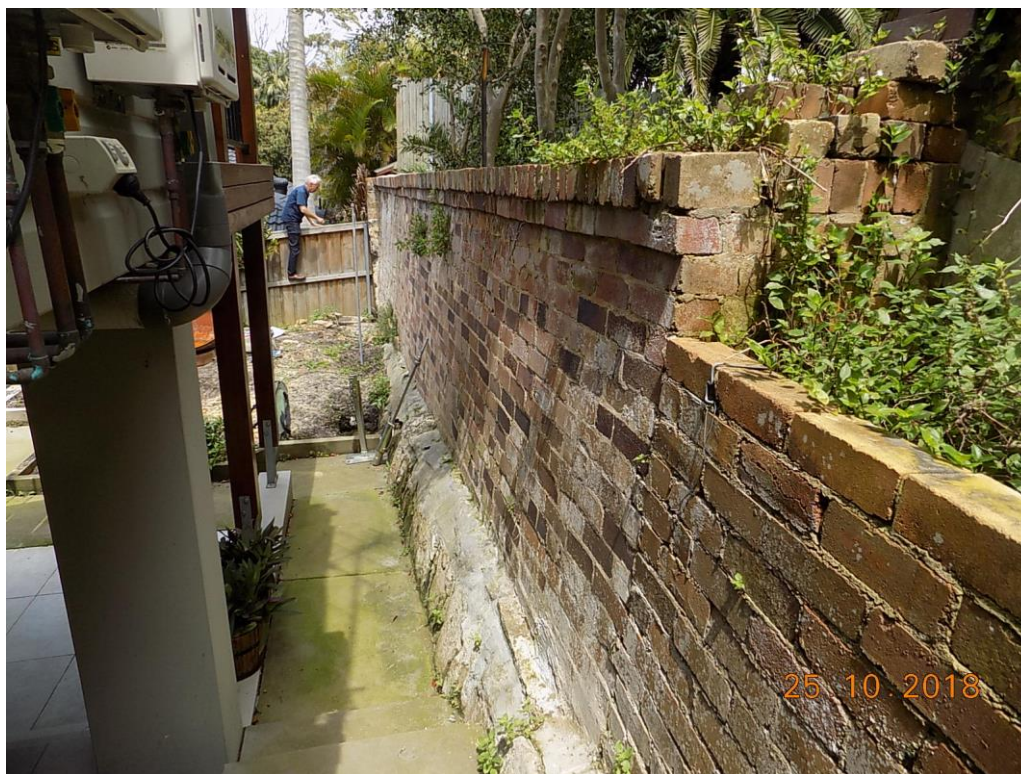
Photo 1

Three small pits had been dug by the owner along the large brick retaining wall (Photo 1) to expose the existing foundation depth and subsurface materials. The ground materials of the pits were recorded. Four Dynamic Cone Penetrometer (DCP) tests were put down to determine the relative density of the overlying soil and the depth to weathered rock. The locations of the tests are shown on the site plan. It should be noted that a level of caution should be applied when interpreting DCP test results. The test will not pass through hard buried objects so in some instances it can be difficult to determine whether refusal has occurred on an obstruction in the profile or on the natural rock surface. This is not expected to be an issue for the testing on this site and the results are as follows:

The large brick retaining wall supporting the fill on the neighbouring property above displays significant cracking (Photo 1). To be prudent, we recommend the retaining wall be inspected by the owners on a biannual basis or after heavy prolonged rainfall, whichever occurs first, keeping a photographic record of the inspections. We can carry out these inspections upon request. Should any new movement be observed, a plan is to be formulated with the owners of the above neighbouring property to remediate or rebuild the wall so it meets current engineering standards.

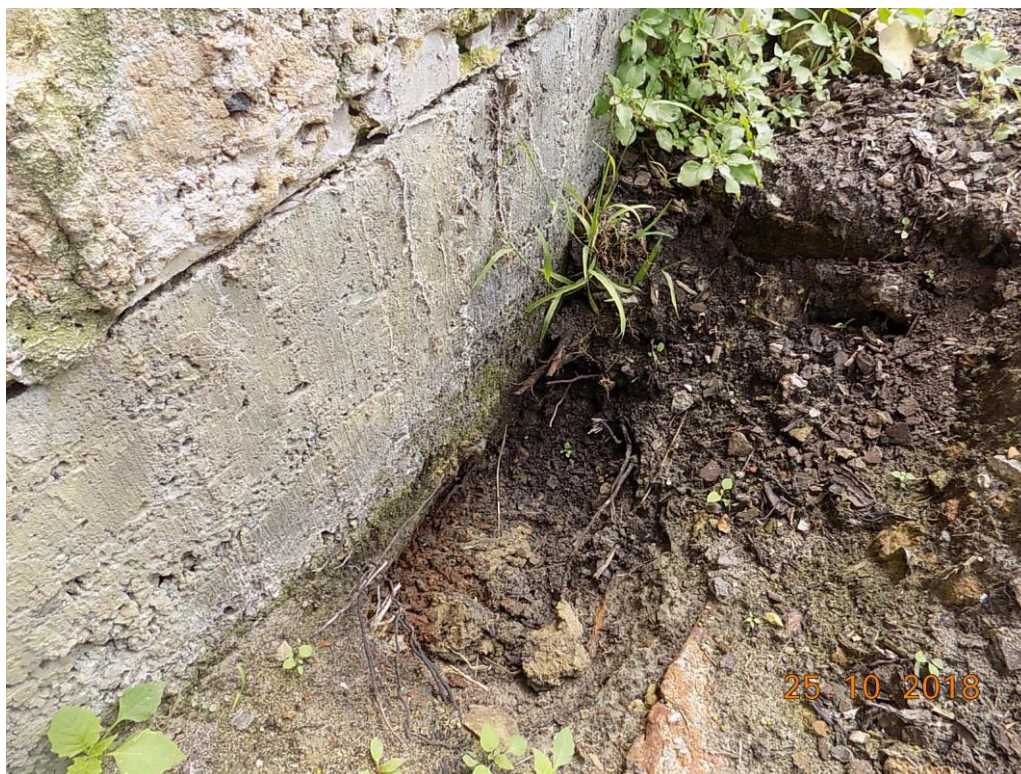
Photo 2: PIT 1

### PIT 1 (~RL11.0) - (Photo 2)

Base of pit @ 0.4m in wet clay. Existing foundations of the brick retaining wall taken to a depth of 0.25m onto the underlying clay.

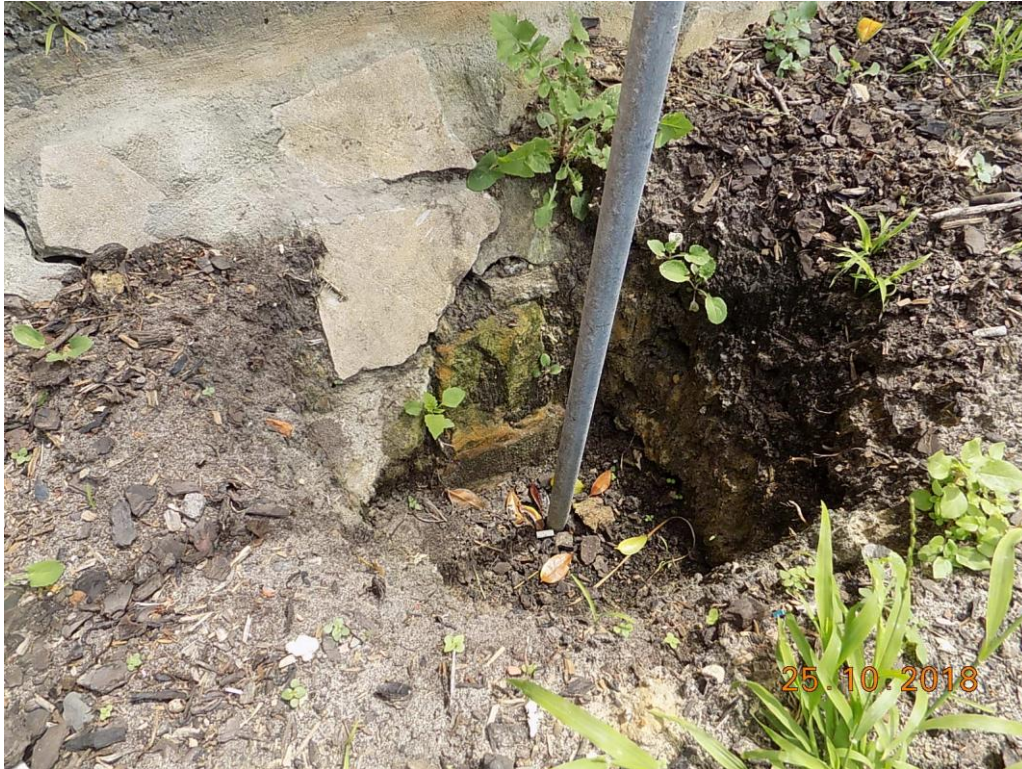
Photo 3: PIT 2

**PIT 2 (~RL11.3) - (Photo 3)**

Base of pit @ 0.5m in wet clay. Existing foundations of the brick retaining wall not visible.

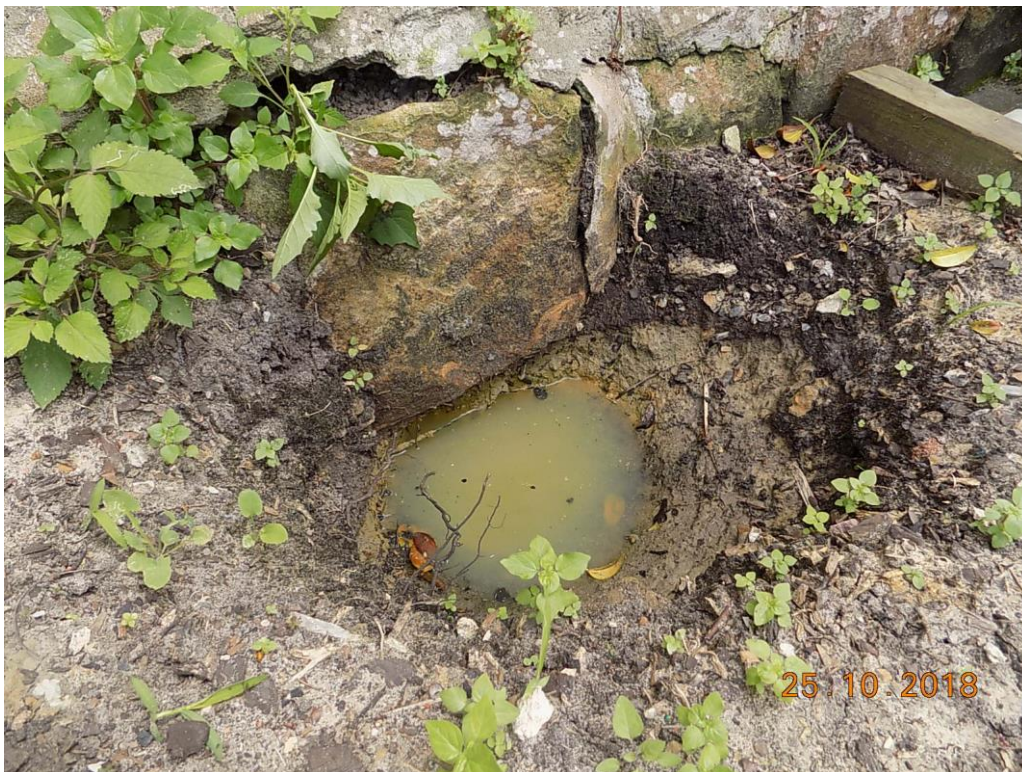
Photo 4: PIT 3

**PIT 3 (~RL11.3) - (Photo 4)**

Base of pit @ 0.5m in wet clay. Existing foundations of the brick retaining wall not visible.  
Water pooling from 0.4m.
