Project name	8 RYRIE AVE FORRESTVILLE
Project date	31/07/2024
Job End Date	31/07/2024

Section No.	US MH	DS MH	Date of inspection	Address/Location	Material	Inspected Length	Pipe Asset ID
1	SPP00846	SPP12487	31/07/2024	RYRIE AVE	Concrete reinforced	67.17	SPI13382

## Section Inspection - 31/07/2024 - SPI13382

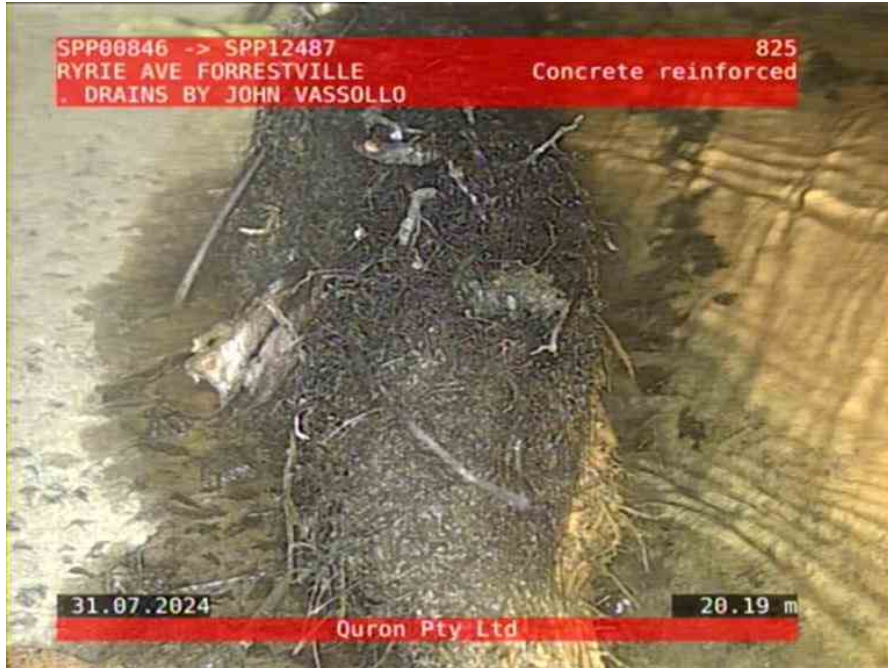
20.19	RM	A mass of mostly fine roots, which has developed into an interwoven clump, at joint, Obstruction: 5-20% at 7 o'clock	00:06:35	SPI13382_7292854f-d61e-4683

SPI13382\_7292854f-d61e-4683-b0d1-0b4fb2d17d08\_20240731\_112515\_449.jpg, 00:06:35, 20.19  
A mass of mostly fine roots, which has developed into an interwoven clump, at joint, Obstruction: 5-20% at 7 o'clock

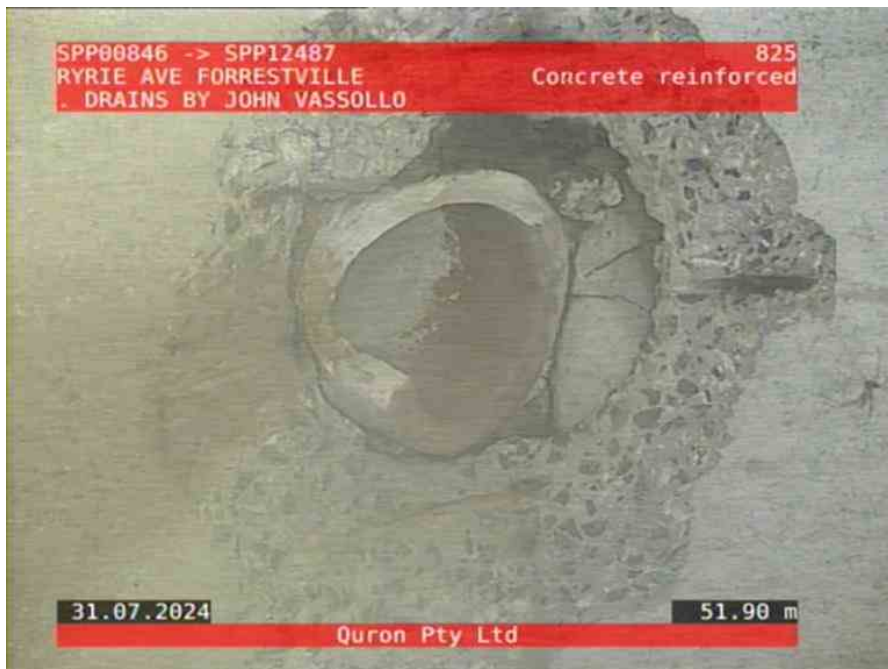
SPI13382\_4a330966-c5b3-497e-8065-c1db63970d04\_20240731\_113308\_437.jpg, 00:12:53, 51.90  
Connection, poor workmanship, connection appears to be open, height: 100mm at 10 o'clock

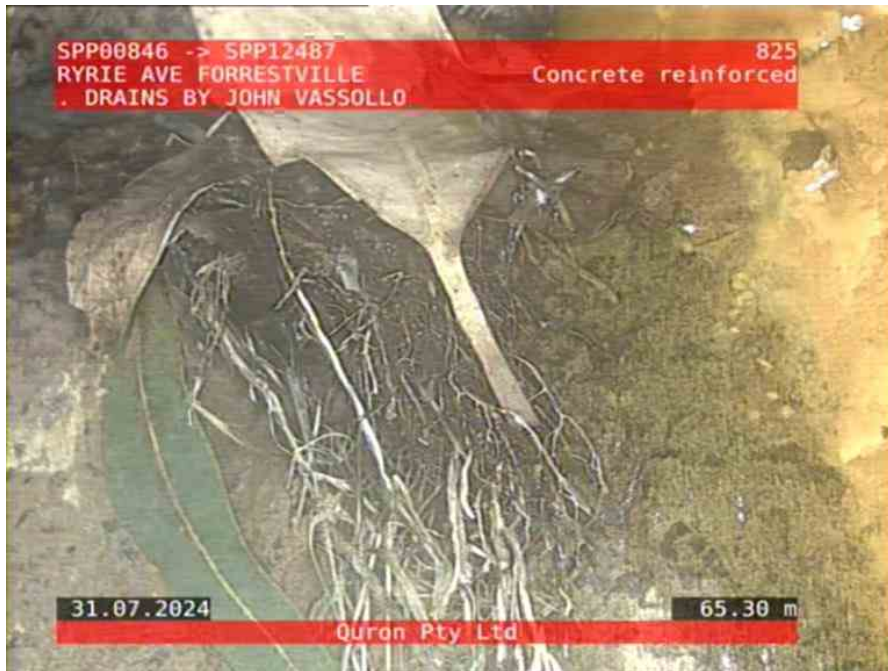
SPI13382\_e0636376-8409-4bd6-842c-7dac866c73a5\_20240731\_113719\_545.jpg, 00:16:50, 65.30  
A mass of mostly fine roots, which has developed into an interwoven clump, at joint, Obstruction: <5% at 7 o'clock
