180 McCarrs Creek Rd, Church Point

Arbor Impact Assessment
Version 1.0
Client: Yu Choong Then
c/o Sydney Earth & Tree Works

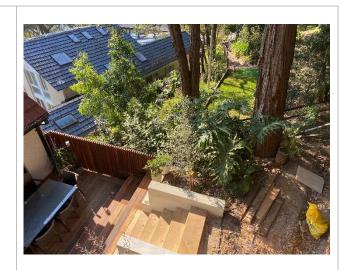
• Tree 1 is a Turpentine(*Syncarpia glomulifera*), is considered to be of medium significance and is suitable for retention. The tree is located 3.3m from the proposed inclinator docking station, providing a potential 4% cut encroachment within the Tree Protection Zone.

- ➤ Tree No.'s 1 and 5 are suitable for retention due to a low/moderate encroachment from the proposed development. Tree protection fencing should be established prior to site establishment to encompass the measured TPZ (allowing access for the development and a maximum 500mm clearance for its construction) as well as an additional area equivalent to the encroachment posed by the development to offset against the impacts posed to the tree. This fenced area should be mulched with a 100mm layer of organic mulch.
- Tree No.'s 2 & 3 are unaffected by the proposed development and suitable for retention.

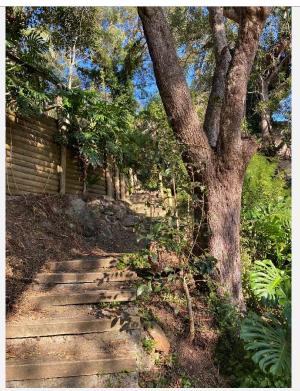
Base of Tree 2

- Tree 2 is a Cheese Tree (*Glochidion ferdinandii*), is located outside the development area and there is no measurable impact to the tree from construction. However, care should be taken when transporting equipment, machinery and goods in and around the tree.
- Tree 3 is a Turpentine (*Syncarpia glomulifera*), is located outside the development area and there is no measurable impact to the tree from construction. However, care should be taken when transporting equipment, machinery and goods in and around the tree.
- A dead tree was surveyed to the north-west of the residence. This tree should be removed prior to commencement of construction.

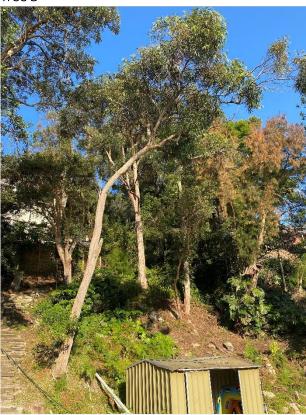
• Tree 4 is a Red Mahogany (*Eucalyptus resinifera*), is located within the proposed footprint of the boatshed and cannot be retained with the development in its current design. Extensive modifications and relocation of the boatshed would be required to retain this tree, however other more significant and healthy specimens are likely to be affected in this process. This tree is a more suitable candidate for removal.

> Tree No. 4 is located within the development footprint and is unsuitable for retention. The tree should be removed prior to site establishment if the development is approved in its current design.

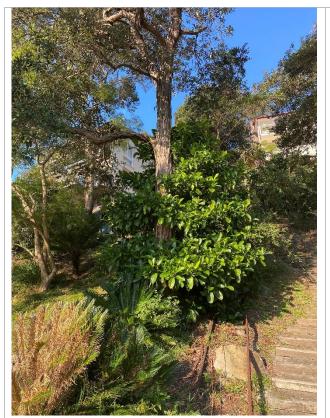
Base of Tree 5

• Tree 5 is a Turpentine(*Syncarpia glomulifera*), is considered to be of high significance and is suitable for retention. The tree is located 2.6m from the stormwater system, providing a 19% cut encroachment within the Tree Protection Zone. While this is classified as a moderate impact encroachment, due the grade of the slope where excavation is potentially occurring and the existence of rocky outcrops surrounding the tree, the likelihood of impact to significant root matter is low.

The tree is located on the neighbouring property and should be retained. Tree sensitive construction measures must be implemented if works are to proceed within the TPZ (as prescribed by the Australian Standard AS4970-2009 Protection of trees on development sites<sup>(b)</sup>). Specifically, trenching for the installation of stormwater system should be completed using appropriate hand-controlled tools under the supervision of a Project Arborist with a minimum AQF5 level qualification. Woody roots >40mm diameter affected by these works should be pruned cleanly under the supervision of the Project Arborist.
