**REPORT ON GEOTECHNICAL SITE INVESTIGATION**

**PROPOSED ALTERATIONS AND ADDITIONS**

**33 PACIFIC ROAD, PALM BEACH**

**Project No.: 2021-004**

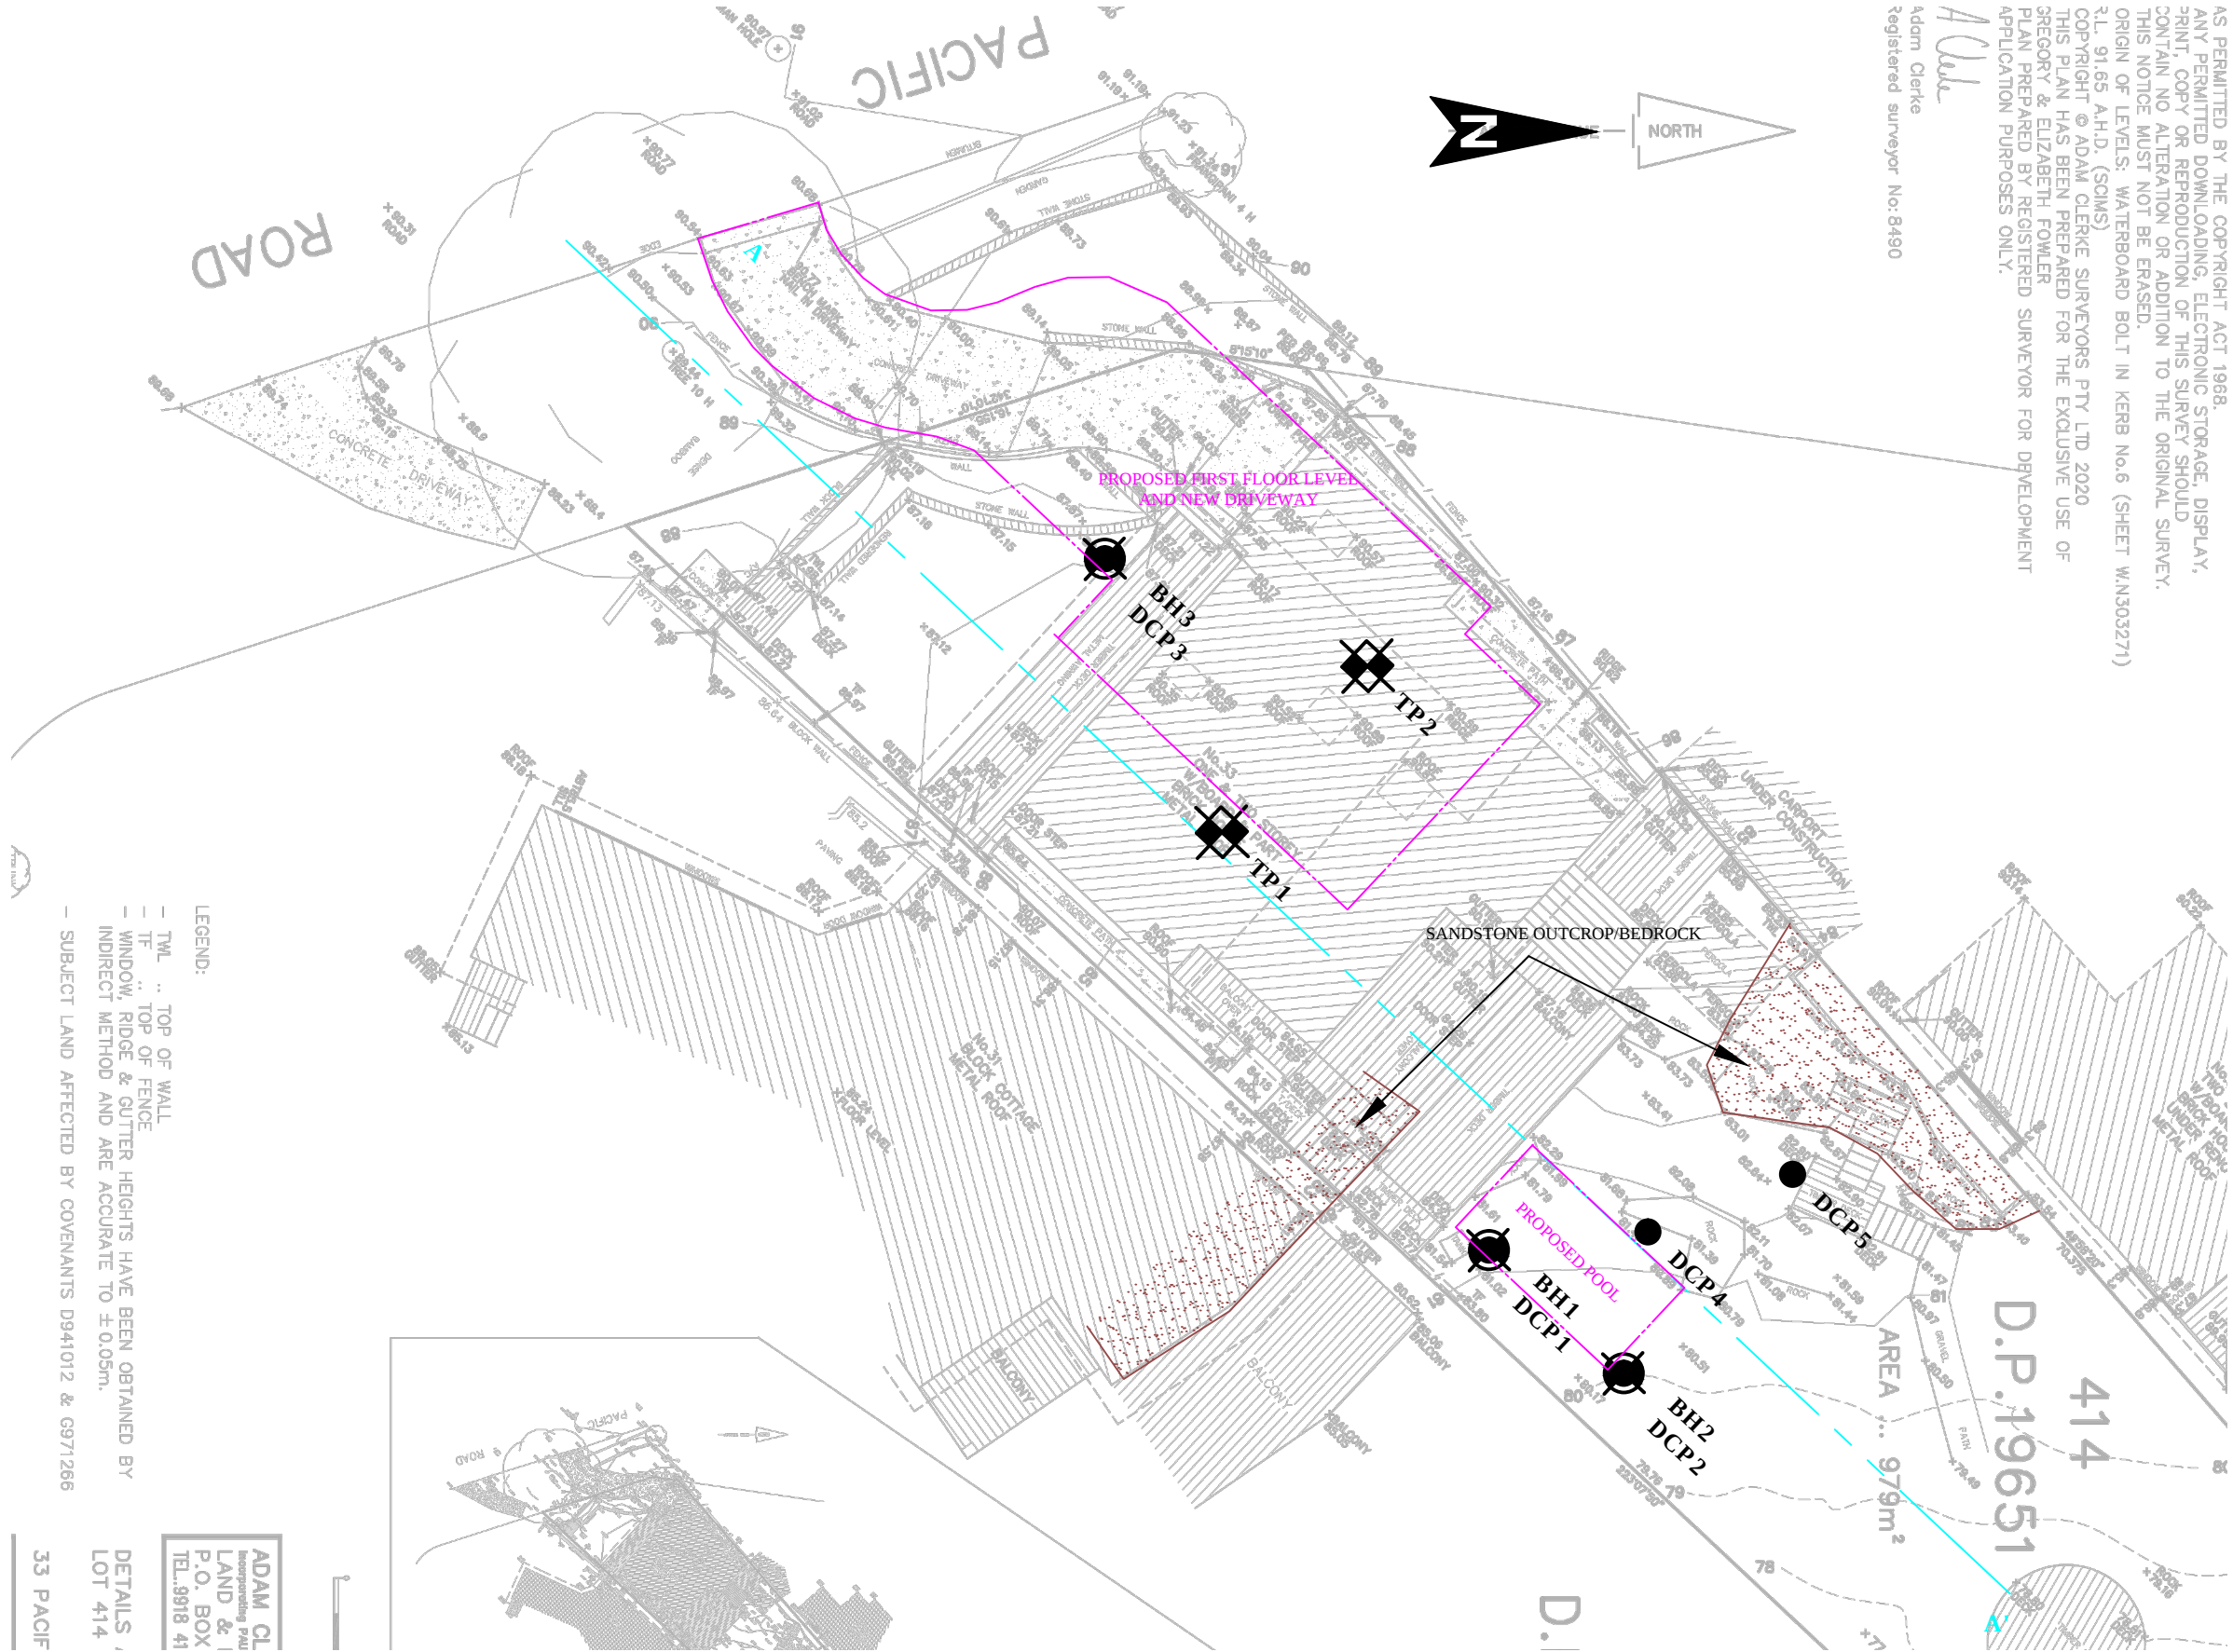
SITE PLAN & TEST LOCATIONS FIGURE 1.

Based on the borehole logs and DCP test results, the sub-surface conditions at the project site can be classified as follows:

- **FILL** – this layer was encountered at all test locations to depths varying from 0.10m (BH3) to 0.40m (BH1). It is classified as dark brown, fine grained silty/clayey sand with roots and gravel.
- **Sandy/Silty CLAY** – this layer was encountered at all test locations to bedrock surface. It is classified as firm to stiff, brown to grey, medium to high plasticity, moist to wet sandy/silty clay.
- **Weathered SANDSTONE BEDROCK** – hand auger refusal was encountered on this layer in BH1 at 1.00m depth. Based on the DCP testing results, sandstone bedrock of at least very low strength was interpreted at varying depth from 0.70m (DCP4) to 1.42m (DCP5). However, auger and DCP refusal on detached sections of rock/boulders is also possible.

TP1 was excavated adjacent to a pad footing on the southern side of the storage area. It identified that the brick pad footing extends to 0.10m depth below the existing ground surface level and is founded on sandstone bedrock of low to medium strength.

TP2 was excavated adjacent to a pad footing on the northern side of the storage area. It identified that the brick pad footing extends to 0.25m depth below the existing ground surface level and is founded in dry, extremely weathered sandstone/sandy clay. Due to limited access, the strength of the foundation could not be tested.

It is recommended that all new footings be founded on sandstone bedrock of similar strength and all new footings will require geotechnical inspection for confirmation.

The proposed construction of a new first floor level will increase the loading of the existing structure footings. The adequacy of the existing footings to support the increased loading should be checked by a Structural Engineer. Based on the investigation results, the existing structure footings appear to be founded on materials of different strength (i.e. sandstone bedrock and dry sandy clay). If the proposed structure could not tolerate any differential settlement, it is recommended that all existing footings be extended to sandstone bedrock of similar strength.
