GEOTECHNICAL INVESTIGATION:

New Pool at 19 West Street, Balgowlah

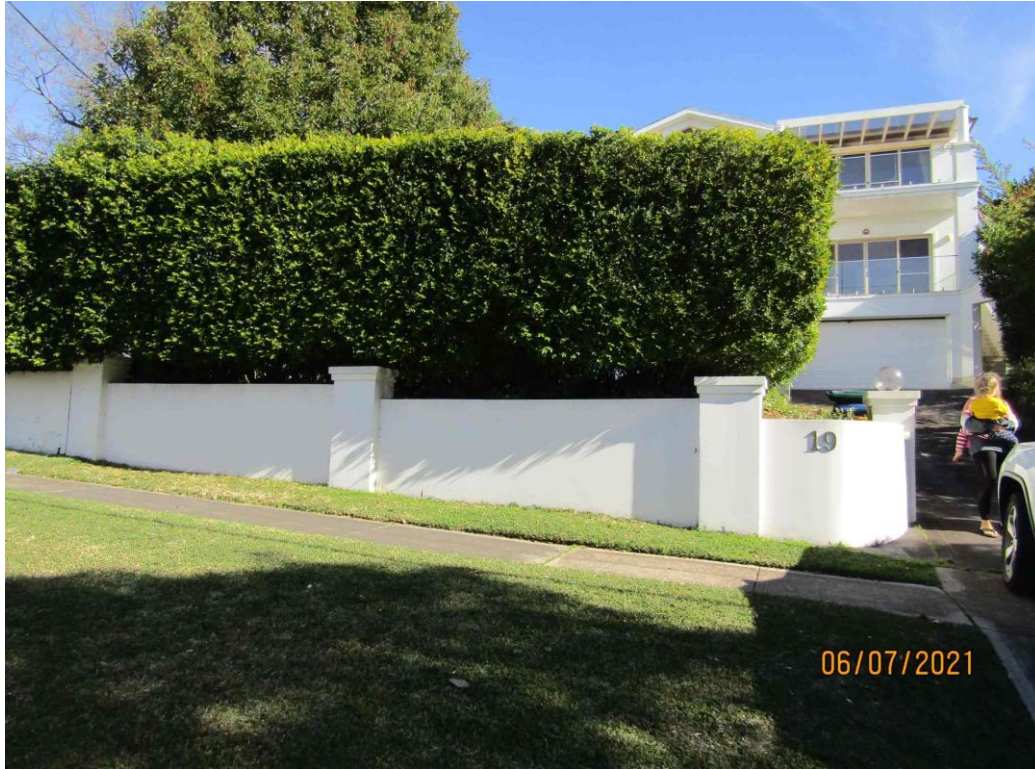
Photo 1

- 2.1** The site was inspected on the 6th of July, 2021.
- 2.2** This residential property is on the high side of the road and has an E aspect. It is located on the gentle to moderately graded middle reaches of a hillslope. The natural slope rises across the property at an average angle of ~12°. The slope below the property gradually increases in grade. The slope above the property decreases in grade.
- 2.3** At the road frontage, a concrete driveway runs up the slope to a garage attached to the house (Photos 1 & 2). Between the road frontage and the house is a

gently sloping lawn area. The fill for the lawn is supported by a low sandstone flagging retaining wall and a stable rendered masonry retaining wall up to ~1.5m high (Photo 1). The part two storey rendered masonry house with garage below is supported by rendered masonry walls (Photos 2 & 3). The external supporting walls show no significant signs of movement. A paved area extends off the uphill side of the house (Photo 4). Low rendered masonry and timber retaining walls support cuts and fills on the uphill side of the pavement. A near level lawn area is located uphill of the paved area (Photo 5). No signs of slope instability were observed on the property. The adjoining neighbouring properties were observed to be in good order as seen from the street and subject property.

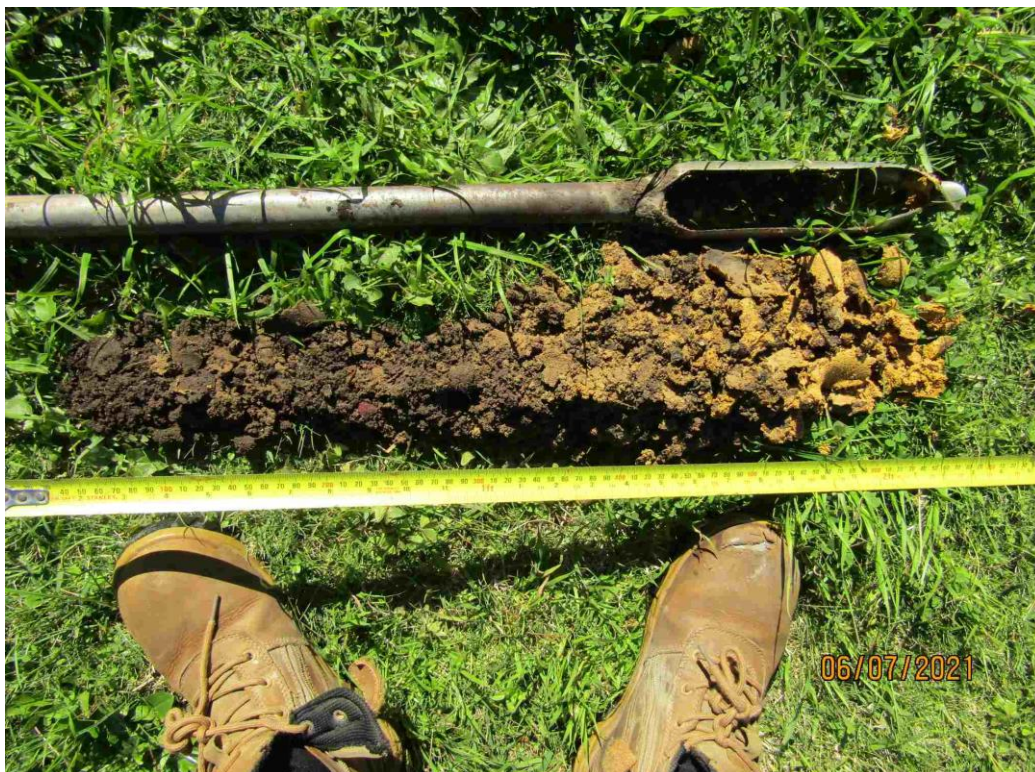
Photo 6

AUGER HOLE 1 (~RL71.4) – AH1 (Photo 6)

Depth (m)	Material Encountered
0.0 to 0.3	TOPSOIL , sandy soil, dark brown, moist, fine to medium grained.
0.3 to 0.5	CLAYEY SAND , light brown, moist, fine to medium grained.
0.5 to 0.7	SANDY CLAY , light orange, moist, firm.

End of Hole @ 0.7m in firm sandy clay. No watertable encountered.

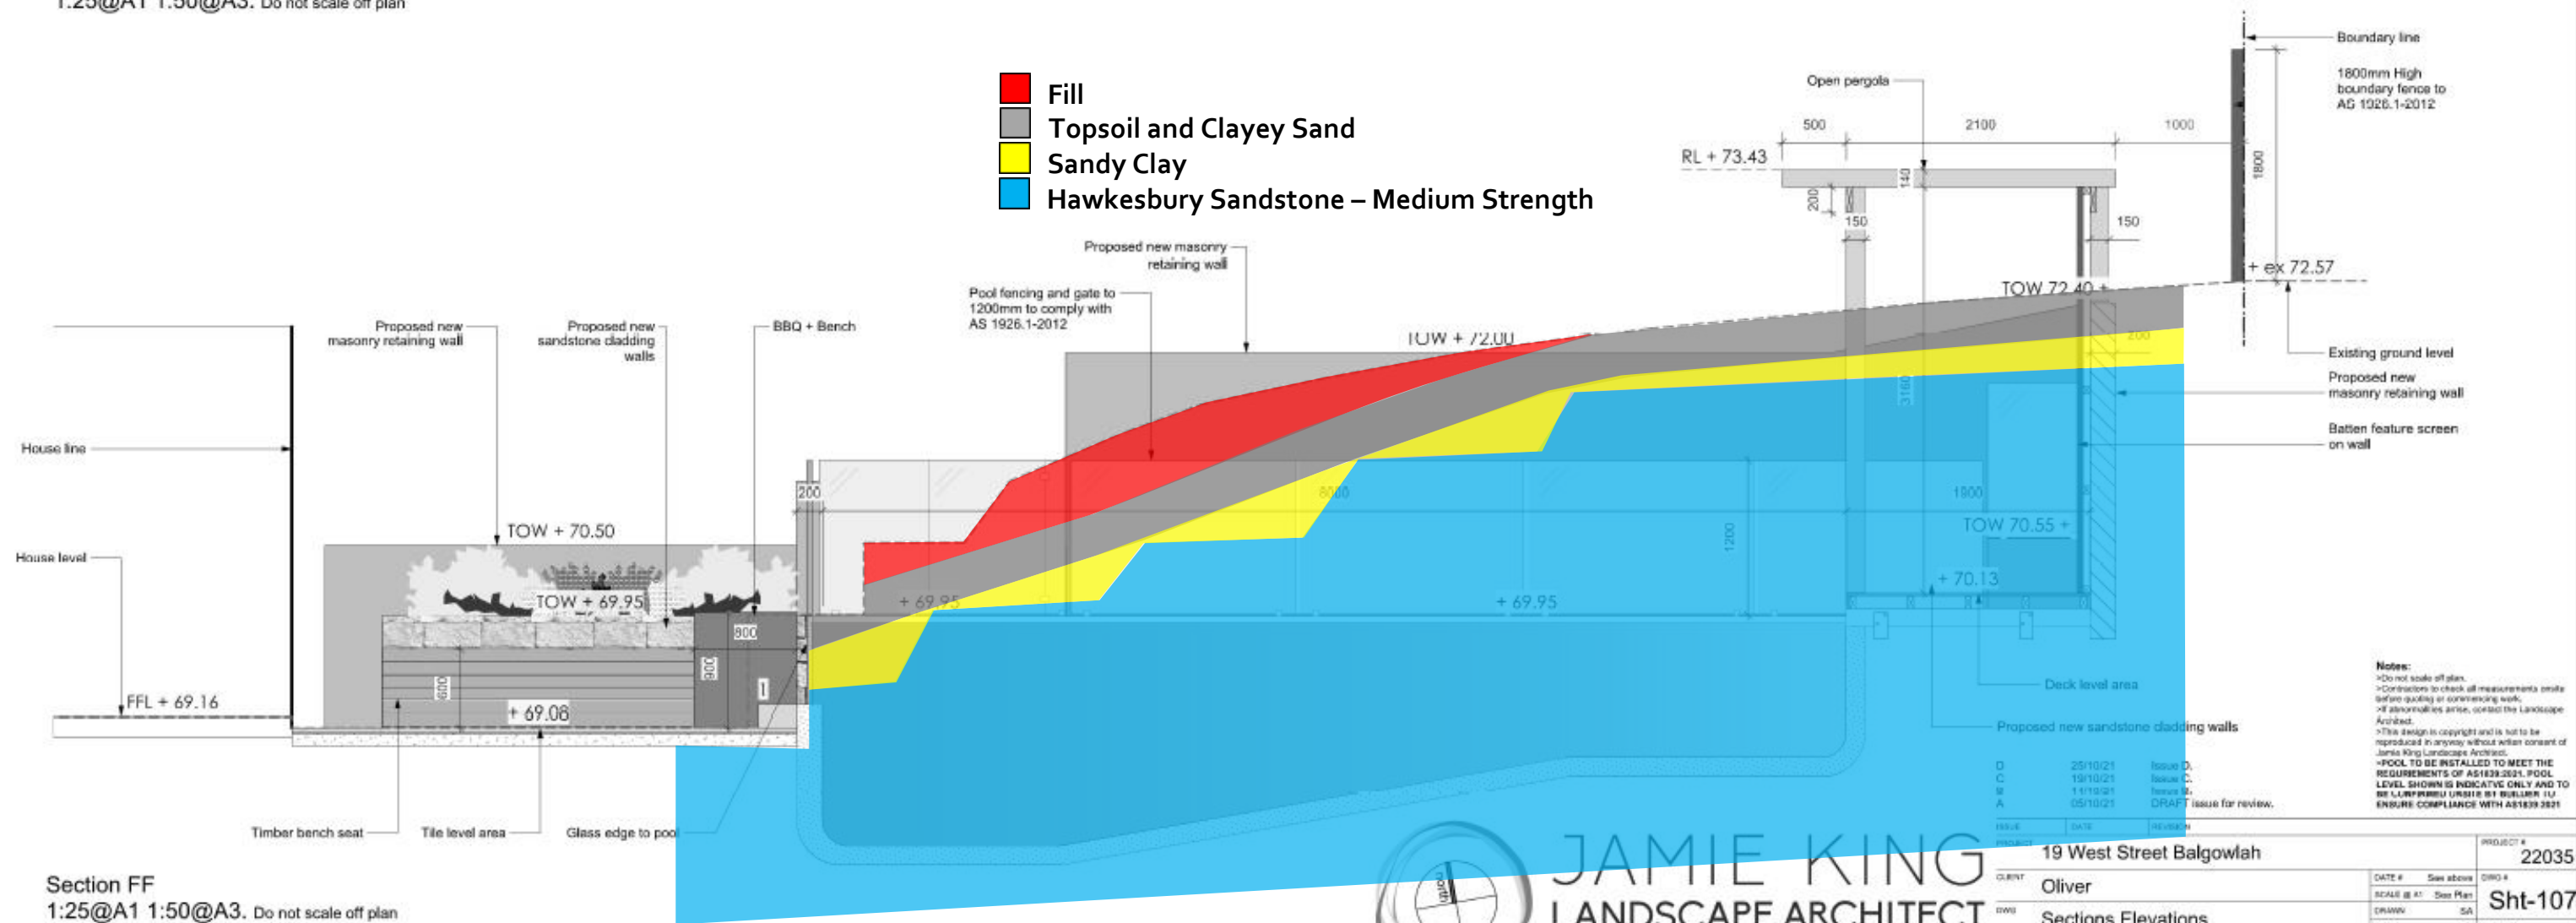
TYPE SECTION – Diagrammatical Interpretation of expected Ground Materials

The surface features of the block are controlled by the underlying sandstone bedrock that steps down the property forming sub-horizontal benches between the steps. Where the grade is steeper, the steps are larger and the benches narrower. Where the slope eases, the opposite is true. The rock is overlain by topsoil, clayey sand and sandy clay that fills the bench step formation. Fill to a maximum depth of ~1.5m provides lawn and garden areas above the natural profile. In the test locations, the depth to rock ranged from between ~0.6m to ~1.2m below the current surface. The sandstone underlying the property is estimated to be Medium Strength or better. See Type Section attached for a diagrammatical representation of the expected ground materials.
