Report Title: Geotechnical Report **136 Pacific Road, Palm Beach**

Report Date: **27/9/24**

## **GEOTECHNICAL INVESTIGATION:**

House Extension, Pool, and Lift at **136 Pacific Road, Palm Beach**

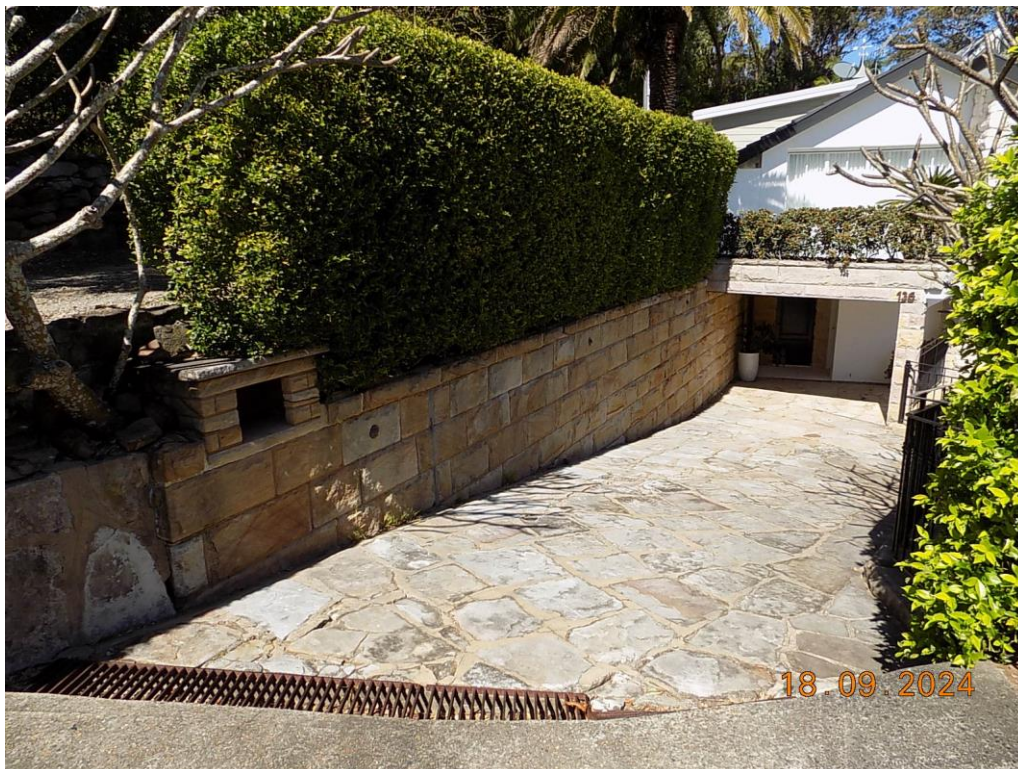
Photo 1

various cuts for the house are supported by mortared sandstone block retaining walls reaching up to ~2.3m high (Photo 1 & 3). These walls also comprise the supporting walls of the three-storey house and were observed to be at least partially supported on outcropping competent Medium Strength Sandstone. Cracking in the mortar was measured up to ~5mm in width. The cracking is likely due to settlement that will have occurred shortly after construction and the walls are considered stable. No significant signs of movement were observed in the supporting brick walls of the house. Fill for landscaping on the downhill side of the house is supported by a mortared sandstone block and brick retaining wall reaching ~2.2m high (Photo 4). A large detached joint block has come to rest on the slope in this location. This joint block as well as a scattering of other smaller boulders (Photo 5) on the slope below were observed to be resting/embedded in stable positions (Photo 6).

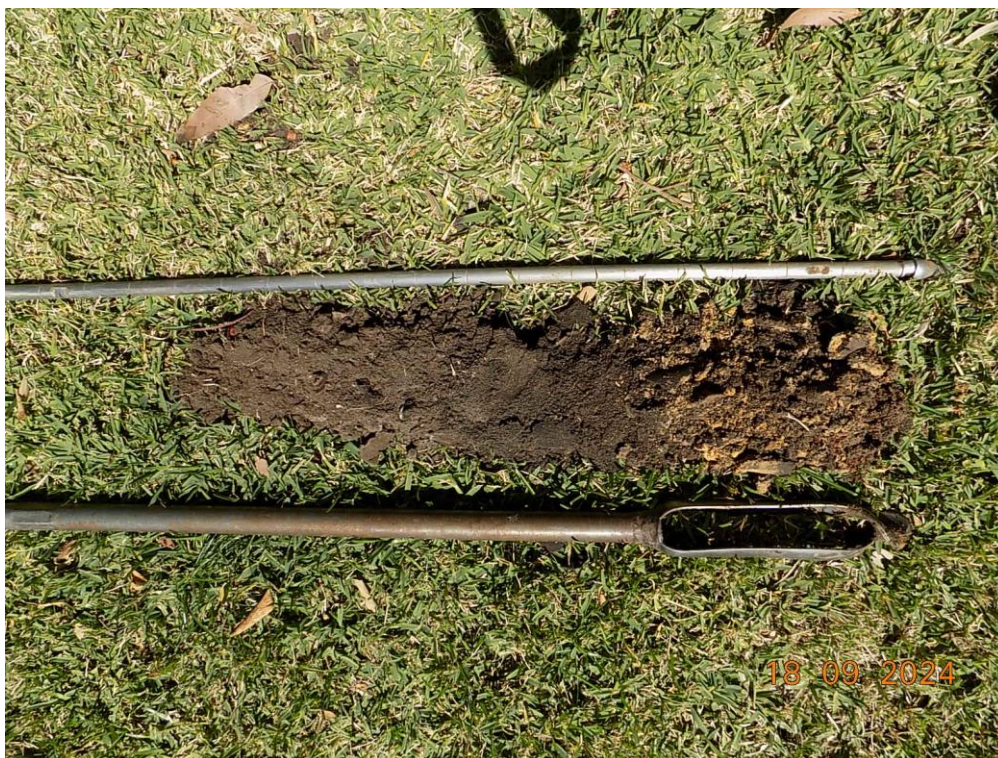
Photo 7 – downhole is left to right

## AUGER HOLE 1 (~RL35.1) – AH1 (Photo 7)

Depth (m)	Material Encountered
0.0 to 0.4	<b>FILL</b> , brown, Medium Dense, dry, medium grained.
0.4 to 0.7	<b>TOPSOIL</b> , clayey, brown, Stiff, damp, fine to coarse grained, maroon and yellow weathered sandstone fragments included.

Refusal @ 0.7m on rock. Auger grinding. No water table encountered.

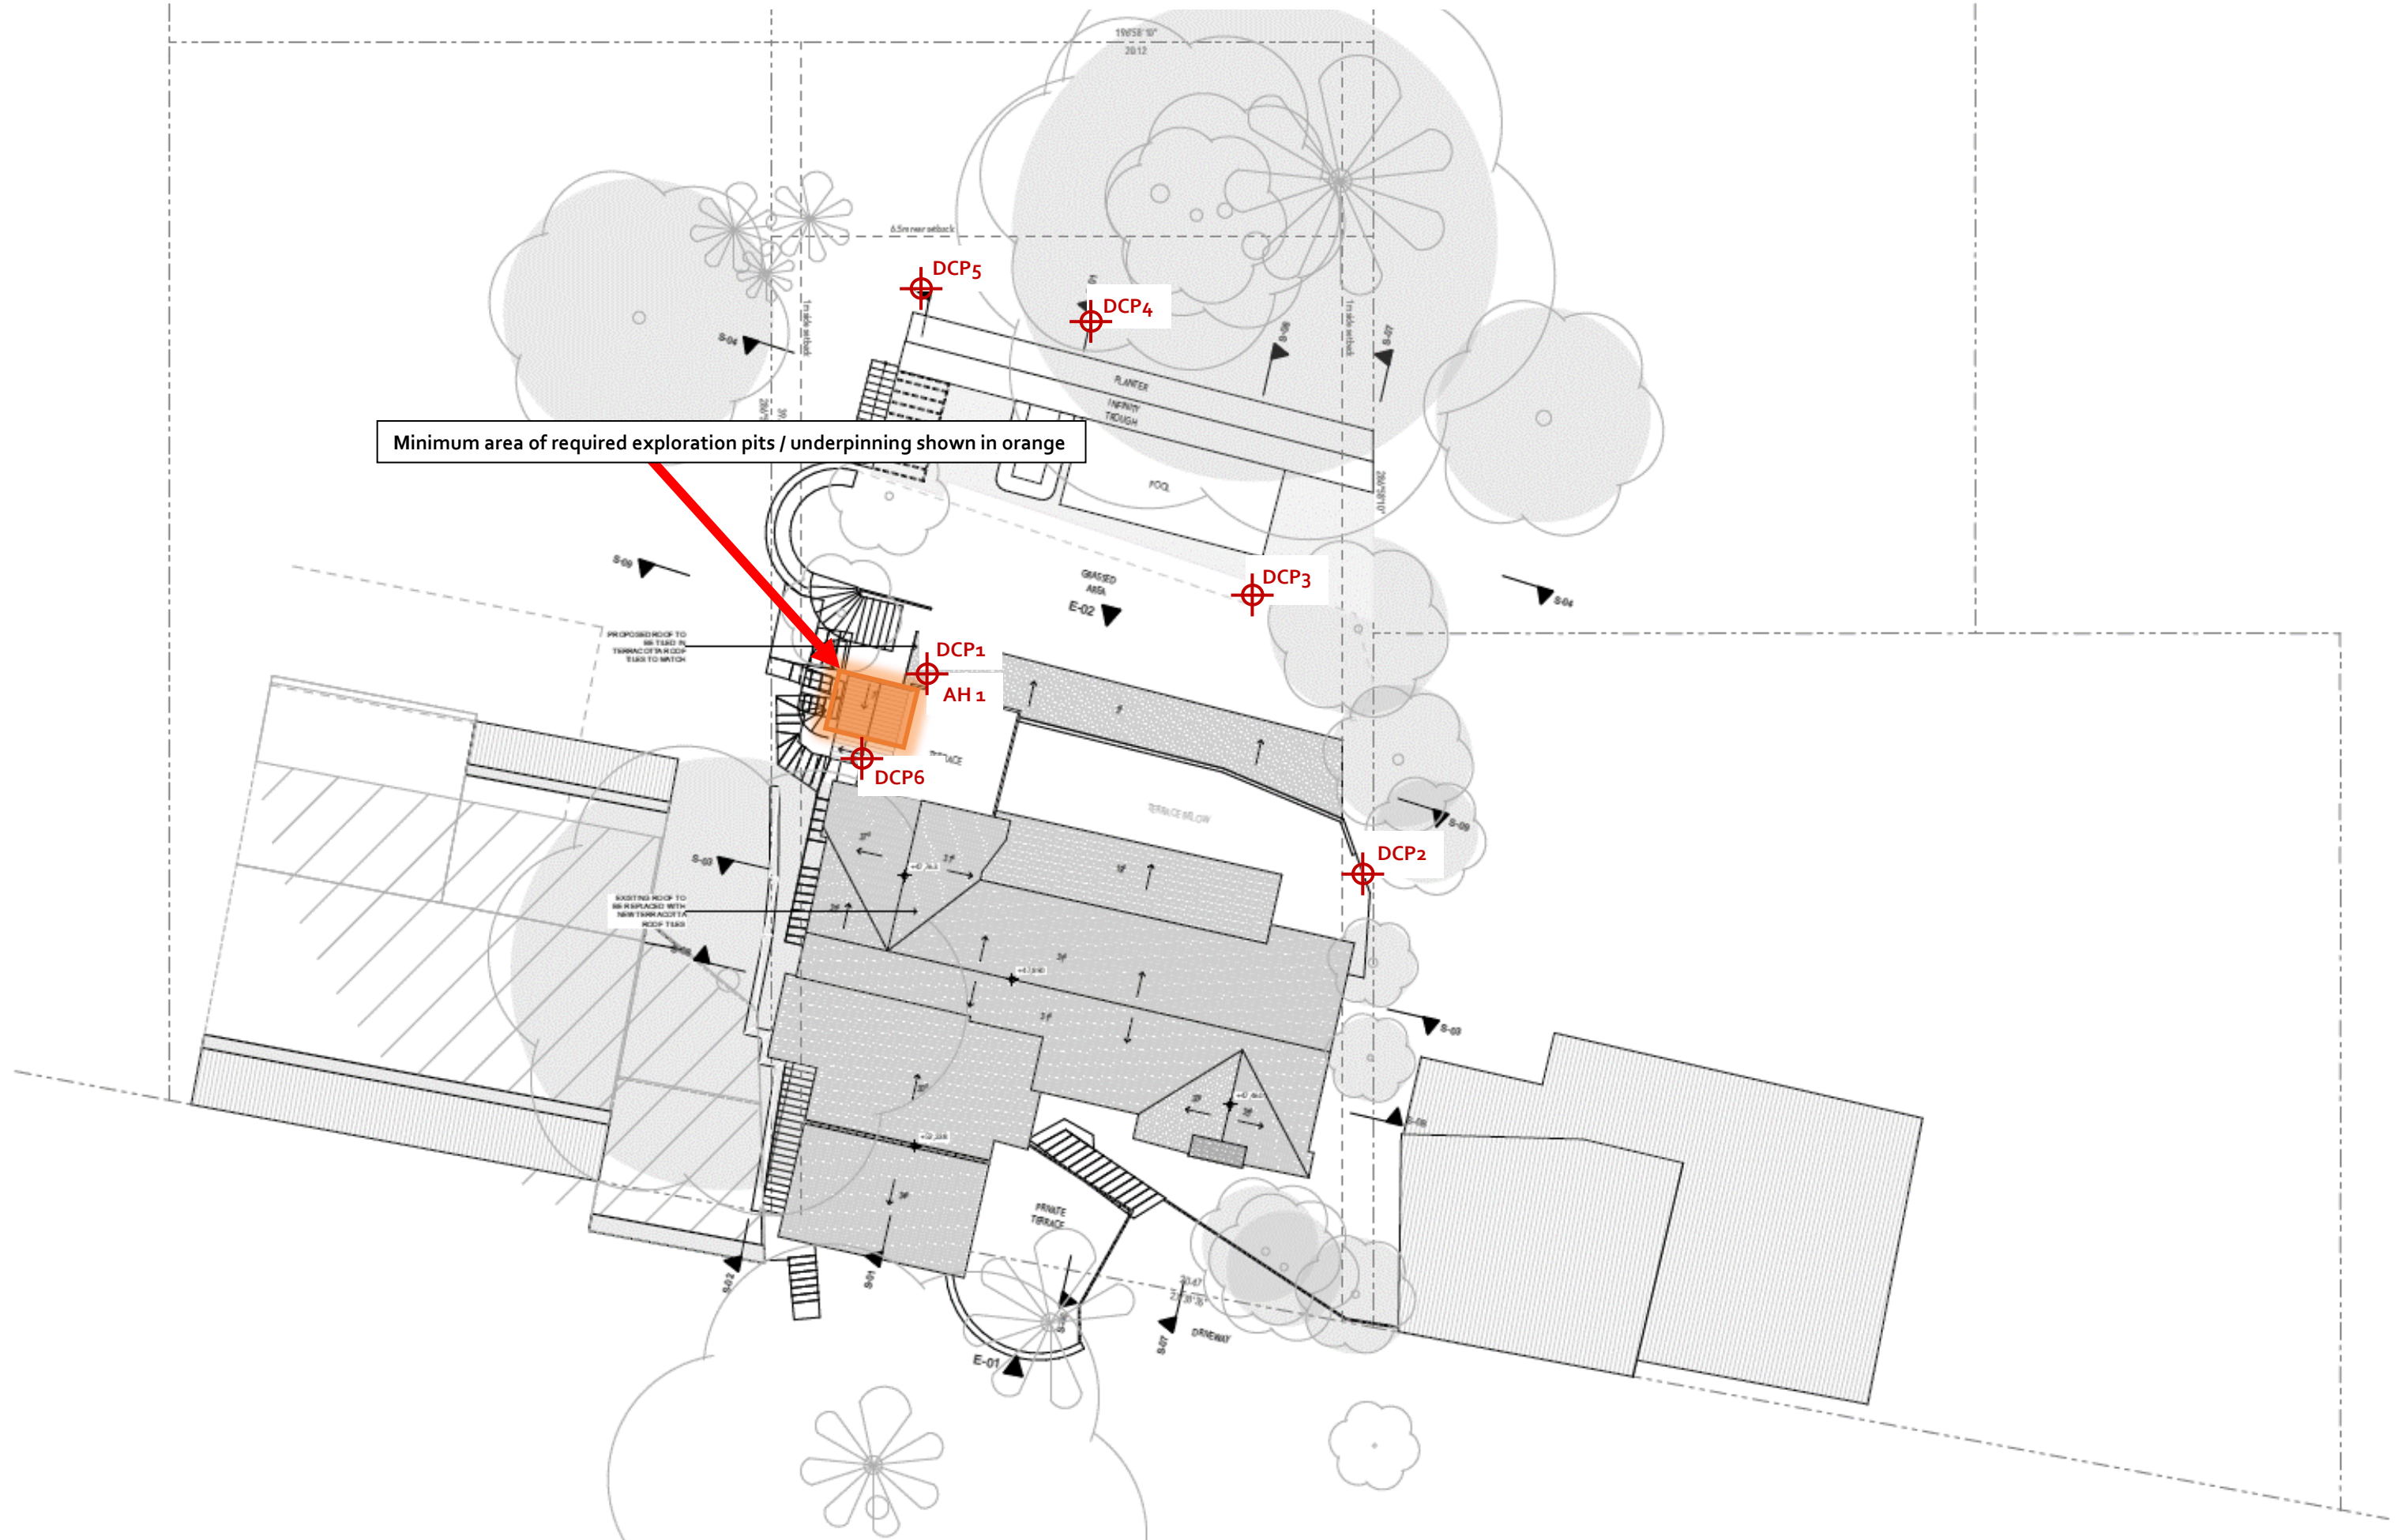
# SITE PLAN – showing test locations and area of required exploration pits / underpinning

One hand Auger Hole (AH) was put down to identify the soil materials. Six Dynamic Cone Penetrometer (DCP) tests were put down to determine the relative density of the overlying soil and the depth to bedrock. The locations of the tests are shown on the site plan attached. It should be noted that a level of caution should be applied when interpreting DCP test results. The test will not pass through hard buried objects so in some instances it can be difficult to determine whether refusal has occurred on an obstruction in the profile or on the natural rock surface. This is not expected to have been an issue for this site. But due to the possibility that the actual ground conditions vary from our interpretation there should be allowances in

Given the shallow depth to rock, we think it is likely the stairs are supported on rock. However, to be sure, where they fall within the zone of influence of the excavation, exploration pits will need to be put down by the builder to determine the foundation depth and material. These are to be inspected by the geotechnical consultant.

If the foundations for the stairs are found to be supported on rock or extend below the zone of influence of the proposed excavation, the excavation may commence. If they are not, the stairs will need to be underpinned to rock prior to the excavation commencing.

- The exploration pits to determine the foundation material along the garden stairs are to be inspected by the geotechnical consultant to determine if underpinning is necessary. This is to occur before the bulk excavation for the lift commences.

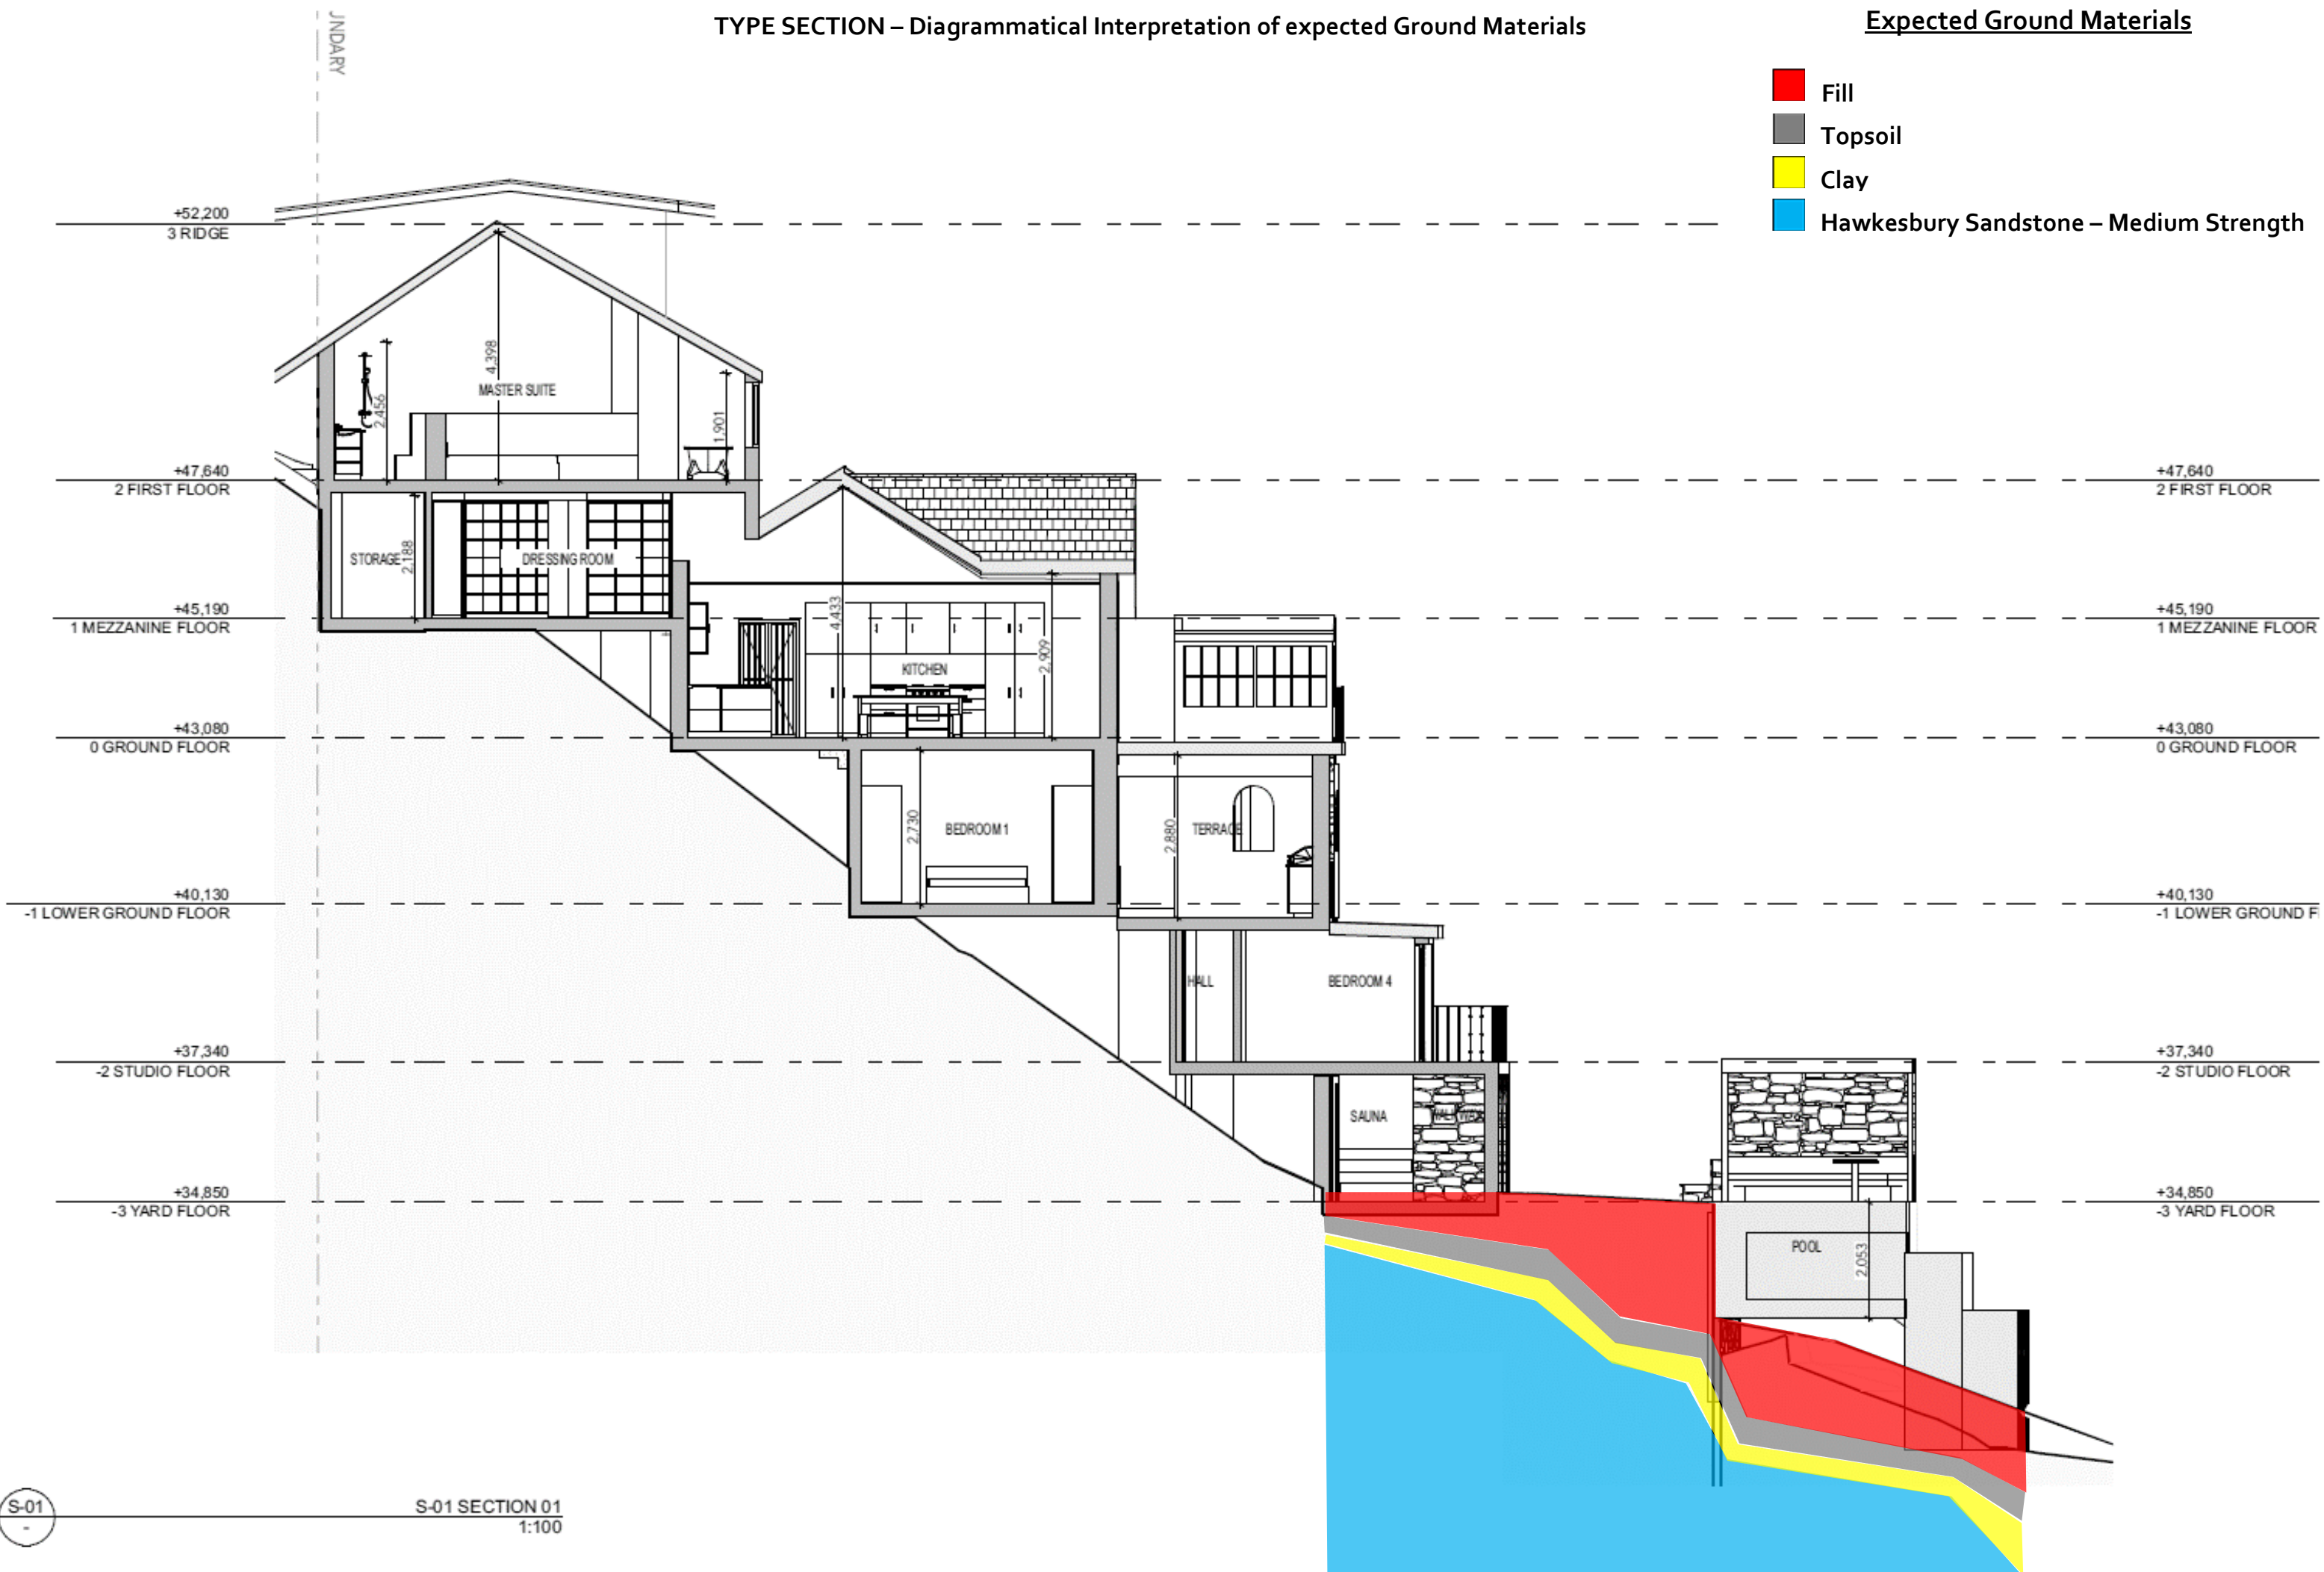
# TYPE SECTION – Diagrammatical Interpretation of expected Ground Materials

The surface features of the block are controlled by the outcropping and underlying sandstone bedrock that steps down the property forming sub-horizontal benches between the steps. Where the grade is steeper, the steps are larger and the benches narrower. Where the slope eases, the opposite is true. Where the rock is not exposed, it is overlain by shallow soils over clays that fill the bench step formation. Filling has been placed to a height of 2.2m across the property and in the location of the proposed works. In the test locations, where the rock is not exposed, it was encountered at depths of between 0.9 to 3.3m below the current surface, being deeper due to the presence of fill and the stepped nature of the underlying bedrock. The outcropping sandstone on the property is estimated to be Medium Strength or better and similar strength rock is expected to underlie the entire site as all the DCP tests bounced at refusal. See Type Section attached for a diagrammatical representation of the expected ground materials.

- Fill
- Topsoil
- Clay
- Hawkesbury Sandstone – Medium Strength
