# Geotechnical Assessment

**Project:** Alterations & Additions  
25 Aranda Drive, Davidson NSW

**Ref:** AG 25056  
19 February 2025

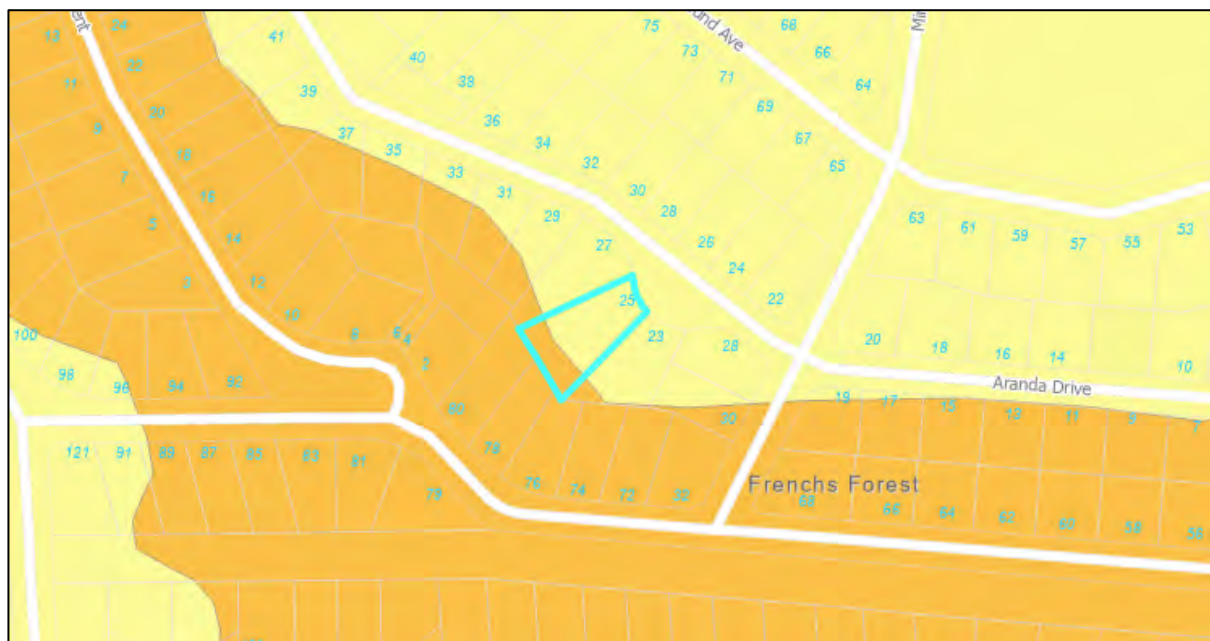
**Image 2.** Warringah Landslip Risk Map:  
25 Aranda Drive, Davidson NSW (© NBC Maps)

- No evidence of significant soil creep, tension cracks or landslip instability were identified across the site or on adjacent properties as viewed from the subject site at the time of our inspection.
- The property is classified as **Area A & B** with reference to Northern Beaches Council WLEP – Warringah Landslip Risk Map (**Image 2**).

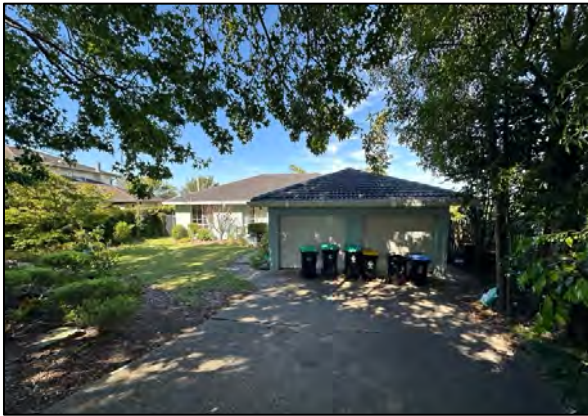
**Photo 1:** Site frontage, looking southwest.

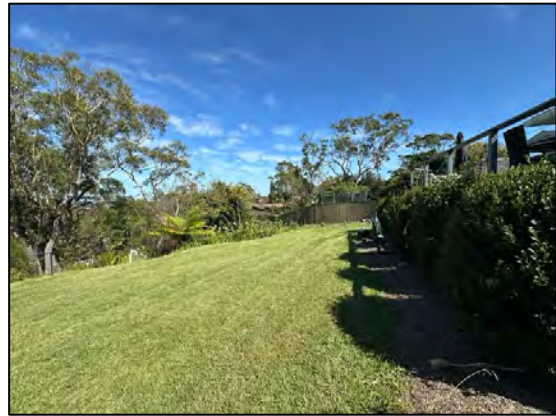
**Photo 2:** Rear of site, looking northwest.

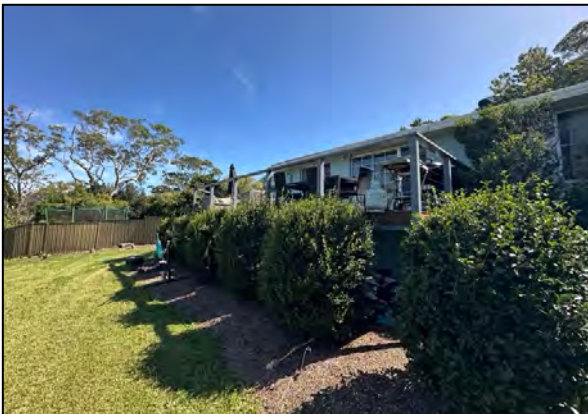
**Photo 3:** Rear of site, looking north.

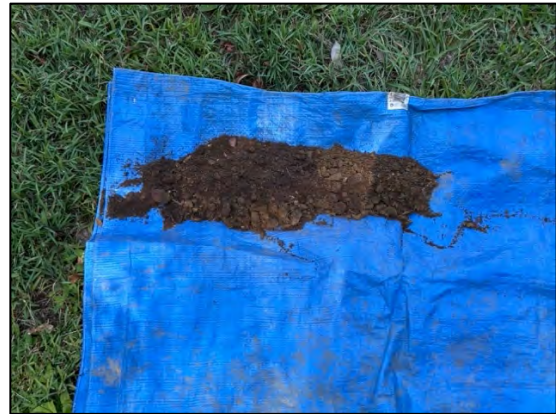
**Photo 4:** Subsurface soil profile of BH01.
