**REPORT TO  
TOBY BROWNE**

**ON  
GEOTECHNICAL ASSESSMENT  
(In Accordance with Pittwater Council Risk  
Management Policy)**

**FOR  
PROPOSED ALTERATIONS & ADDITIONS**

**AT  
3 PANIMA PLACE, NEWPORT, NSW**

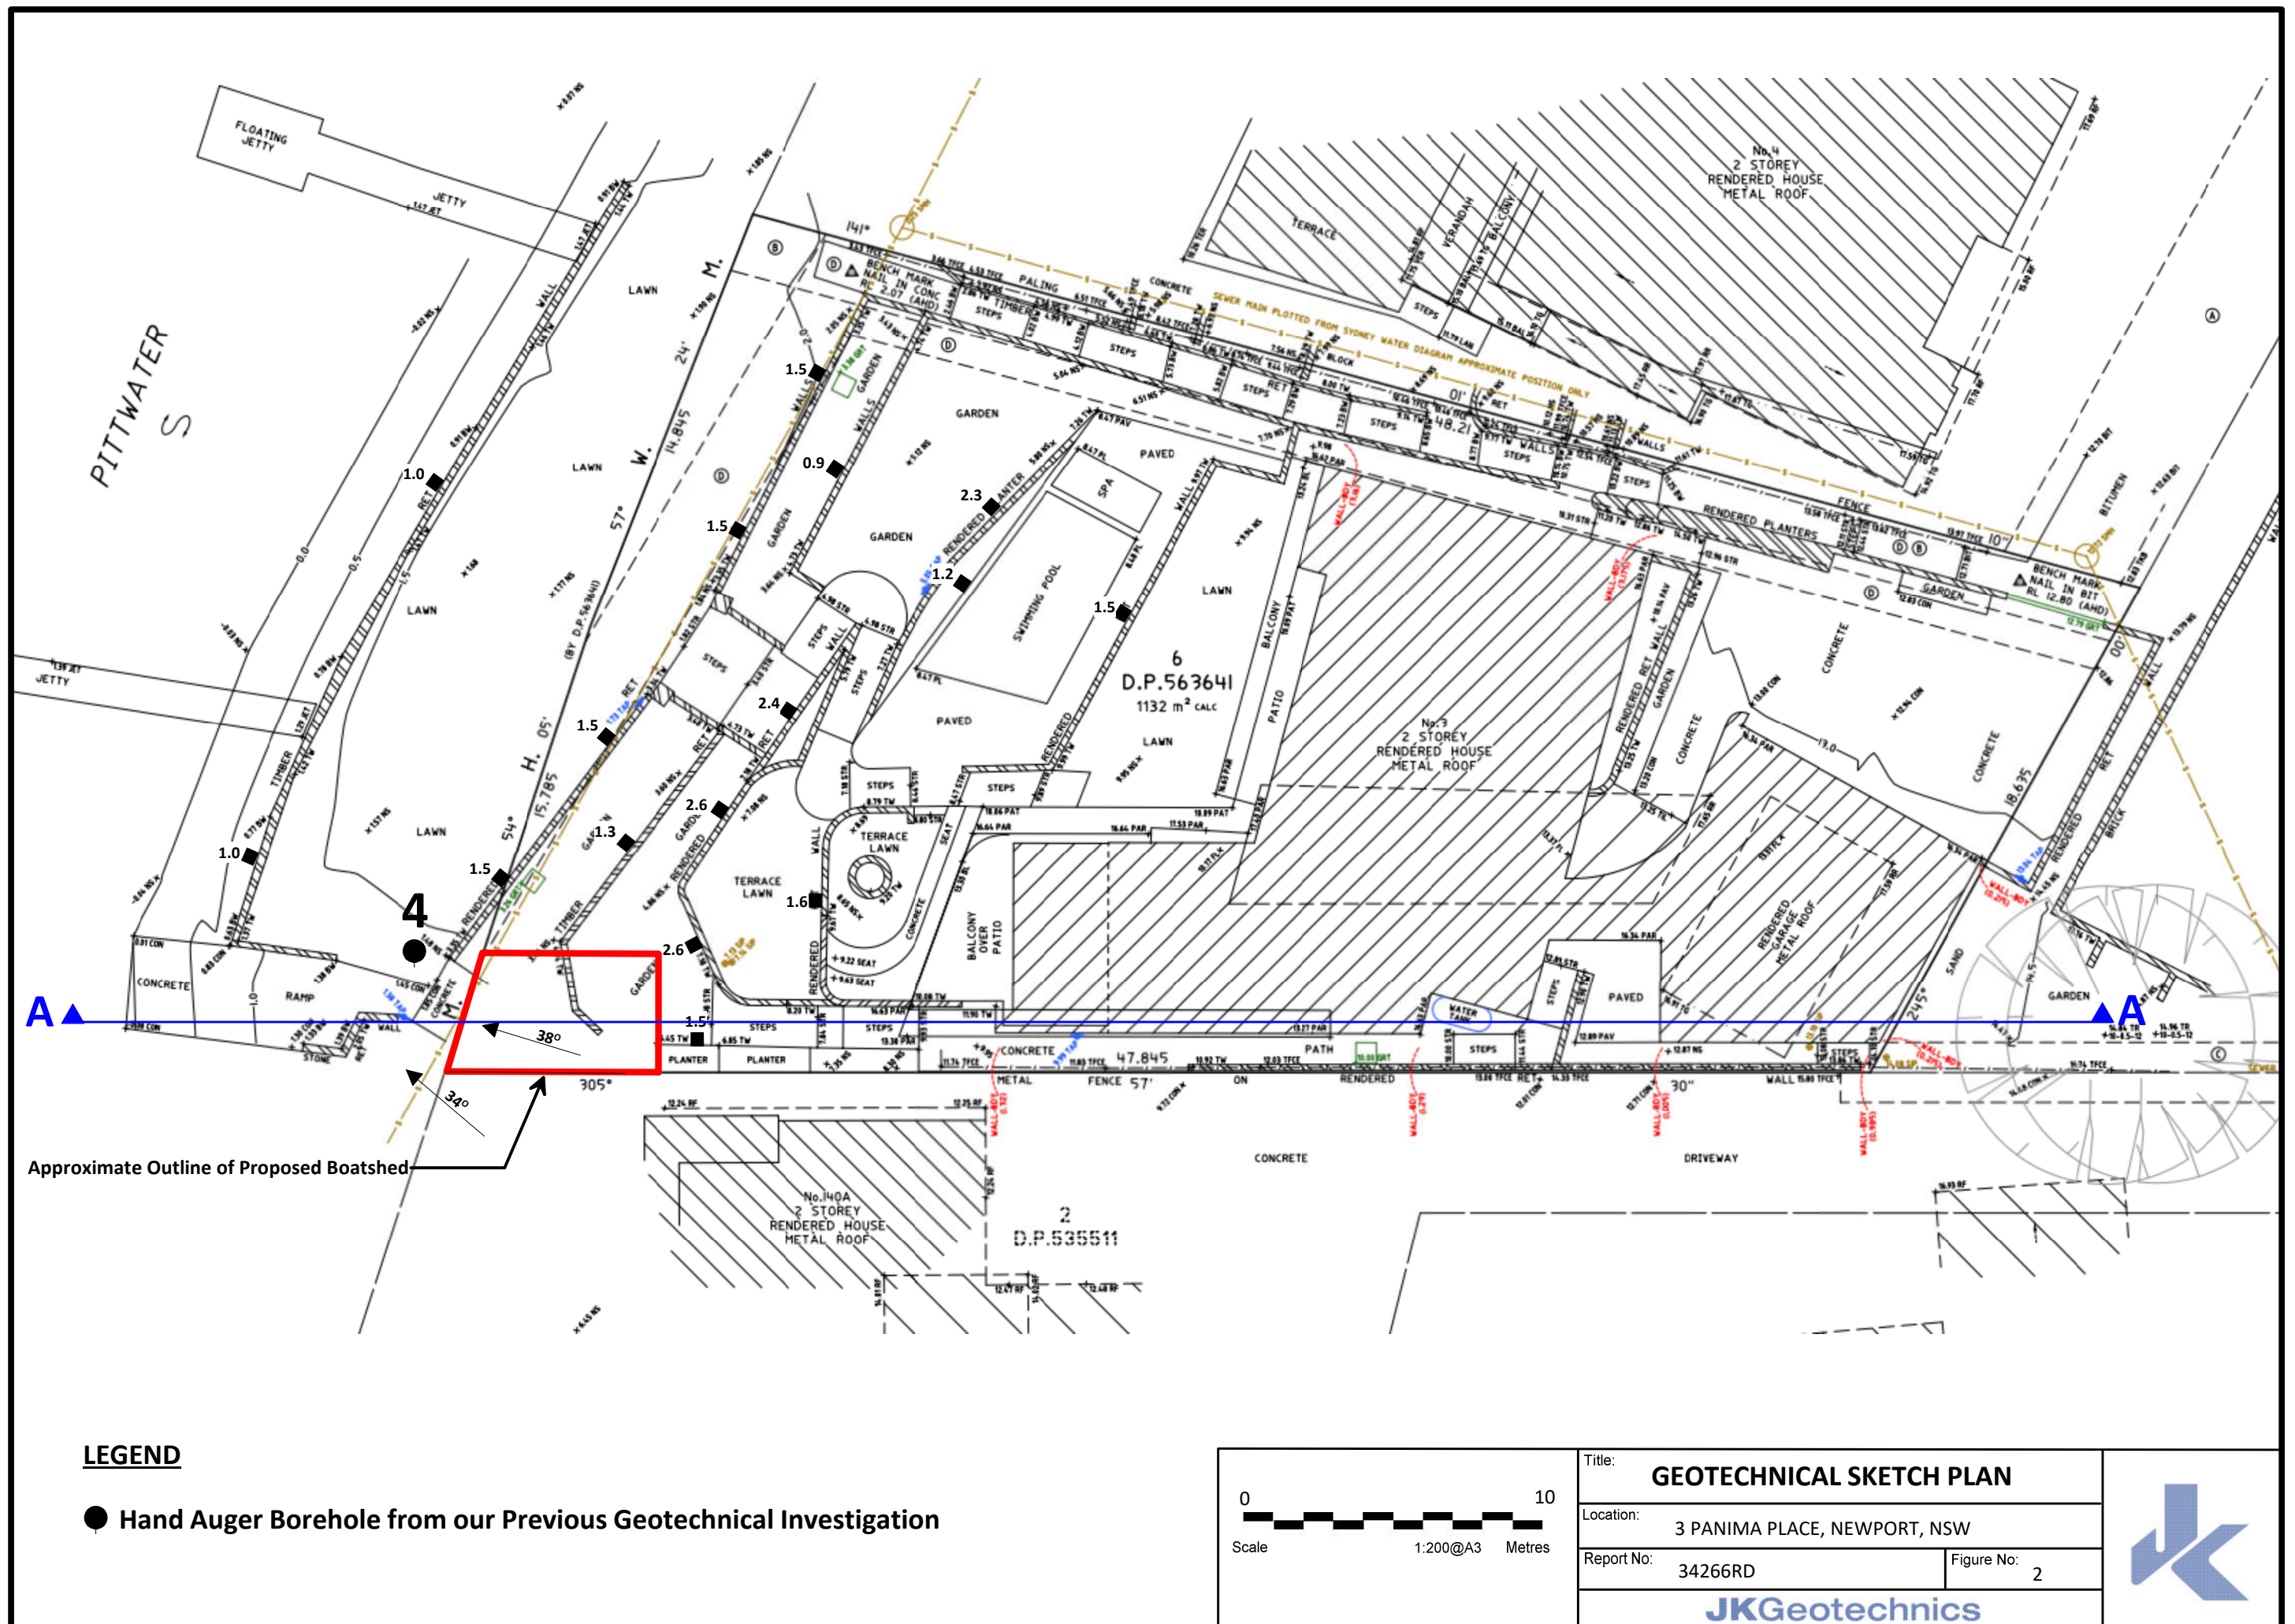
The attached Figure 2 presents a geotechnical sketch plan showing the principal geotechnical features present at the site and includes the test locations from our previous investigation. Figure 2 is based on the survey plan prepared by C.M.S. Surveyors Pty Ltd (Ref 12715detail dated 23 April 2021) with the proposed boatshed superimposed. Additional features on Figure 2 have been measured by hand held inclinometer and tape measure techniques and hence are only approximate. An explanation of geotechnical mapping symbols used on Figure 2 are presented on the attached Figure 4. Figure 3 presents a typical cross-section through the site based on the survey data augmented by our mapping observations.

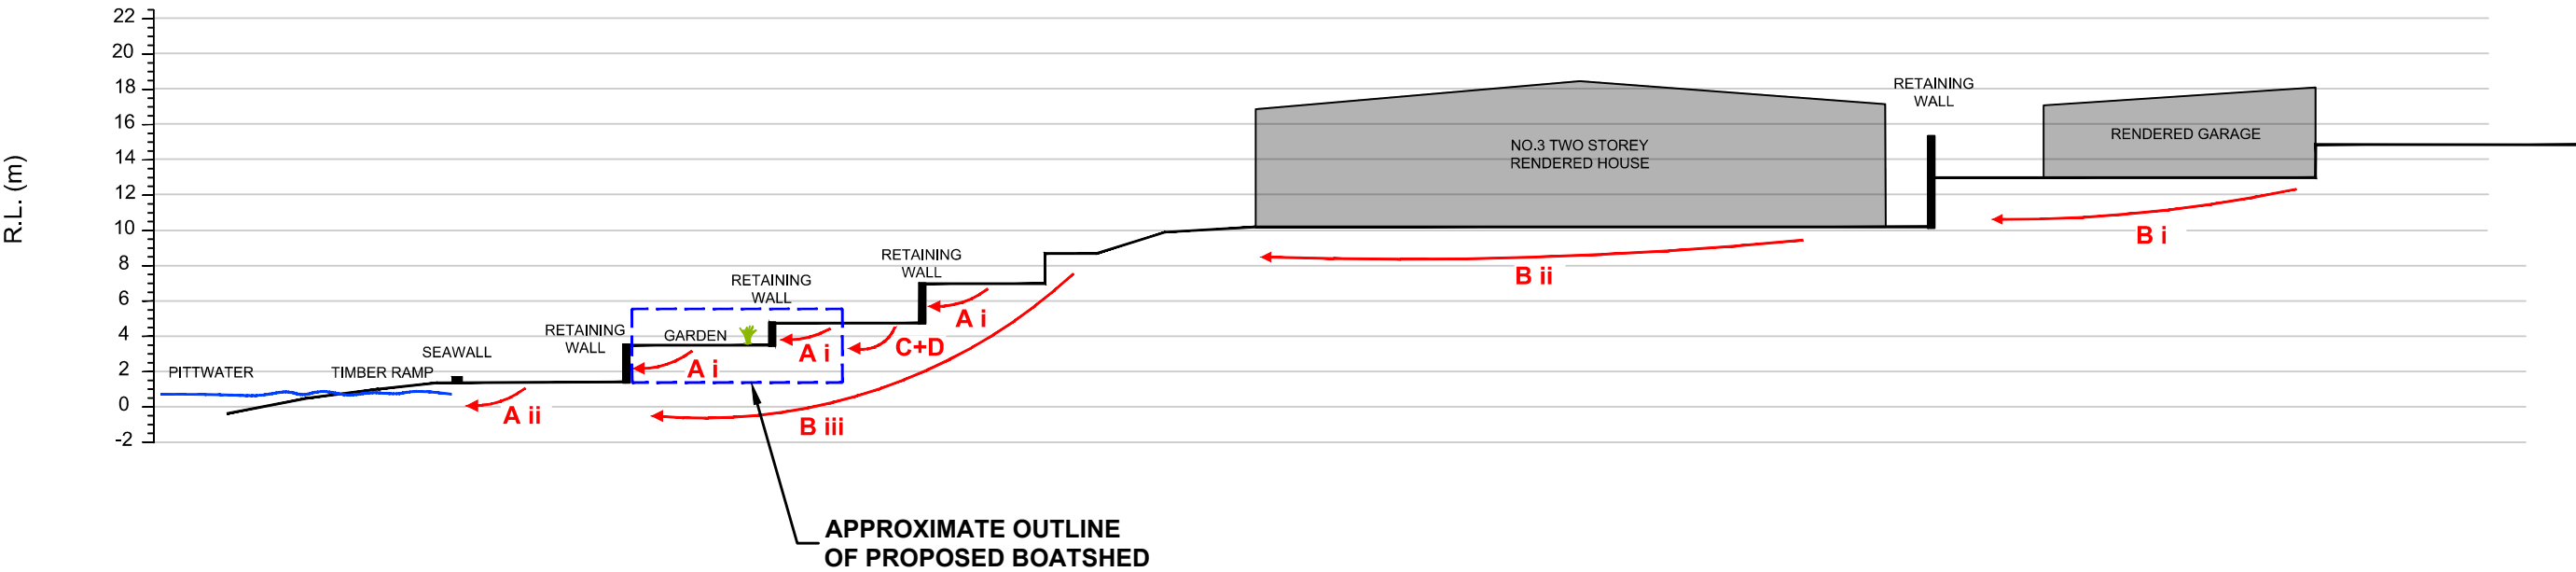
| <div>0 4 8 12 16 20</div> <div>V:SCALE 1:400 @A3 METRES</div> <div>0 2 4 6 8 10</div> <div>H:SCALE 1:200 @A3 METRES</div> <div>This plan should be read in conjunction with the JK Geotechnics report.</div> | Title: <b>GEOTECHNICAL SKETCH SECTION A-A</b> | |

These potential hazards are indicated in schematic form on the attached Figure 3.
