**GEOTECHNICAL RISK MANAGEMENT POLICY FOR PITTWATER  
FORM NO. 1 – To be submitted with Development Application**

| Address of site _____ 85 Grandview Drive, Newport, NSW | |

| Report Title: <i>Geotechnical Assessment for Proposed Alterations and Additions</i> | |
| Report Date: <i>27 May 2025</i> | Report Ref No: <i>37607YMrpt</i> |

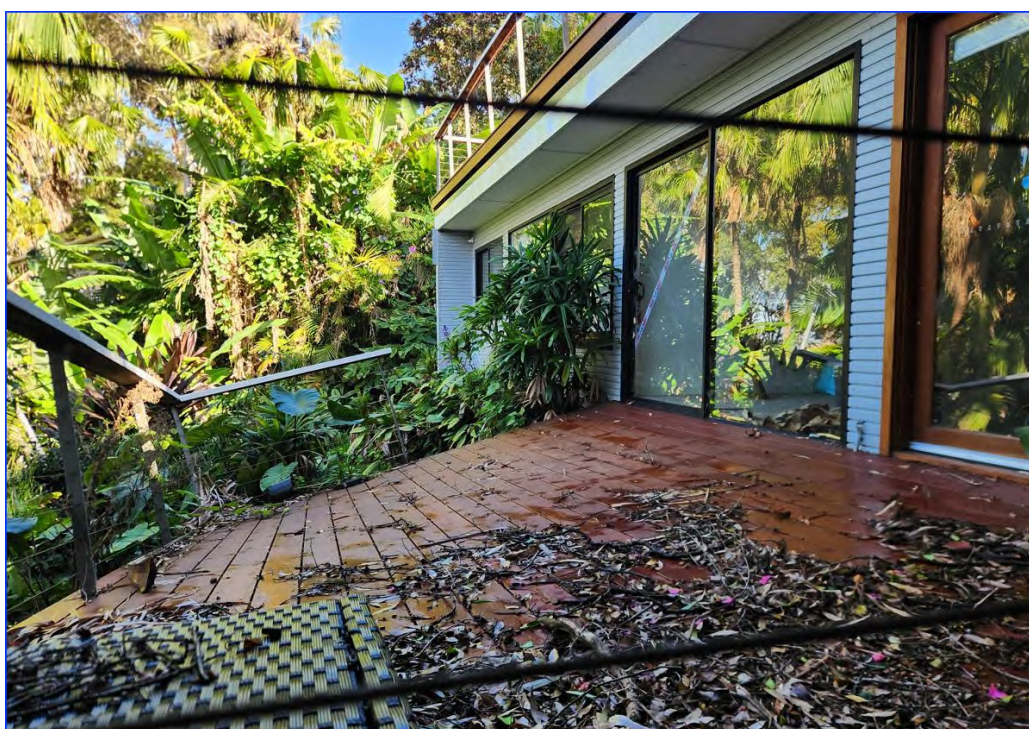
On the south-eastern/downslope side of the house is an upper deck, which is at ground floor level (GFL) with a partial lower ground floor (LGF) level located below. This LGF included a deck, however at the time of our inspection its southern corner has slumped down about 0.7m, as shown on **Photo 1** below.

*Photo 1- looking westwards showing slumped deck*

- i. Slumping of the southern corner of the deck and severe cracking and deformation of the deck and timber path to the south-west.
- ii. Failure of about two thirds the length of the sandstone retaining wall can be observed with distress in the form of tilting and outward movement downslope. The north-eastern end of the wall is cracked but has not moved downslope. The remainder of the wall may have slipped downslope but its original alignment /position is unknown.

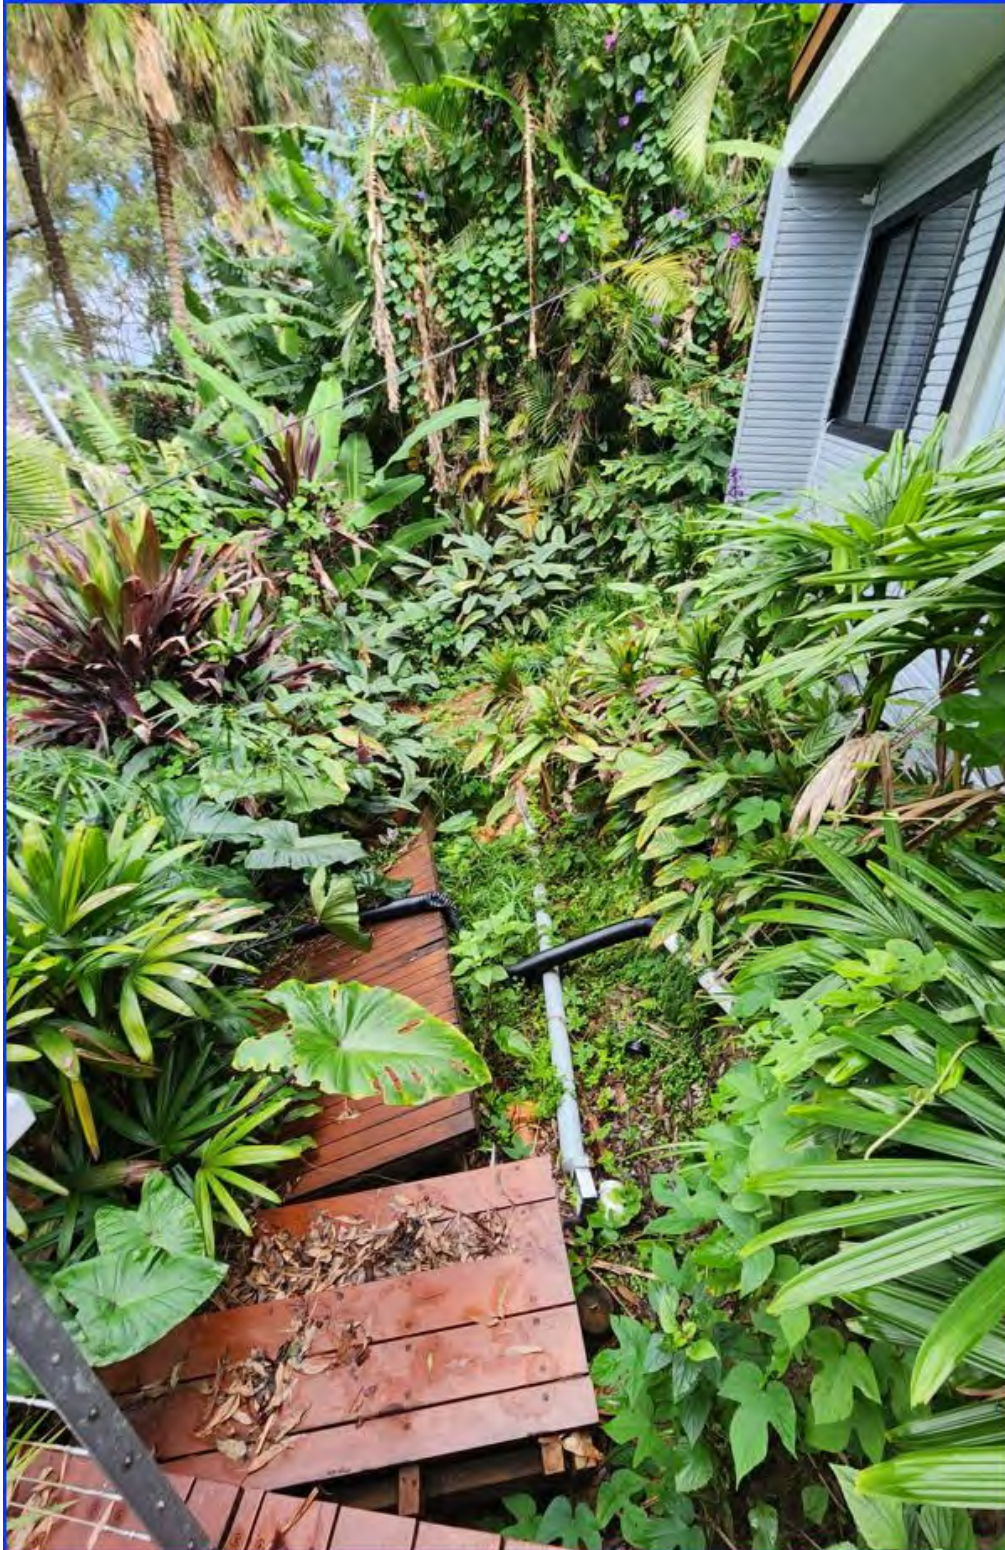
A decked pathway leading to the south-west also appeared to have slumped and failed, and was inaccessible and lying on the ground at the time of our inspection. This can be seen in **Photos 2 and 3**.

*Photo 2- looking westwards showing slumped deck*

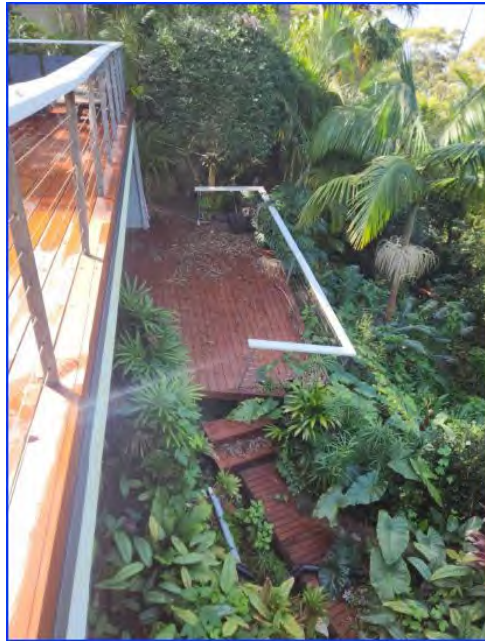
*Photo 3- looking down eastwards showing damaged deck and slumped path*

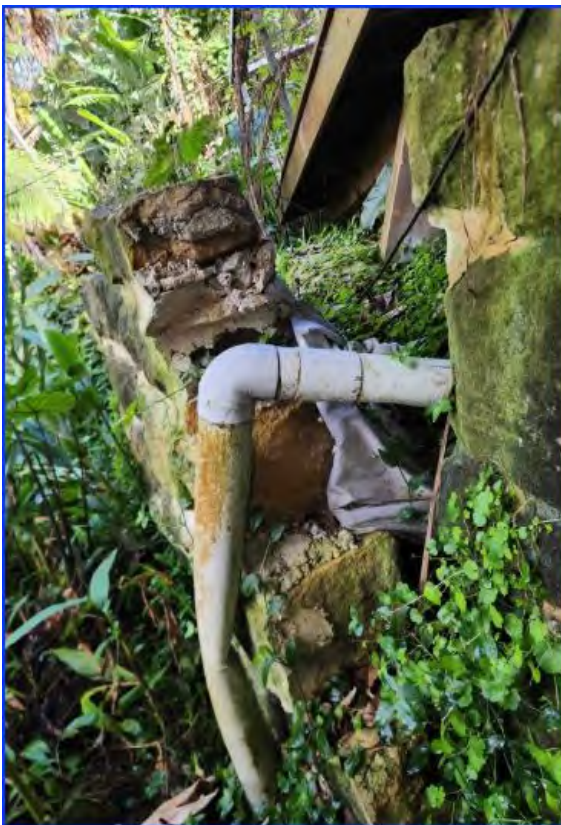
Immediately down slope of the deck is a mortared rough-hewn sandstone retaining wall that has cracked tilted and appears to have translated or moved sideways and slid some distance downslope. The upper portion of the wall has moved outward 0.45m while the lower courses appear to have moved outwards about 0.2m as shown in **Photo 4 and 5**.

*Photo 4- looking westwards*

- 7.1.5 The existing retaining wall along below the failed deck has failed and is leaning over, cracked and has translated laterally and moved down the slope. It requires either replacement or stabilisation. We note the DA plans indicate a new shotcreted wall. Such a wall must be anchored to bedrock. We note the alignment of the new wall is upslope of the existing sandstone wall and consequently this wall will need to be removed once the new wall has been installed.

- 7.1.6 The retaining wall will require lateral restraint from rock anchors.
- 7.1.7 Geotechnical investigation comprising at least two cored boreholes must be completed to confirm the depth to and quality of the rock. This information must then be used to confirm that the proposed design is suitable. We recommend test pits be excavated adjacent to walls suspected to be poorly founded.

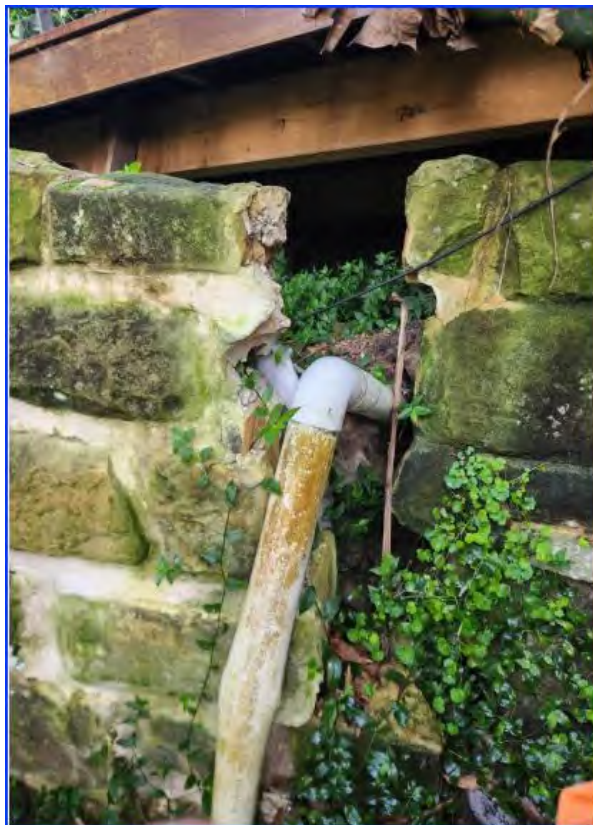
*Photo 5- looking north-westwards*

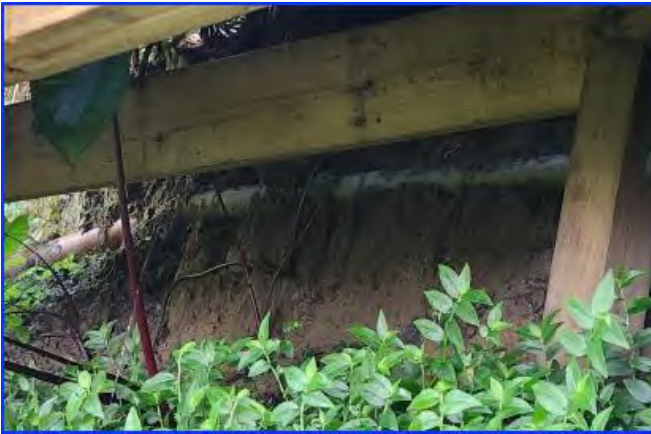
*Photo 6 looking north-westwards*

There were at least two ruptured white PVC pipes below the damaged deck and signs of a possible backscarp, which may suggest a rotational type failure. This is shown in **Photos 6 and 7** below. It is also possible that rather than being a backscarp, it may have formed following erosion from the broken stormwater pipe(s).

- iii. Ruptured stormwater and sewer pipes are visible below the lower deck. A possible backscarp appears to be located directly below these pipes.
- iv. Downslope (southwards) are two sandstone walls used to terrace the slope that have also collapsed. A section of paling fence has fallen over and further stormwater pipes have been ruptured. This area was densely vegetated and could not be assessed in more detail.

- 7.1.1 All stormwater and sewer pipes from the house, garage and surrounds are to be pressure tested and where found to be leaking fixed. Stormwater pipes must be connected to Council's stormwater system and must be designed with some flexibility to accommodate some creep movement. Plans showing the pipe details must be provided to the geotechnical engineer for review.
- 7.1.2 Both ponds should be monitored for leaks and should any leaks be detected they must be fully drained or repaired.
- 7.1.3 A structural engineer is to assess the stability of the house and nominate any portions of the structure that are of concern and may require further investigation, monitoring, underpinning and/or other works. The structural engineer's report must be reviewed by the geotechnical engineer for consideration in the scope of further geotechnical investigation.

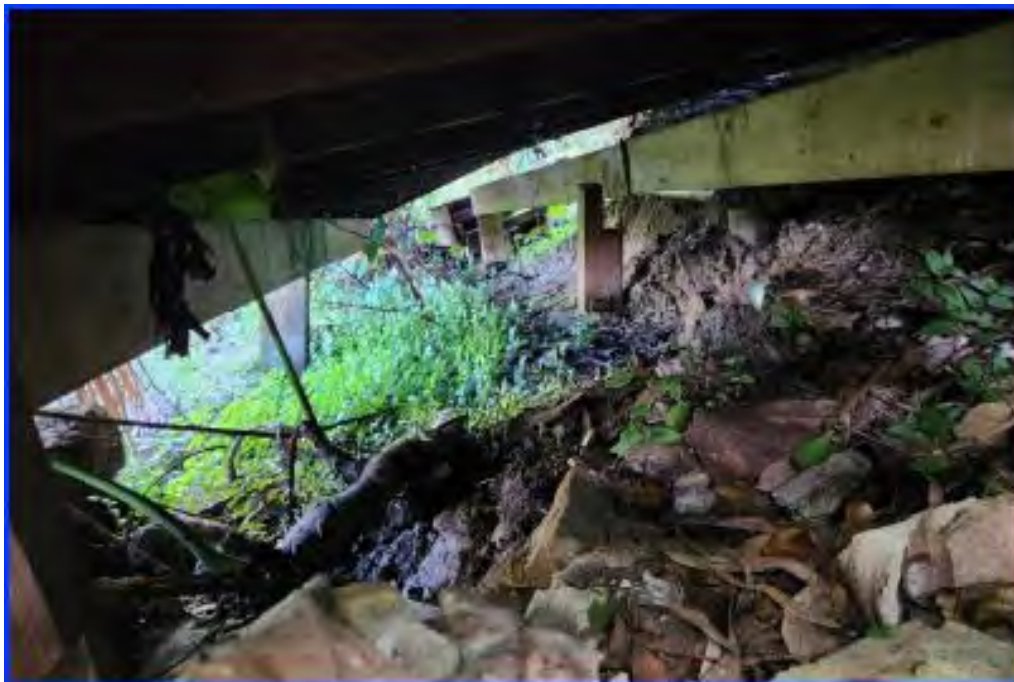
*Photo 8-looking south-west under the lower deck showing a possible backscarp.*

The backscarp, or steep localised unvegetated slope, is about 1m from the rear wall of the house. The footings for the deck appeared to be on rough poured shallow concrete pads founded within the backfill material that has been placed behind the wall that has failed. There has been some soil loss from behind the wall. The alignment of the wall diverges from the deck to the west, though it was not obvious what its prior position was.

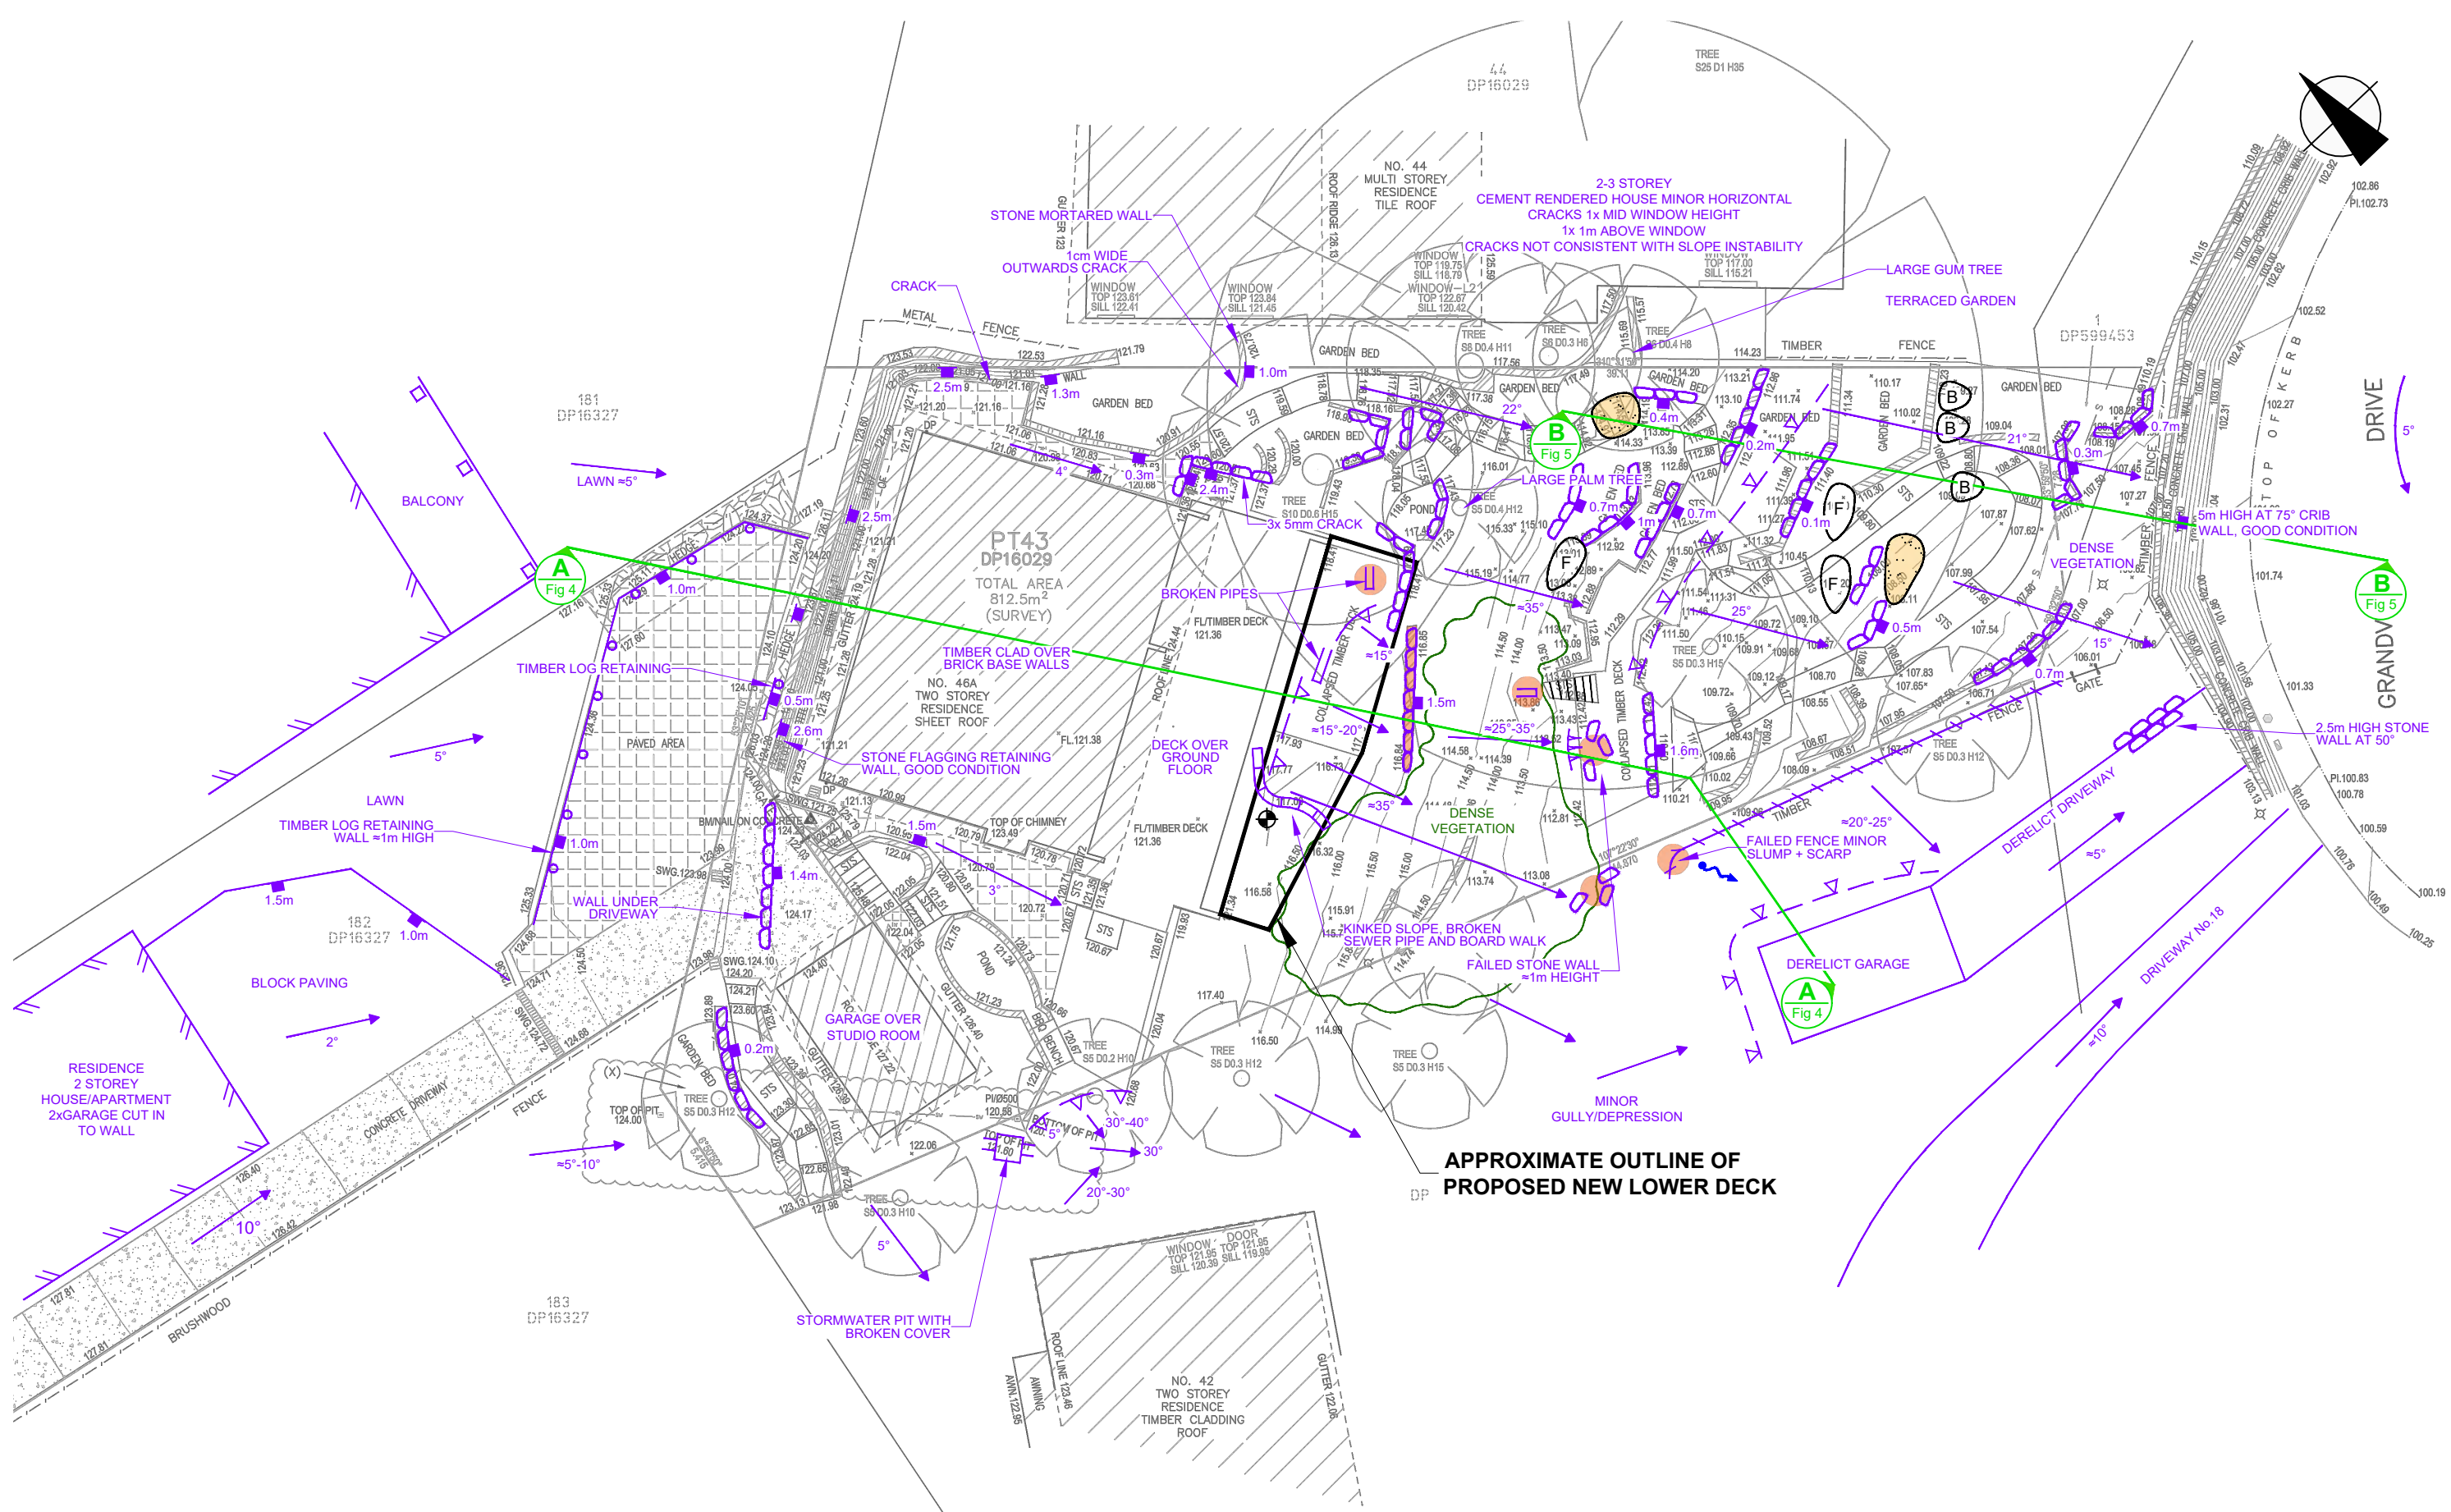
- A. Failure of non-engineered sandstone retaining walls (of less than 2.5m height).

- B. Localised failure of slopes, including terraced areas with closely spaced low height walls.
- C. Failure of embedded boulder and outcrops on moderate slopes.
- D. Failure of timber log walls to 1.2m height.
- E. Large scale slope failure.
- F. Failure of crib wall and proposed engineered retaining structures.

These potential hazards are indicated in schematic form on the attached Figure 3 to 5.
