Business Securities Pty Ltd  
3/14 Esther Road  
Mosman NSW 2088

Project 24750.02  
19 July 2013  
RKL:pc

**Unit 16, 20 Narabang Way, Belrose  
Development Application DA2013/0714  
Preliminary Geotechnical Assessment and Report**

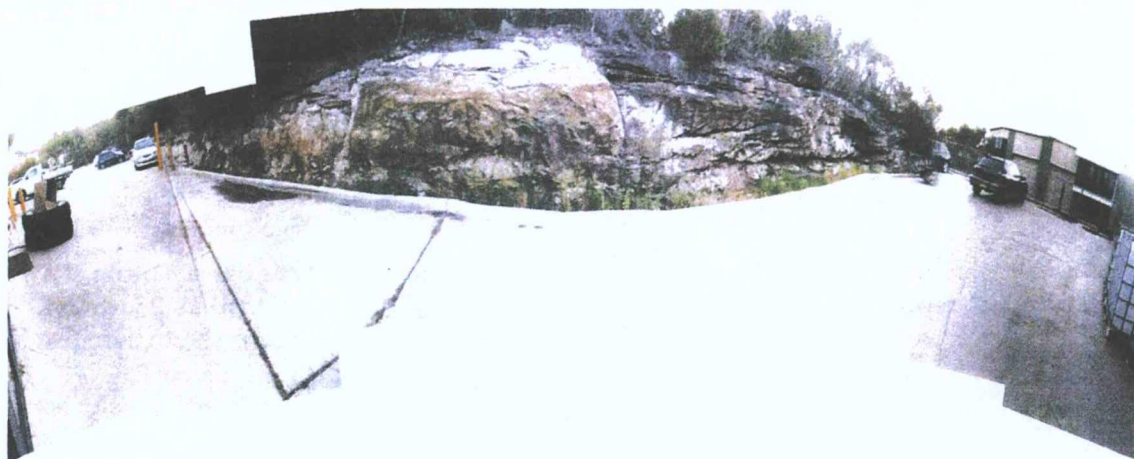
The construction comprises an on-grade concrete pavement (refer to Figure 1 below) which is supported at the western side by a concrete block retaining wall of up to about 1.4 m height (refer to Figure 2).

Figure 1. 270° panorama of the hardstand area (distortion due to photo merging).

- it is noted that the eastern side of the hardstand area comprises a natural cliff (refer to Figure 1), however the height is less than 3 m and, although some weathering of the lower part is likely, the exposed rock is considered to be of adequate stability.

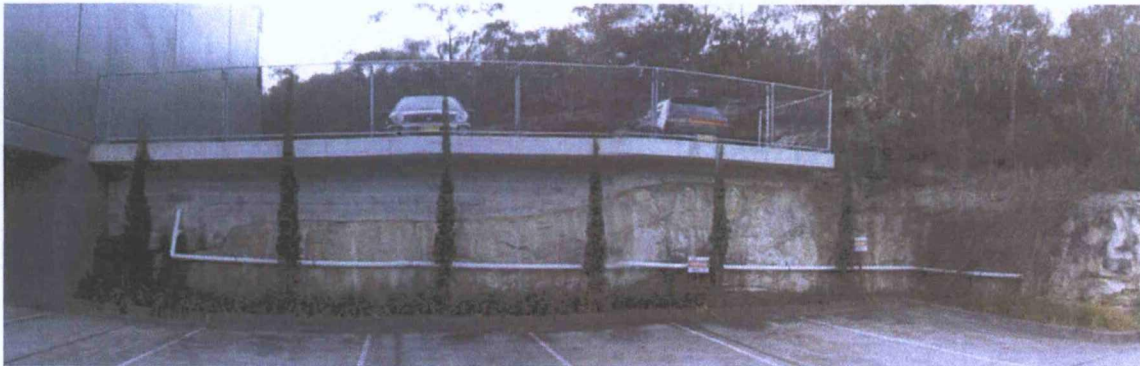
Figure 2. Panorama of the low, western side of the hardstand area.

- the site is currently developed and there appears to be filling of up to about 1.8 m depth present at the northern end of the western retaining wall (refer to Figure 2). It is noted that the filling is retained by a well-constructed concrete block retaining wall, with no evidence of distress or cracking of the wall. The wall is founded on sandstone of at least medium to high strength which is more than adequate to support the wall.
