## **GEOTECHNICAL INVESTIGATION:**

New House at **41 Marine Parade, Avalon**

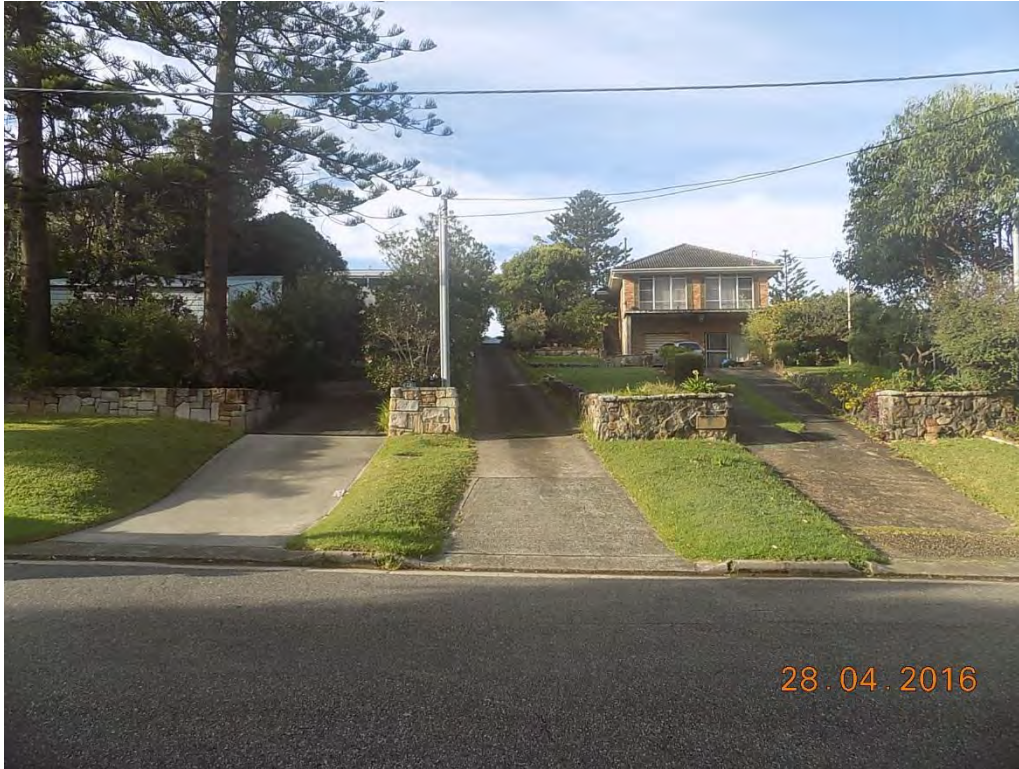
Photo 1

- 2.3** At the road frontage a long concrete driveway runs up the slope to a stable, brick garage and a car parking area beside the house (Photo 1 & 2). A cut that increases in height to the S has been made into the slope for the parking area and the uphill side of the house. The N portion of the cut is supported by a low elevation, rough, stack rock retaining wall that currently appears stable (Photo 3). The majority of the S side of the cut is through competent, medium strength sandstone. The very shallow soil and clay portions are slightly battered uphill and appear stable (Photo 4). The two storey rendered brick and timber framed house is in good condition for its age. No significant signs of movement or cracking were observed in its external supporting walls. Under the W corner of the house a cut through competent, medium strength sandstone has been made into the slope for a storage area (Photo 5). On the downhill side the house medium strength sandstone beds outcrop (Photo 6 & 7). Some areas of the beds are undercut however the cantilever arms are thick in relation to the overhang length and the rock faces are considered stable. No other significant geological defects were observed on the exposed rock faces

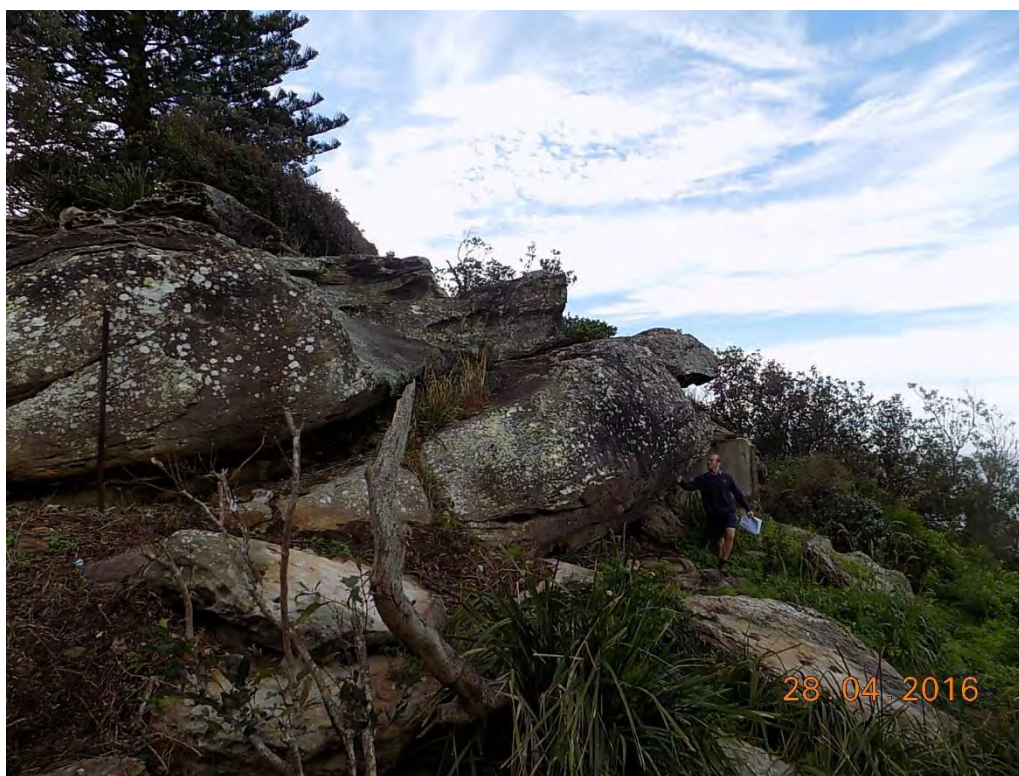
Photo 6

| HAZARDS | Hazard One | Hazard Two | Hazard Three |
|---|---|---|---|
| TYPE | The undercut sandstone beds that line the lower boundary toppling and impacting the existing house or the proposed works. | The vibrations produced during the proposed excavations causing failure of the undercut sandstone beds along the lower boundary of the subject property (Photo 6 & 7). | The proposed excavation collapsing onto the work site before retaining walls are in place. |

It is expected that the majority of the excavations will be through medium strength sandstone or better. Excavations through rock should be carried out to minimise the potential to cause vibration damage to the undercut sandstone beds along the lower boundary of the subject property (Photo 6 & 7). The closest neighbouring house is at least ~20m from the edge of the proposed excavation. Close controls by the contractor over rock excavation are recommended so excessive vibrations are not generated.

Excavation methods are to be used that limit peak particle velocity to 10mm/sec at the common boundaries of the subject property. Vibration monitoring will be required to verify this is achieved.

If a milling head is used to grind the rock vibration monitoring will not be required. Alternatively if rock sawing is carried out around the perimeter of the excavation boundaries in not less than 1.0m lifts, a rock hammer up to 600kg could be used to break the rock without vibration monitoring. Peak particle velocity will be less than 10mm/sec at the common boundaries using this method provided the saw cuts are kept well below the rock to be broken.
