Proposed Multistorey Residential Building

67 Pacific Parade, Dee Why, NSW

GEOTECHNICAL INVESTIGATION REPORT

Job No. SYD2022-0051AC | Version Rev 2

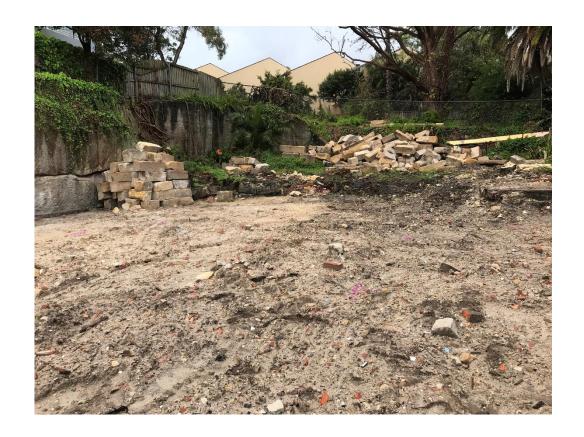
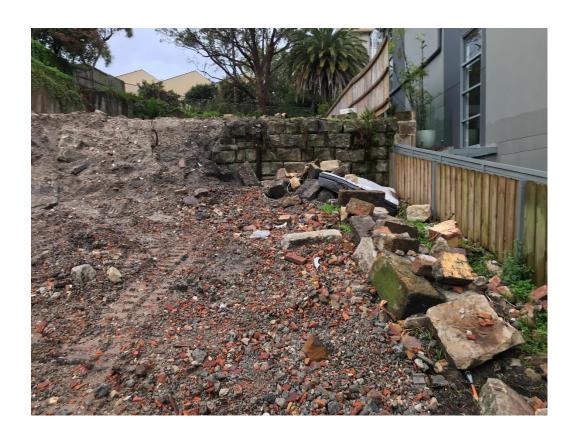
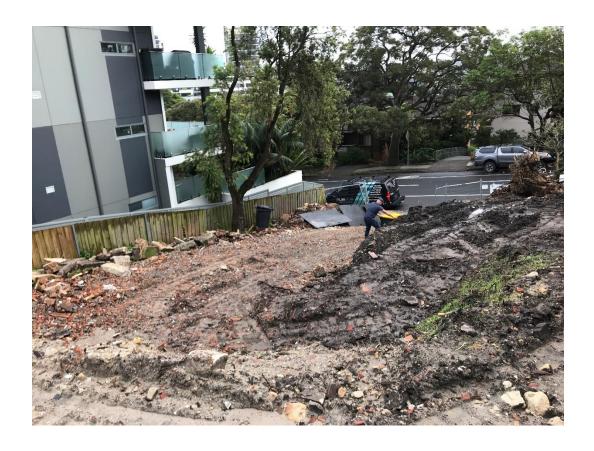
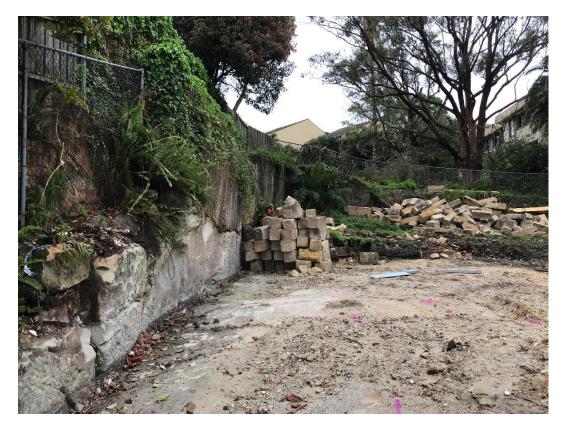
A large crack was observed in the brick retaining wall at the western end of the southern boundary. The current stability of the wall is unknown and should be investigated by a Structural Engineer if it is to remain.

The concrete block wall at the rear of the property was visibly cracked at the time of our field investigation. We recommend a suitably qualified structural engineer assess the current stability of the wall prior to undertaking any of the proposed works on site, so that suitable stabilisation measures can be installed should they be required. We note the potential for vibrations associated with excavation may further reduce the wall stability.

The site is located on a north-west facing hillside, with the slope broken by retaining walls at all site boundaries. Brick retaining walls and cut sandstone faces support the neighbouring property to the east (1 The Crescent) and south (7 The Crescent) above the subject site, while a retaining wall supports the subject site above the neighbouring property to the west (65 Pacific Parade). Based on our visual assessment the existing retaining walls appeared to be in good condition except for the brick and sandstone block retaining wall located at the south-western corner of the site. The brick work has a vertical crack extending the full height of the bricks (i.e., 0.9m) and some slumping of the sandstone blocks was observed immediately above the location of the crack in the brickwork.

Allowable vibration limits should be determined by the Structural Engineer following review of the dilapidation reports. As a guide the German Standard DIN4150-3:1999-02, would indicate that vibrations should be limited to a peak particle velocity of 5mm/s (for frequencies up to 10Hz) for nearby residential buildings in good condition, however lower limits are expected to be required for the existing rear retaining wall in poor condition.
