Report Title: Geotechnical Report 14 Loquat Valley Road, Bayview

Report Date: 30/7/25

## **GEOTECHNICAL INVESTIGATION:**

House Alterations and Additions and New Pool at **14 Loquat Valley Road, Bayview**

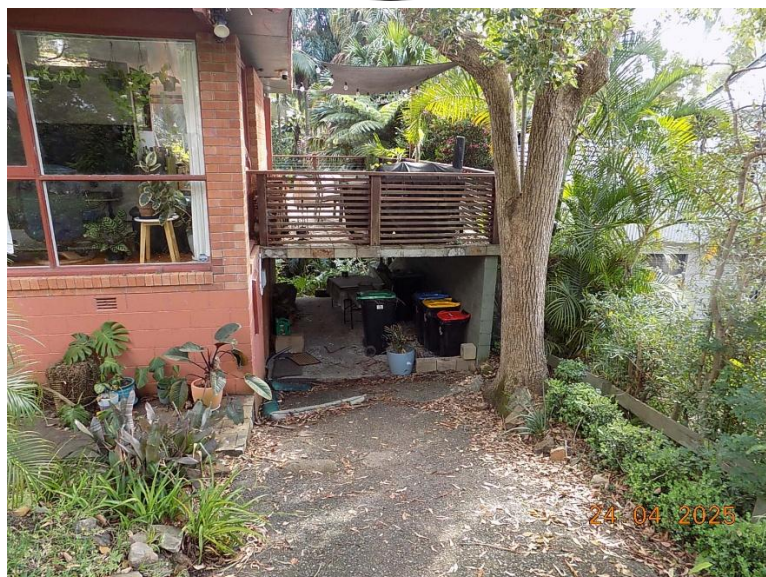
Photo 1

**2.3** At the road frontage, a concrete driveway runs downslope to a carport on the NE side of the house (Photo 1). The moderately graded slope between the road frontage and the house is lawn and garden covered (Photo 2). A ~1.3m cut for the lower ground floor of the house has been battered at steep angles. The cut batter is lined with boulders (Photo 3). This batter will be demolished as part of the proposed works. The two-story house is supported on concrete block and brick walls. No significant signs of movement were observed in the visible supporting walls. Fill has been laid off the downhill side of the house (Photo 4). The fill batter is ~1.4m high, stands at stable angles and is well vegetated. Below the fill batter is a moderately graded lawn (Photo 5). A natural watercourse which was dry at the time of inspection cuts across the property near the downhill property boundary (Photo 5).

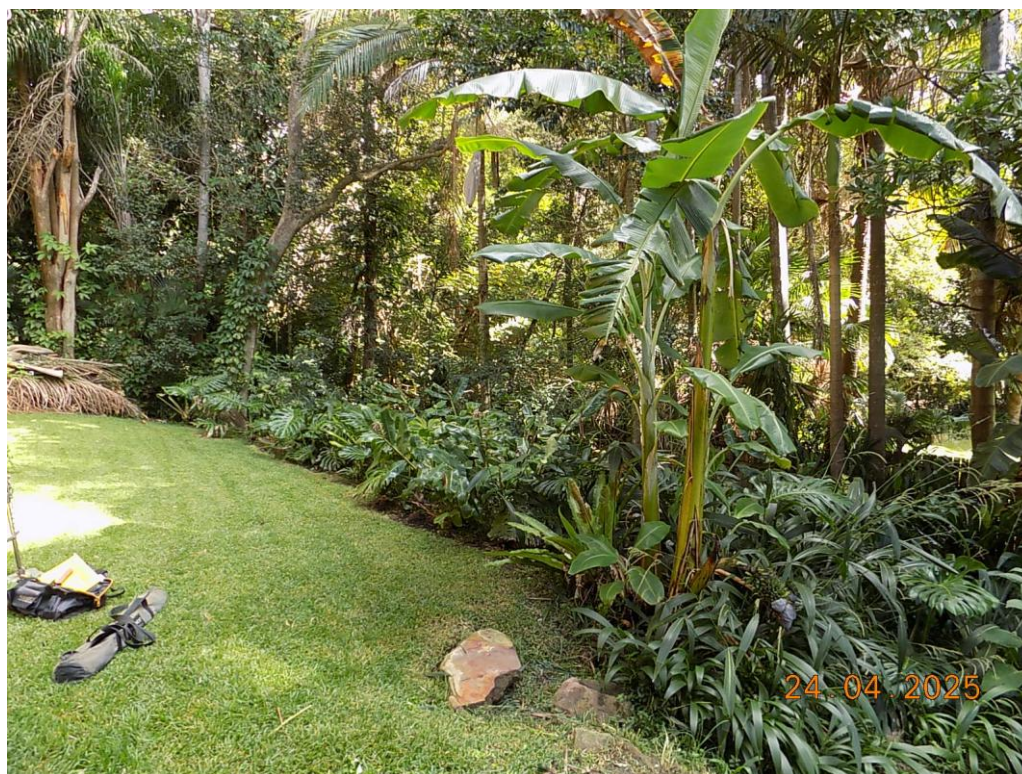
Photo 5

There is fall to the creek below the property (Photo 5). Roof water from the development is to be piped to a spreader pipe positioned on the slope above the creek. Stormwater is to be directed through any tanks that may be required by the regulating authorities.

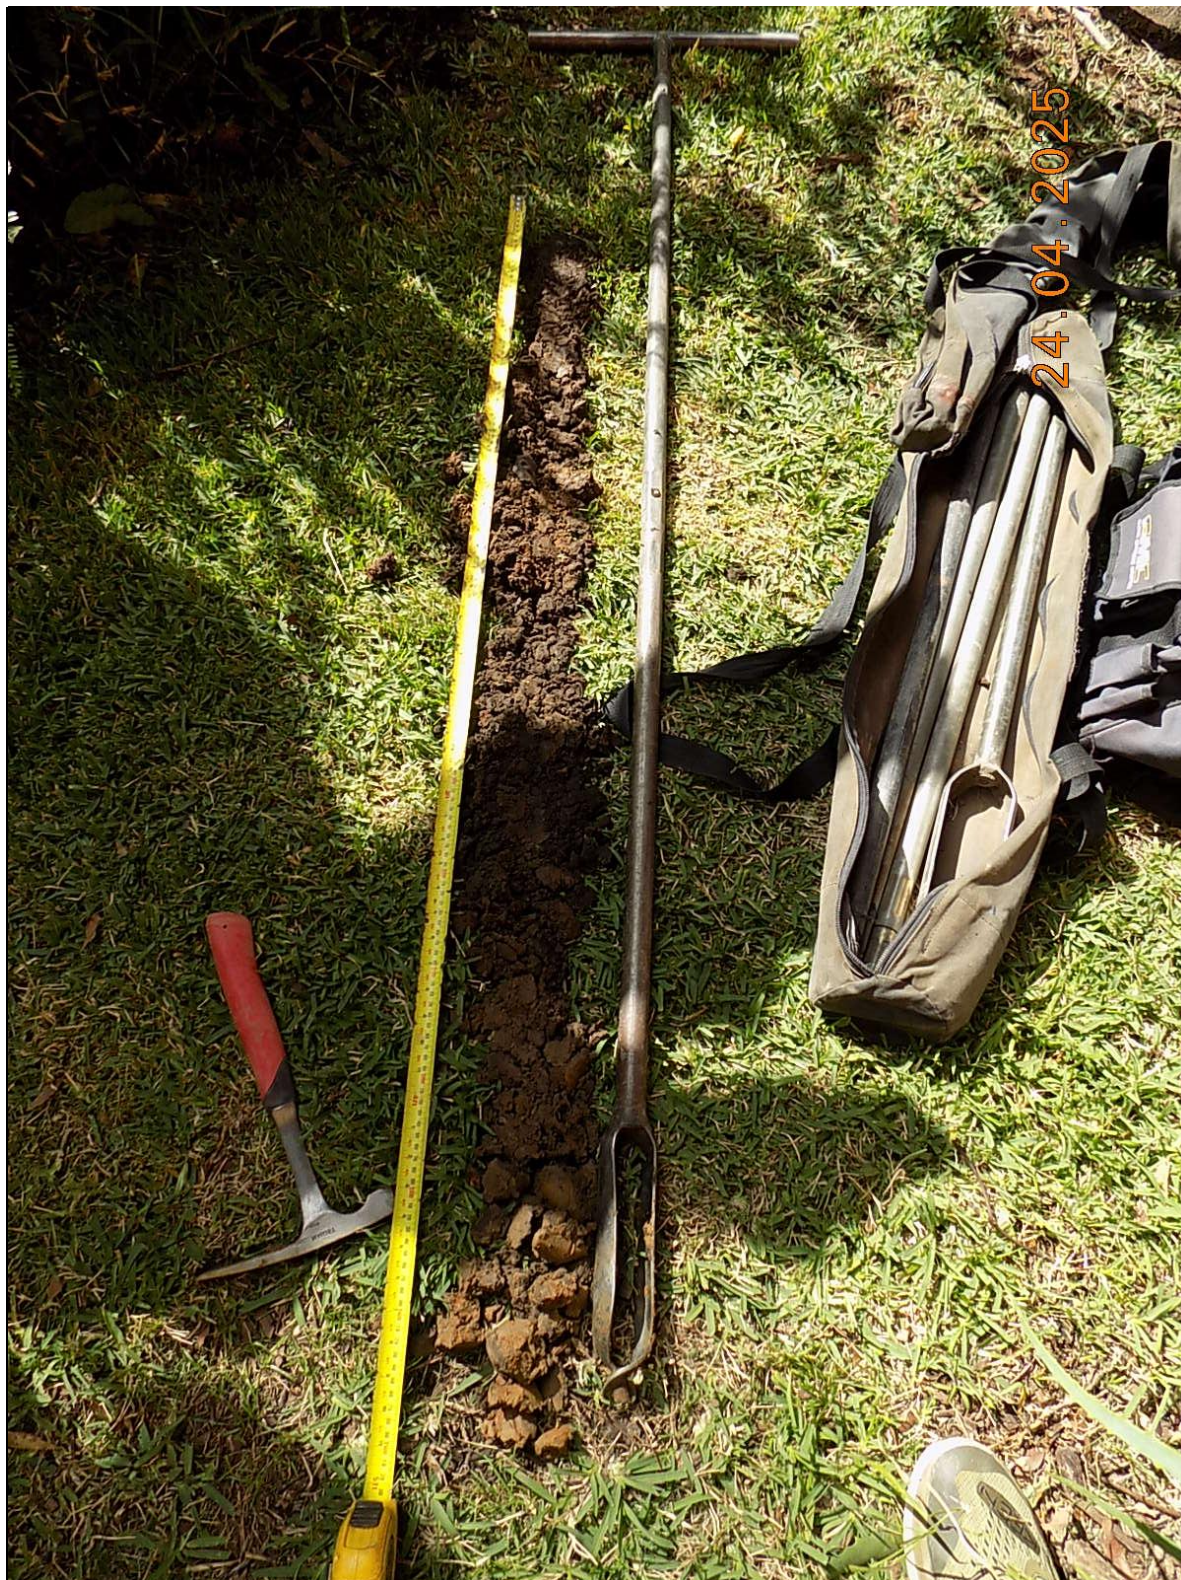
Depth (m)	Material Encountered
0.0 to 0.9	<b>FILL</b> , derived from natural clayey sandy soil, brown, Very Soft to Firm, damp, fine to medium grained.
0.9 to 1.2	<b>TOPSOIL</b> , clayey sandy soil, Firm, damp, fine to medium grained.
1.2 to 1.5	<b>RESIDUAL CLAY</b> , mottled brown and maroon, Firm, dry, fine grained.

End of test @ 1.5m in residual clay. No water table encountered.

Photo 6 – downhole is top to bottom

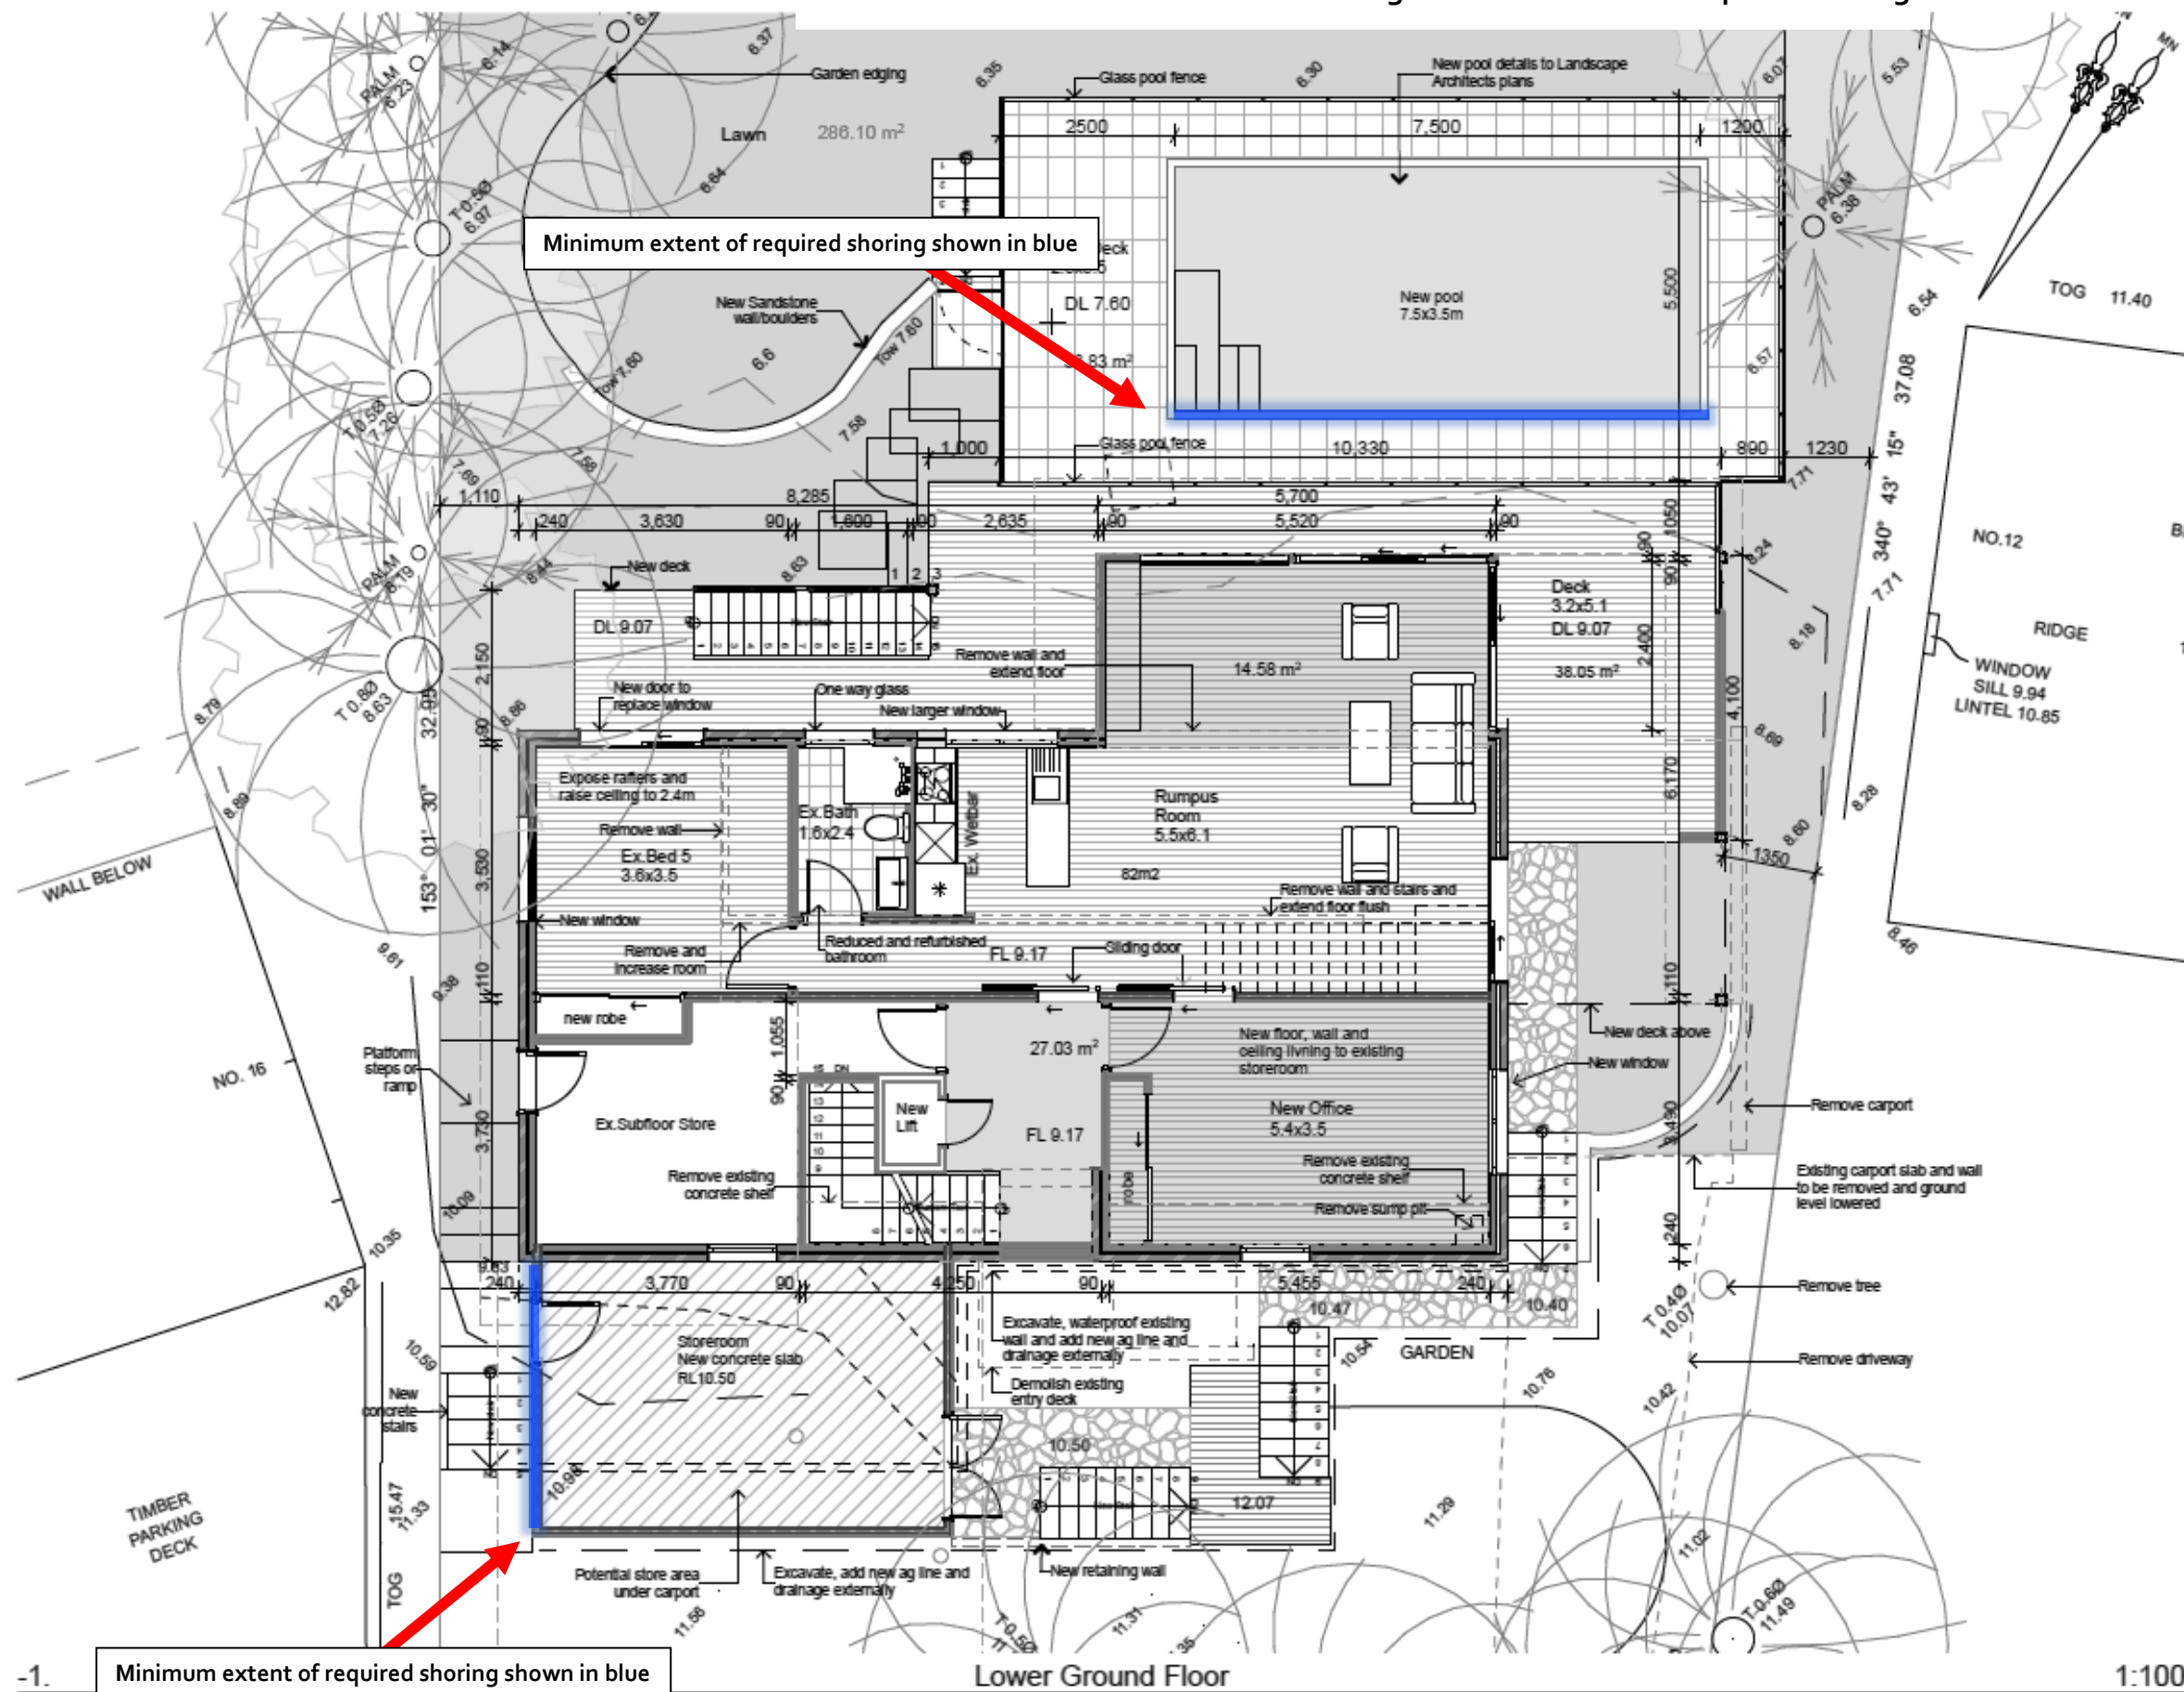
# LOWER GROUND FLOOR PLAN – showing minimum extent of required shoring

The excavation for the proposed pool will reach a maximum depth of ~1.5m. Following the demolition of the existing timber deck off the downhill side of the house, no structures or boundaries are expected to lie within the Zone of Influence of the pool excavation.

Due to the depth of the excavation and the depth of fill in this location, we recommend the uphill side of the cut be temporarily supported with typical pool shoring such as braced sacrificial form ply, until the pool structure is in place. The remaining sides of the cut are

expected to stand at near-vertical angles for short periods of time until the pool structure is installed provided the cut batters are kept from becoming saturated. If the cut batters through fill, soil and clay remain unsupported for more than a day before pool construction commences, they are also to be supported with typical pool shoring until the pool structure is in place. The support will need to be designed by the structural engineer. See site plan attached for extent of minimum required shoring shown in blue.
