Arboricultural Impact Assessment Report

Mr Ray Balcomb
At
83 - 85 Bower St, Manly

15th July 2020

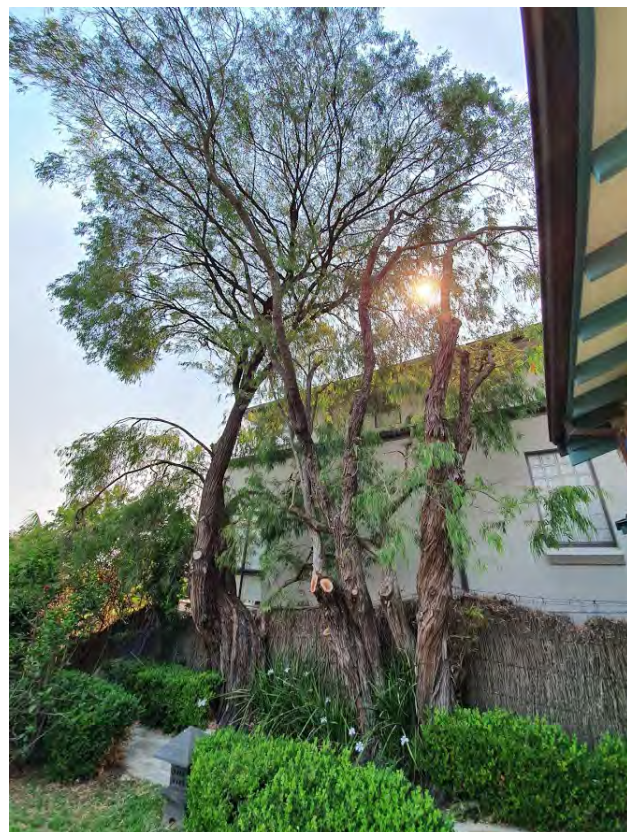
Figure Nine - This image shows Trees 6 and 5 viewed from western side (from left to right).

Tree 5 and Tree 6 are both *Agonis flexuosa* (Willow Myrtle) which are located on the eastern boundary fence of the site. They both have poor form and habit. These trees have a low retention value due to their low landscape significance and short life expectancy. Due to their location they are exempt from requiring permission for removal as they are growing within two (2) metres of the neighbouring dwelling.

Tree 8 is growing in close proximity to Tree 3 - we would recommend that this tree is relocated. Please refer to the Transplant Method Statement in Appendix 8. Tree 5 and 6 are both poor specimens with low retention values we would recommend that they are removed. Due to their closeness to the neighboring property they are exempt from requiring permission from Council for removal.

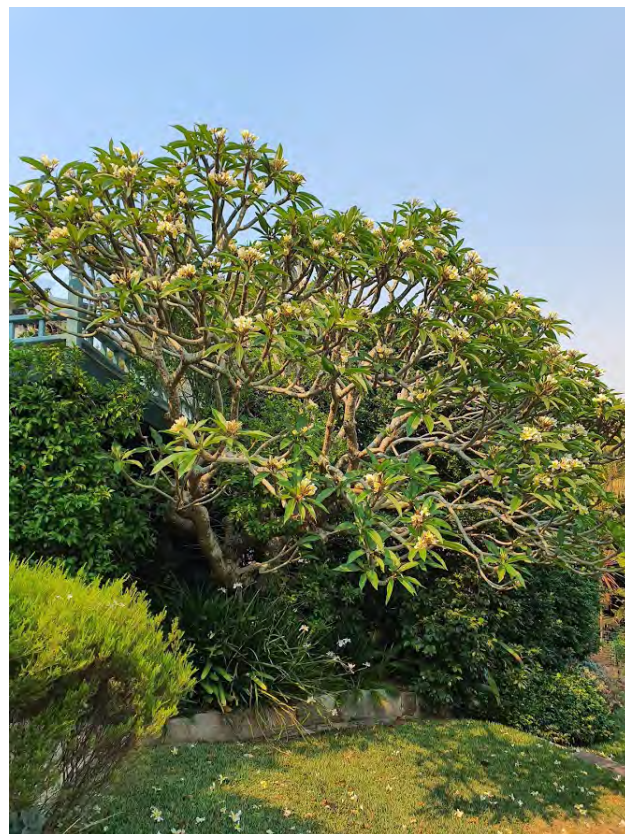
Figure Eleven - This image shows Tree 7 viewed from northern side.

Tree 7 is a mature *Plumeria* (Frangipani) which is in good condition and has good form and signs of good vigour. The proposed development in this area is to construct a set of stairs where this tree is located. This stairway will connect the main veranda on the northern end of the house to the garden and also around to the access pathway to Bower St. This tree will need to be removed. It is a species which will relocate to another location. Tree 8 is a mature *Dracena draco* (Dragon Blood Tree). It has good form and signs of good vigour. The proposed development will require this tree to be removed due to changes in level and the construction of new retaining wall. It will also be directly in the main pathway/access from the courtyard down on to the lawn area. We have recommended that Tree 3 be removed due to its structural stability and as they are both growing very close together we do not think Tree 3 will be able to be removed without damaging Tree 8. This tree will relocate to another location.

We would recommend that Tree 7 be relocated. Please refer to the Transplant Method Statement in Appendix 8. If these trees are removed we would recommended that replacement trees are planted out in alternate locations. Ideally these trees should be indigenous or native as per Council's list of recommended species.
