# Geotechnical Assessment

**Project:** Alterations & Additions  
10 Florida Road, Palm Beach NSW

**Prepared for:**  
Peter Princi Architects

For **Alterations & Additions** at  
**10 Florida Road, Palm Beach NSW**

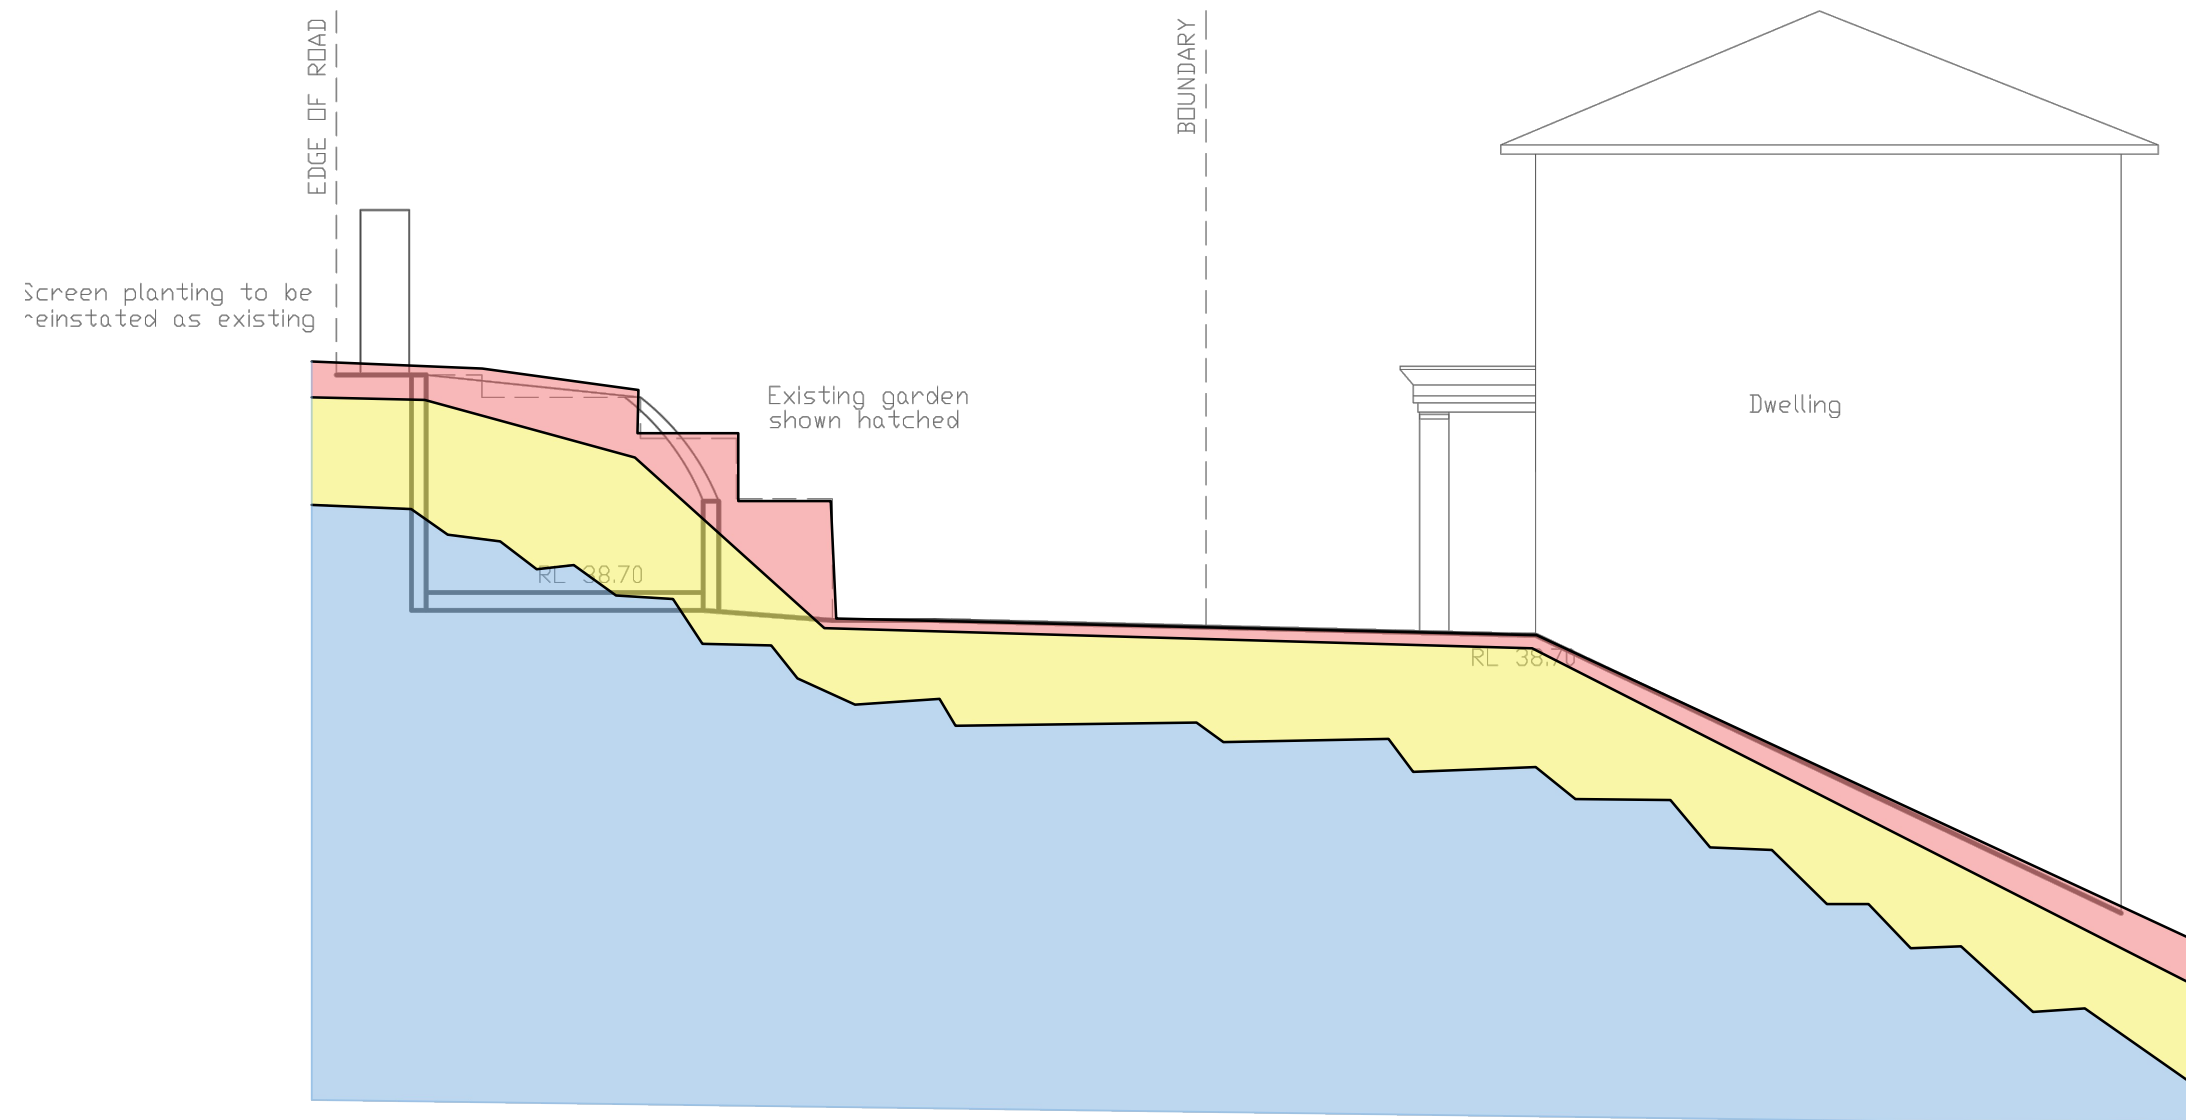
**INFERRED GEOLOGICAL SECTION**  
SCALE NTS

INTERPRETED SUBSURFACE SECTION ONLY.  
ACTUAL GROUND CONDITIONS MAY VARY.
