Report Title: Geotechnical Report 129 Riverview Road, Avalon

Report Date: 29/5/19

## **GEOTECHNICAL INVESTIGATION:**

### **New Inclinator at 129 Riverview Road, Avalon**

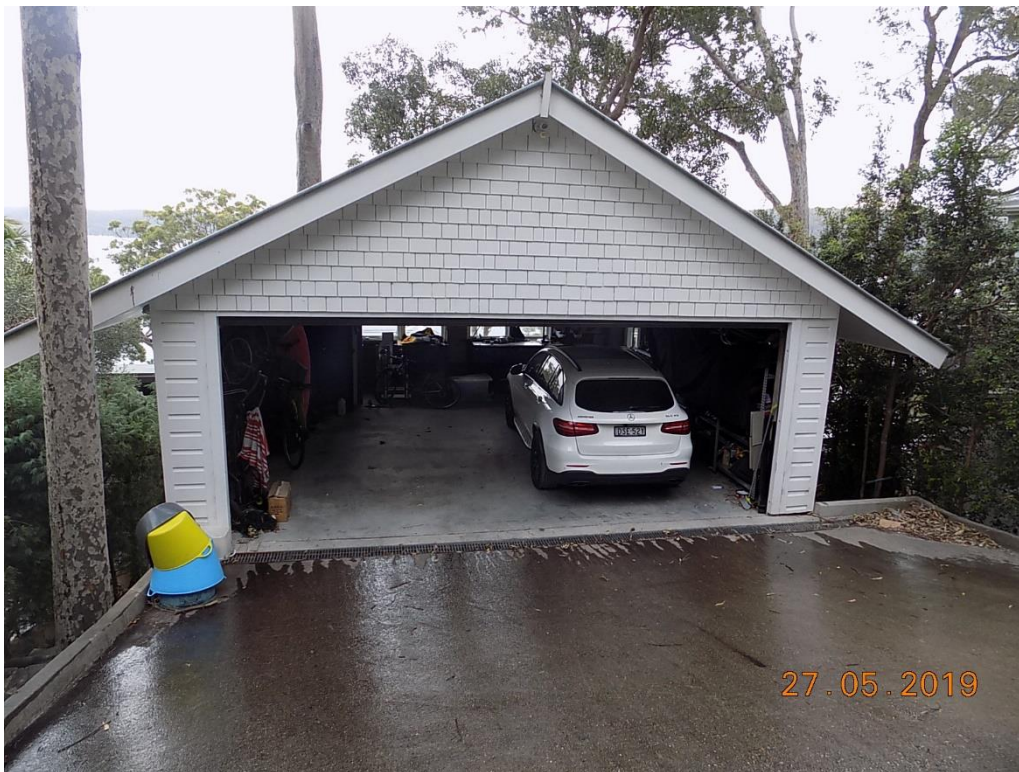
Photo 1

- 2.3** At the road frontage, a concrete driveway runs down the slope to a garage on the uphill side of the property (Photo 1). A moderately sloping lawn falls from the downhill side of the garage to a patio area that has been cut into the slope on the uphill side of the house (Photo 2). The cut for the patio area is supported by a stable ~2.0m high rendered masonry retaining wall. The part five-storey brick, sandstone, and concrete block house steps down the slope and is supported on brick, sandstone, and concrete block walls and brick piers (Photo 3). No significant signs of movement were observed in the supporting walls of the house and the supporting piers stand vertical. Some of the walls and piers were observed to be supported directly off an outcrop of competent Medium Strength Sandstone bedrock that runs the width of the property (Photos 4 & 5). A steep, densely-vegetated slope falls from the downhill side of the house to the top of a ~7m high cliff at the waterfront (Photo 6). The cliff face

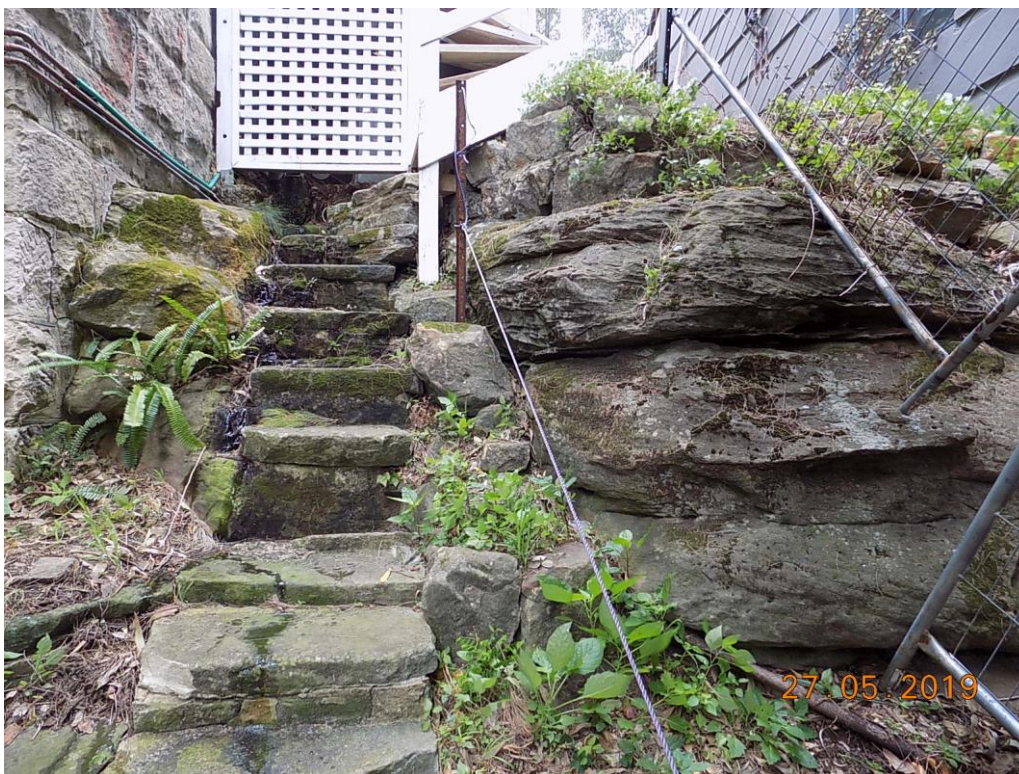
Photo 4

Concrete slabs supported directly off Low Strength Rock are suitable footings for the proposed inclinator landings. This ground material is expected to be exposed across the entire base of the excavation, and exposed at the surface in the location of the proposed upper landing (Photo 4).

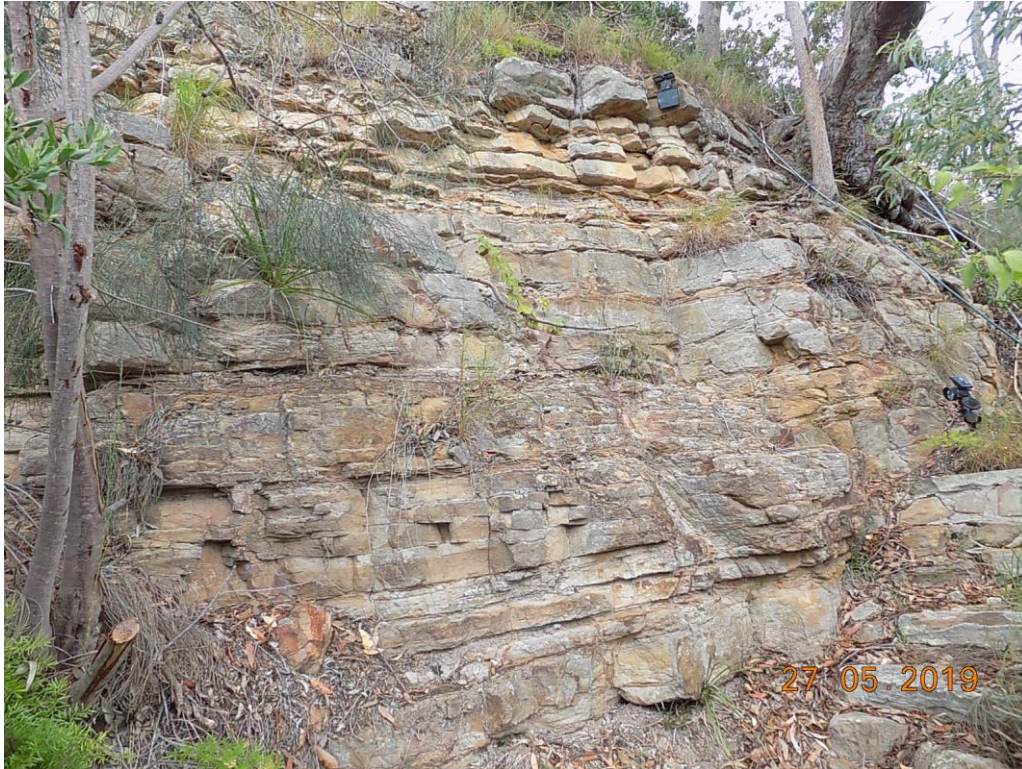
Photo 7

consists of alternating bands of thinly-bedded Very Low Strength Shale and thicker bands of Low Strength Sandstone (Photo 7). The majority of the cliff face consists of thin sandstone beds. The weathering process of the cliff face is that the softer beds undercut the harder beds. Because the bedding is thin and tightly jointed, the resulting failures are very small in scale. Additionally, the weathering process is slow and the failures are not considered a threat to life or property. A stable boatshed has been constructed at the waterfront (Photo 8).

The slope materials are colluvial at the near surface and residual at depth. A cliff face at the waterfront reveals the underlying bedrock (Photo 7). The cliff face consists of alternating bands of thinly-bedded Very Low Strength Shale and thicker bands of Low Strength Sandstone. The majority of the cliff face consists of thin sandstone beds. This ground profile is expected to extend upslope under the entire proposed works. In the test locations, where rock was not exposed at the surface, it was encountered at depths of between 0.7 to 1.5m

| HAZARDS | Hazard One | Hazard Two |
|---|---|---|
| TYPE | The moderate to steep slope that falls across the property and continues above failing and impacting on the property. | The cliff face at the waterfront failing and impacting on the proposed works (Photo 7). |

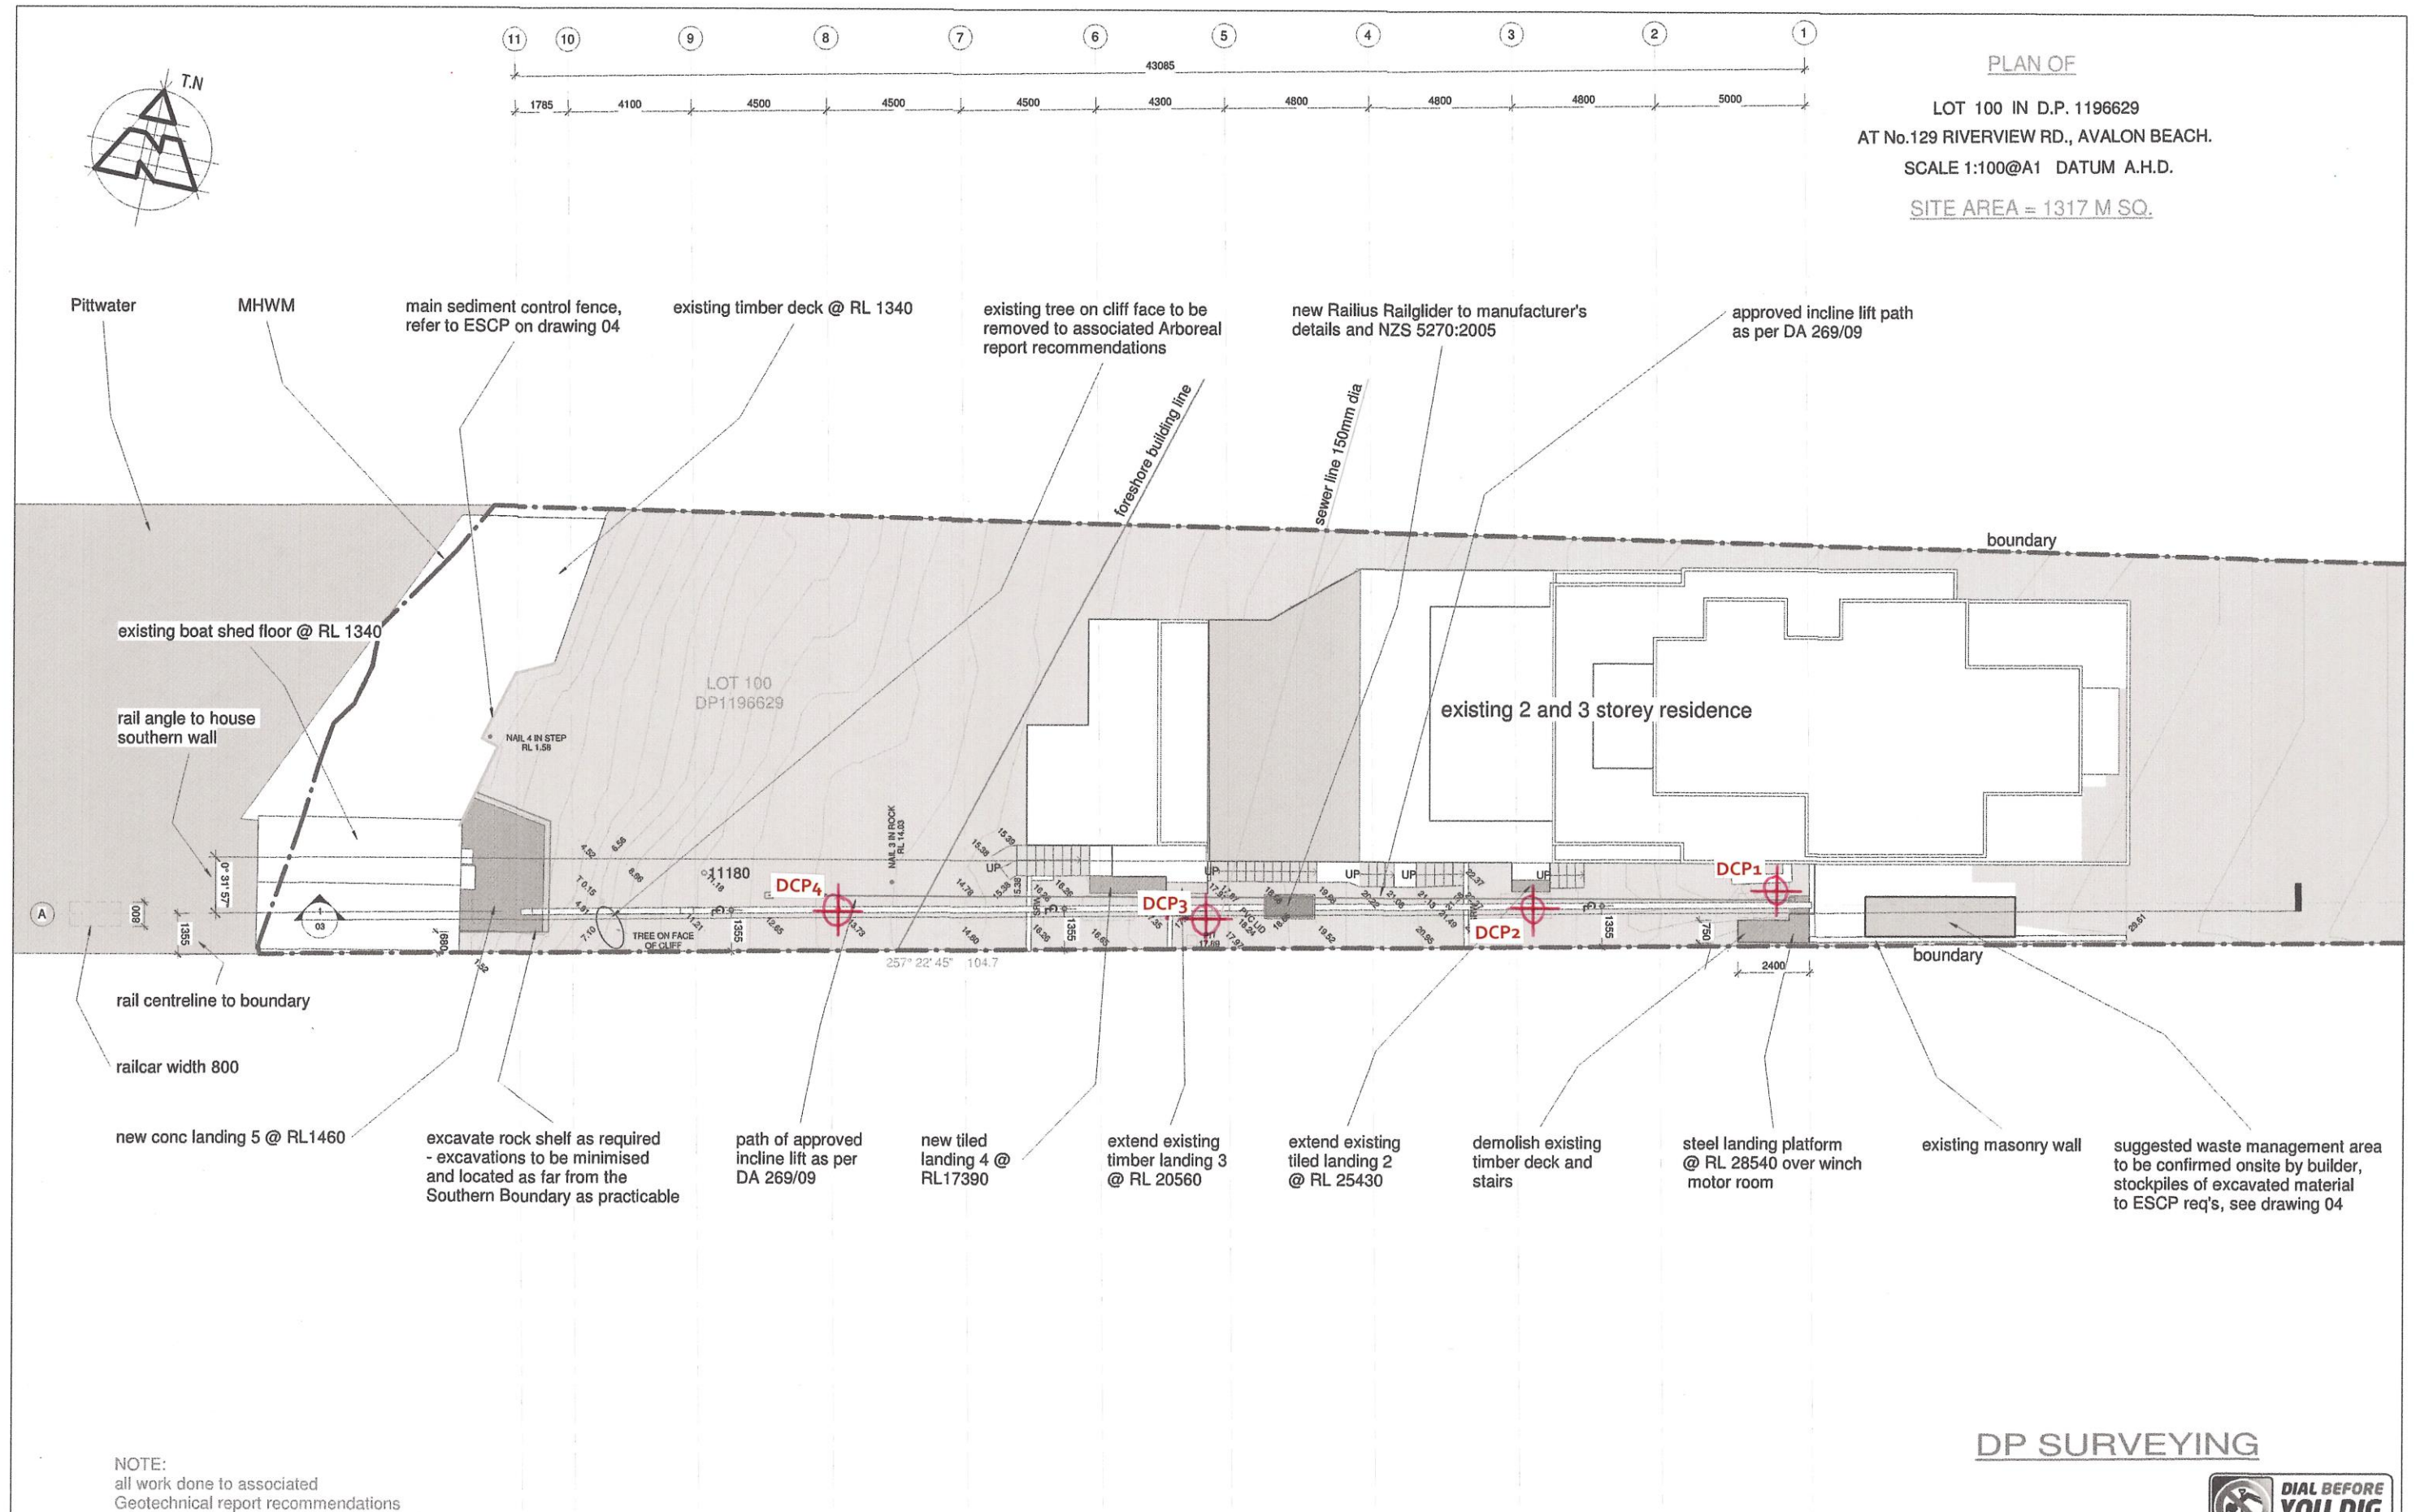
**SITE PLAN – showing test locations**

Four Dynamic Cone Penetrometer (DCP) tests were put down to determine the relative density of the overlying soil and the depth to bedrock. The locations of the tests are shown on the site plan. It should be noted that a level of caution should be applied when interpreting DCP test results. The test will not pass through hard buried objects so in some instances it can be difficult to determine whether refusal has occurred on an obstruction in the profile or on the natural rock surface. This is not expected to be an issue for the testing on this site and the results are as follows:

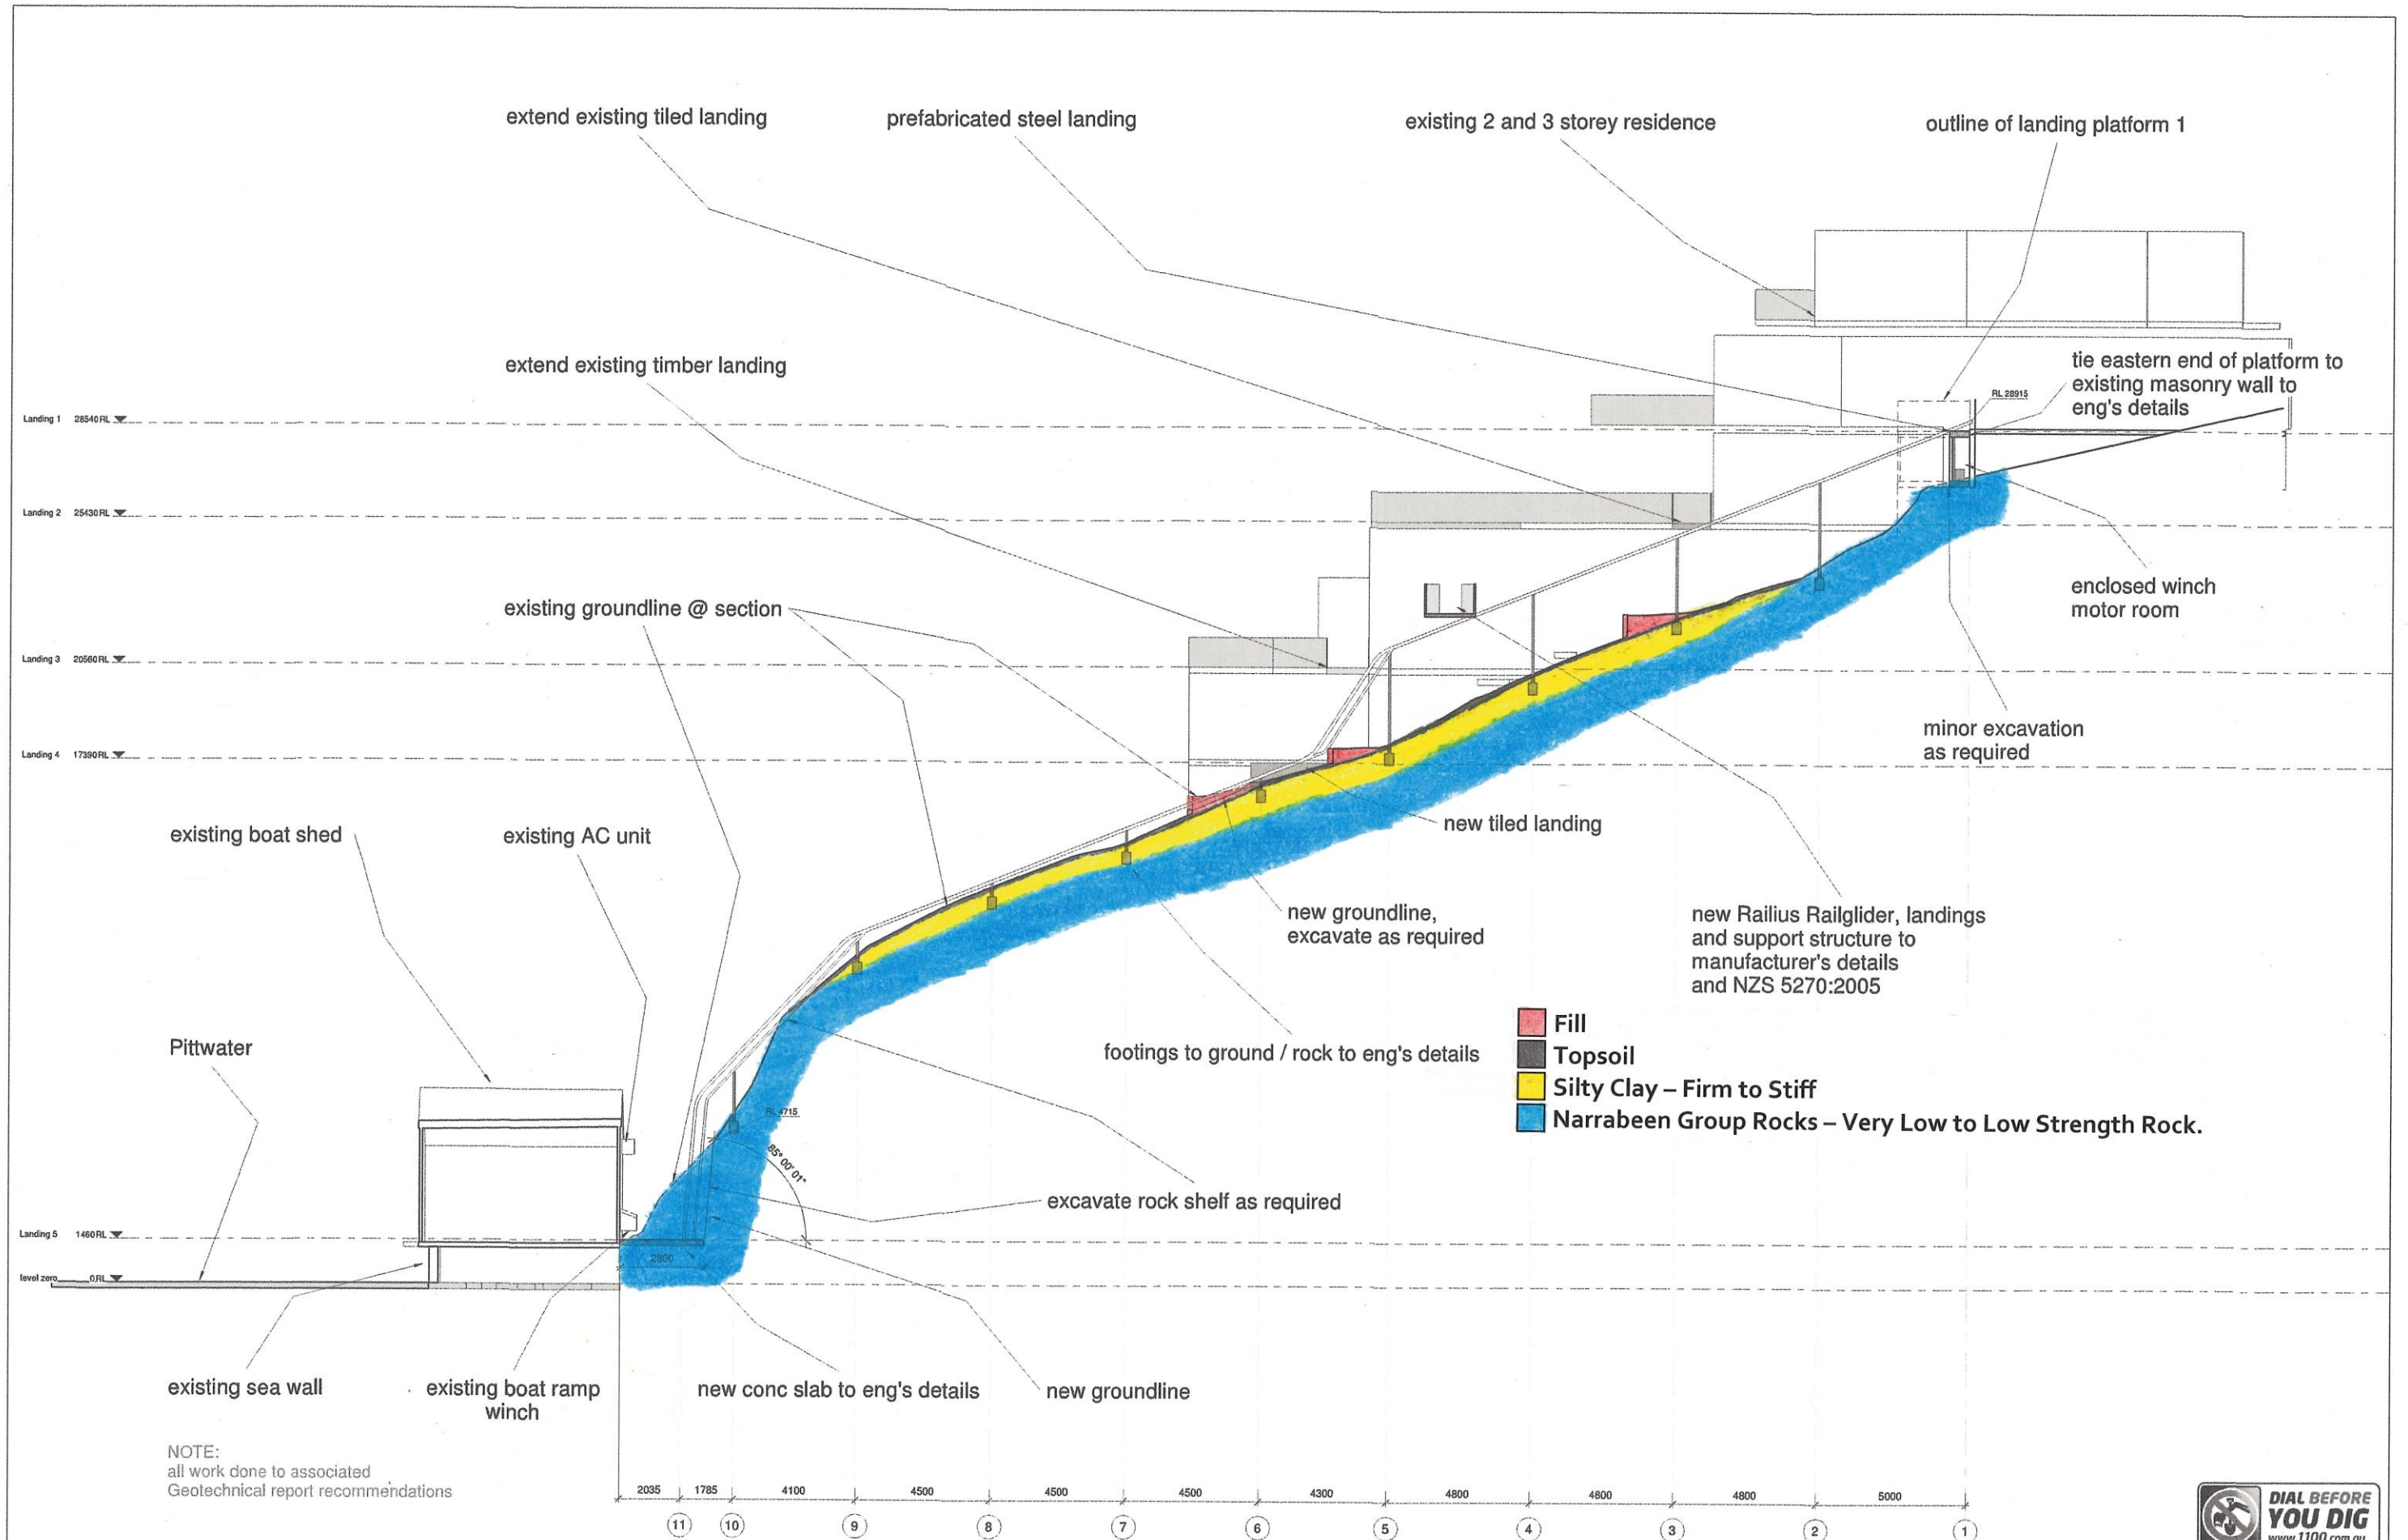
# TYPE SECTION – Diagrammatical Interpretation of expected Ground Materials

below the current surface. See Type Section attached for a diagrammatical representation of the expected ground materials.
