Report Title: Geotechnical Report 133 Riverview Road, Avalon Beach

Report Date: 23/5/25

## **GEOTECHNICAL INVESTIGATION:**

Alterations and Additions and New House and Garage at **133 Riverview Road, Avalon Beach**

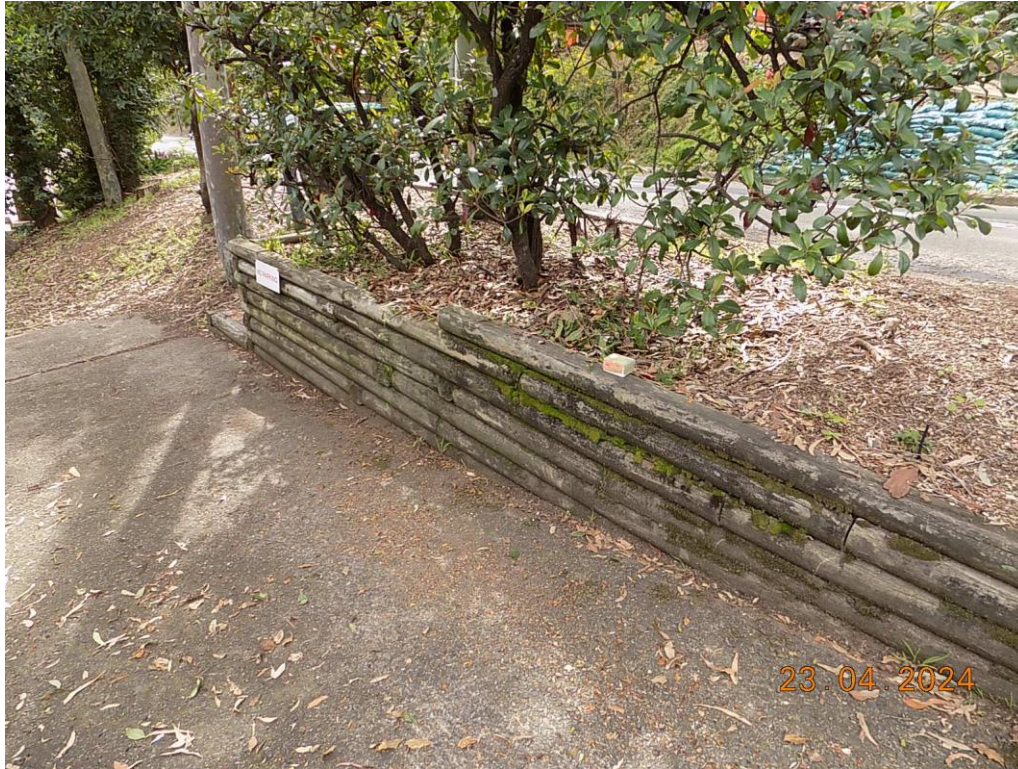
Photo 2

Riverview Road is supported by a low stable timber retaining wall (Photo 2), or is battered at stable angles (Photo 3). Between the parking space and the house is a moderately graded lawn (Photo 4). The cut for the house is battered at stable angles, has a covering of dense vegetation (Photo 5), and is partially supported by a mortared rock retaining wall (Photo 6). The retaining wall exhibited cracking in the mortar, however it will be demolished as part of the proposed works. The single-story fibreboard house is supported on sandstone block walls and sandstone piers. The house will also be demolished for the proposed works. Sandstone boulders are scattered across the steep slope below the house (Photo 7), and were observed to be sufficiently embedded in stable positions. This slope continues for some ~20m before increasing to very steep angles (Photo 8). The very steep slope in this location consists of alternating bands of thinly-bedded Very Low Strength Shale and thicker bands of Low Strength Sandstone (Photo 9). The majority of the slope consists of thin sandstone beds. The weathering process of the bedrock is that the softer beds undercut the harder beds. Because the bedding is thin and tightly jointed, the resulting failures are very small in scale. There is evidence of these failures occurring in the past and they are expected into the future, particularly during and immediately after heavy rainfall. Additionally, the weathering process is slow and the failures are not considered a threat to life or property. A near level shelf of Low to Medium strength sandstone extends from the base of this cliff to the waterfront (Photo 10).

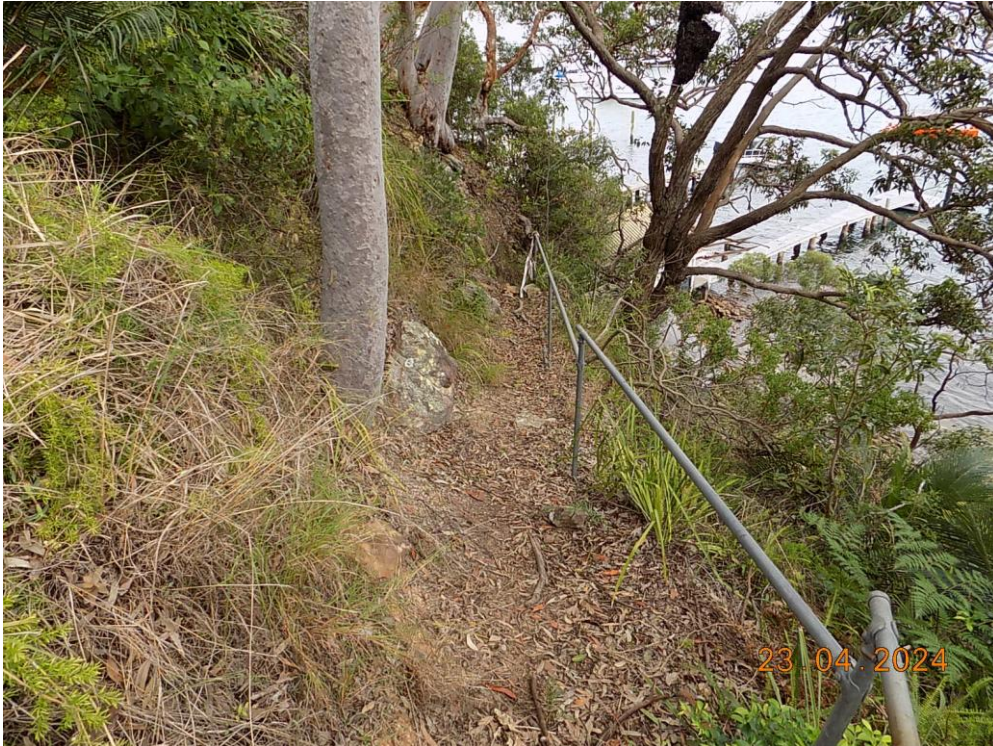
Photo 8

| HAZARDS | Hazard One | Hazard Two |
|---|---|---|
| TYPE | The moderate to steep slope that falls across the property and continues steeply above, failing and impacting on the property/proposed works. | Small scale surface failures occurring across the Very Steep portion of the slope (Photos 8 & 9) immediately above the waterfront. |

**16.2** To reduce risk, during heavy and prolonged rainfall events, the Very Steep portion of the slope that drops to the waterfront (Photos 8 & 9) should not be approached until the slope materials are fully dry, as small-scale failures are expected to occur while the slope is saturated. The risk assessment in **Section 8** is subject to this advice being followed.

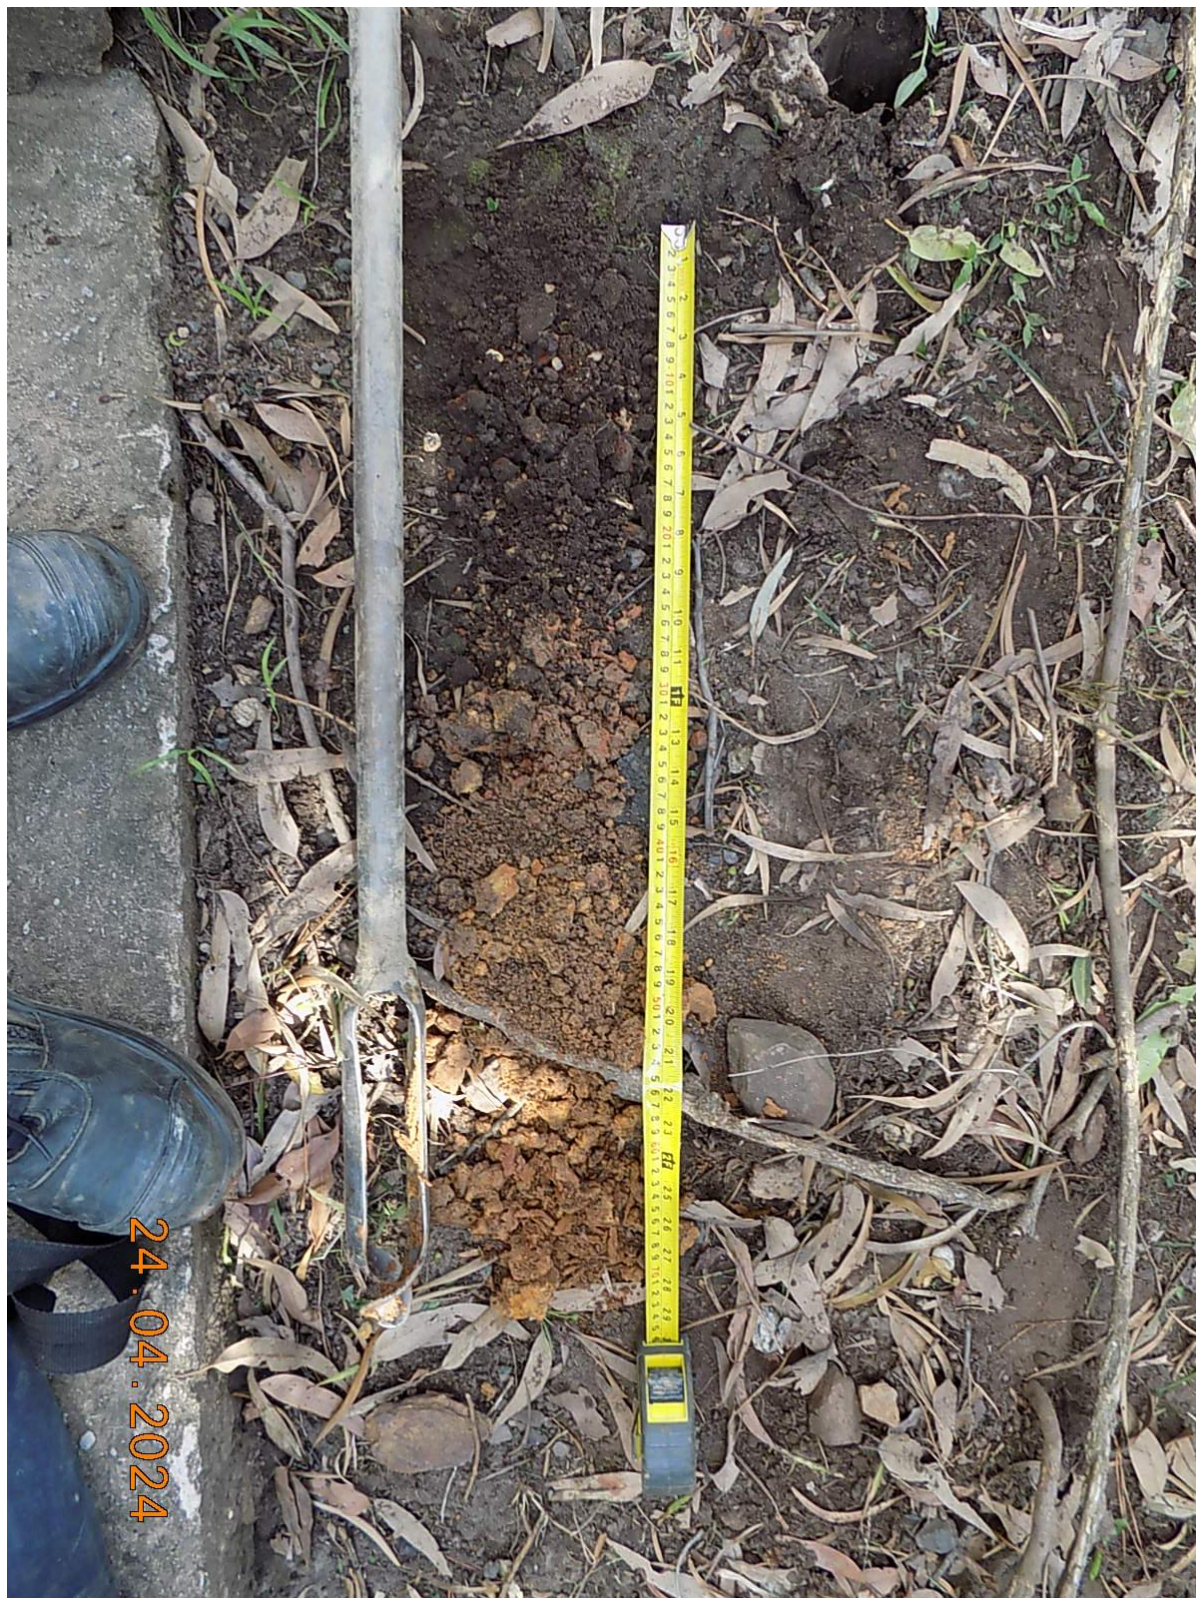
Photo 11 – Ah1 – Downhole is top to bottom

#### **AUGER HOLE 1 (~RL38.5) – AH1 (Photo 11)**

| <b>Depth (m)</b> | <b>Material Encountered</b> |
|---|---|
| 0.0 to 0.3 | <b>TOPSOIL</b> , dark brown, medium dense, dry, medium grained, rock fragments included. |
| 0.3 to 0.7 | <b>SANDY CLAYEY COLLUVIUM</b> , orange to brown, stiff, fine to coarse grained, rock fragments included. |

Refusal @ 0.7m. Auger grinding in clayey colluvium. No water table encountered.
