## **Geotechnical Assessment**

**Project:** Alterations and Additions  
33 Beach Road, Collaroy NSW.

**REF: AG 20106**  
4 August 2021

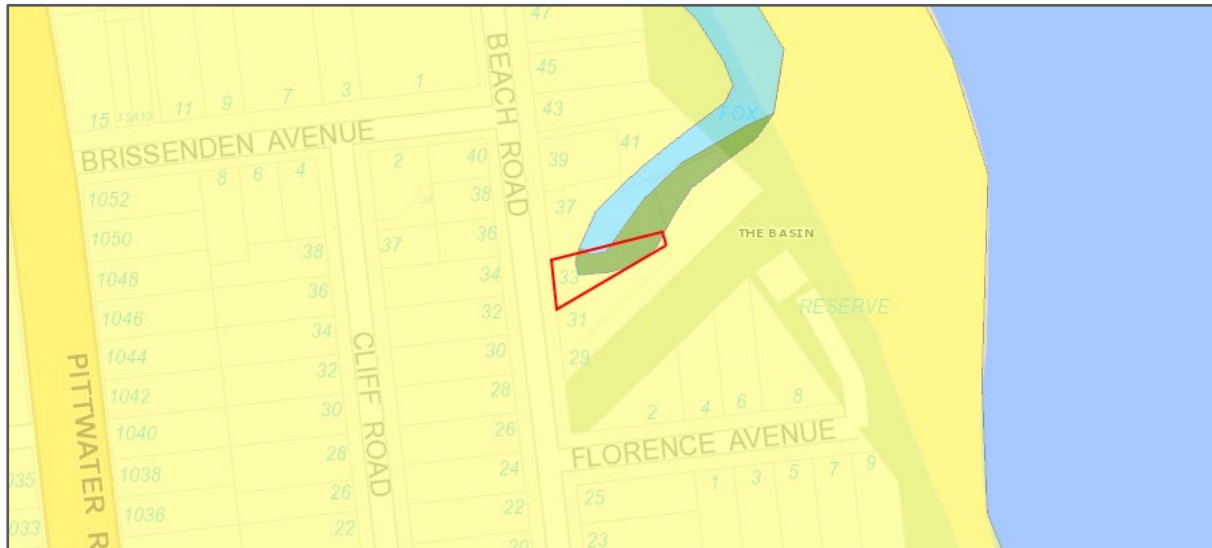
**Image 2.** Landslip Risk Map (WLEP 2011): 33 Beach Road, Collaroy NSW –

- No evidence of significant soil creep, tension cracks, unstable outcrops, or other indicators of slope instability were identified at the time of our inspection.
- The existing structure displayed no evidence of significant cracking or settlement that could be attributed to slope instability.
- The property is classified as ‘Class A, D & E’ in Northern Beaches Council WLEP Landslip Risk Map (WLEP Landslip Risk Map; **Image 2**).

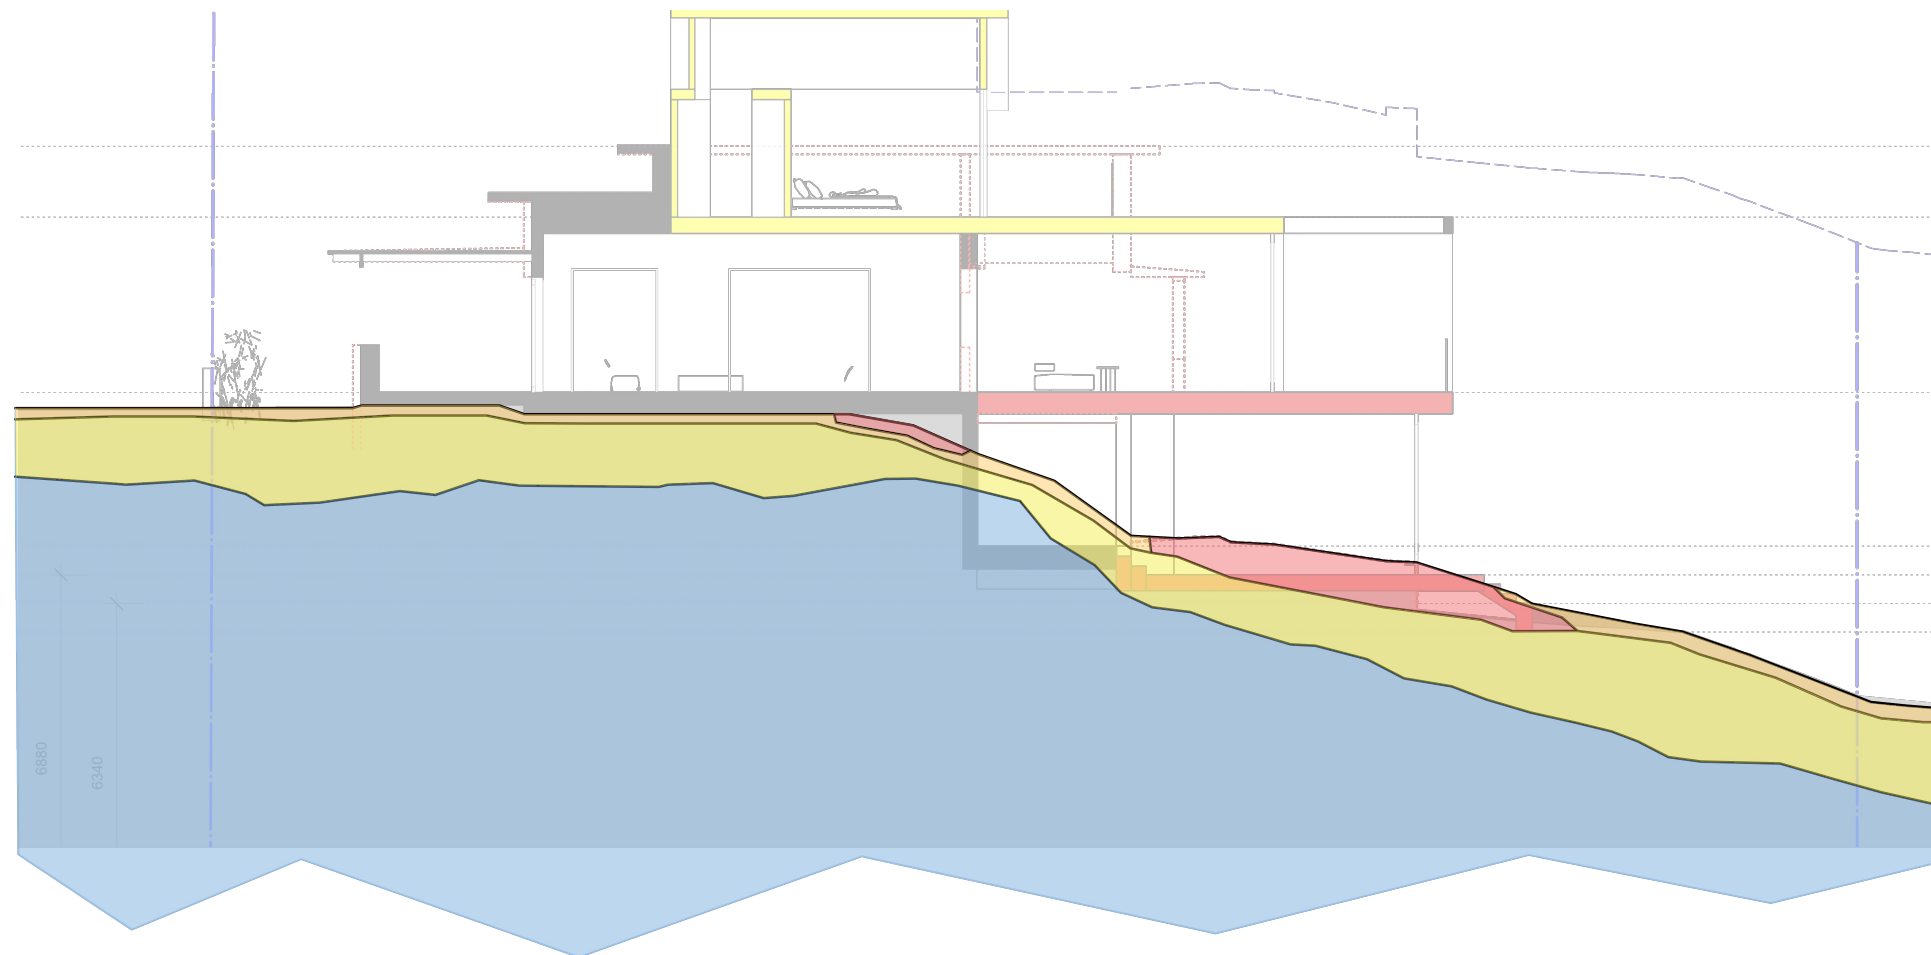
**INFERRED GEOLOGICAL SECTION**  
SCALE NTS

INTERPRETED SUBSURFACE SECTION ONLY.  
ACTUAL GROUND CONDITIONS MAY VARY.
