GEOTECHNICAL INVESTIGATION:

Alterations and Additions and New Pool at 38 The Drive, Freshwater

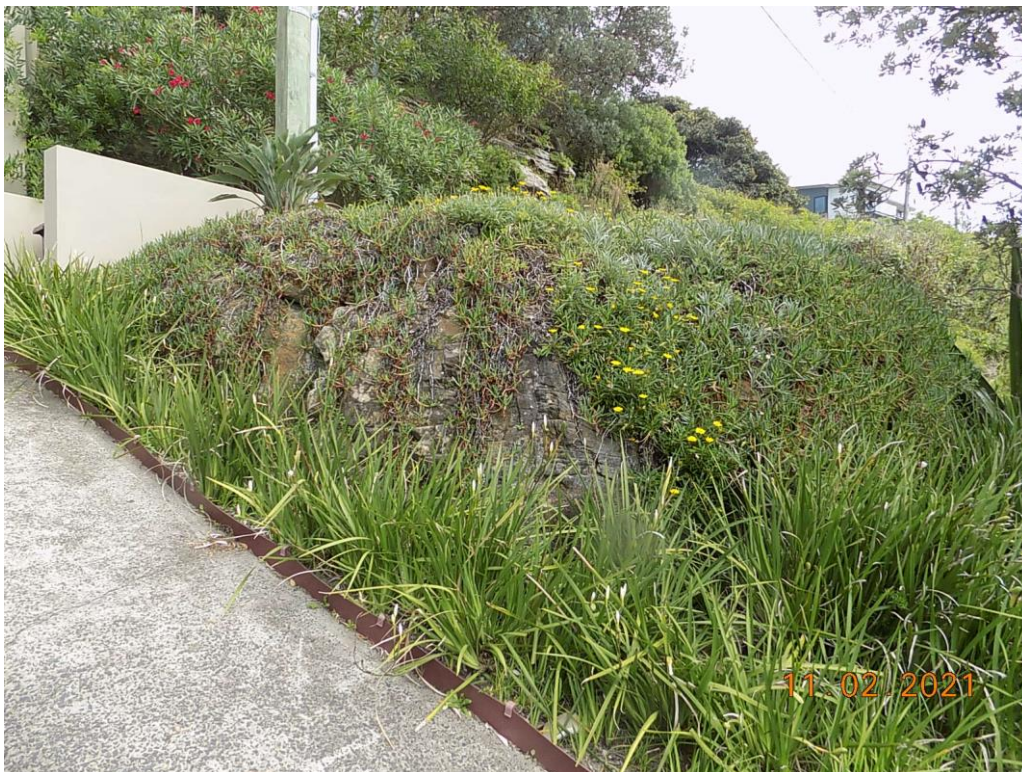
Photo 2

- 2.1** The site was inspected on the 11th February, 2021.
- 2.2** This residential property is on the high side of the road and has an E aspect. It is located on the gentle to steeply graded upper reaches of a hillslope. From the road frontage to the uphill side of the house, the natural surface rises at steep angles of ~30°. The slope continues at angles of <5° to the upper common boundary.
- 2.3** At the road frontage, a concrete driveway runs to a garage on the downhill side of the property (Photo 1). The garage will be demolished as part of the proposed works. Competent Medium Strength Sandstone outcrops on both sides of the garage

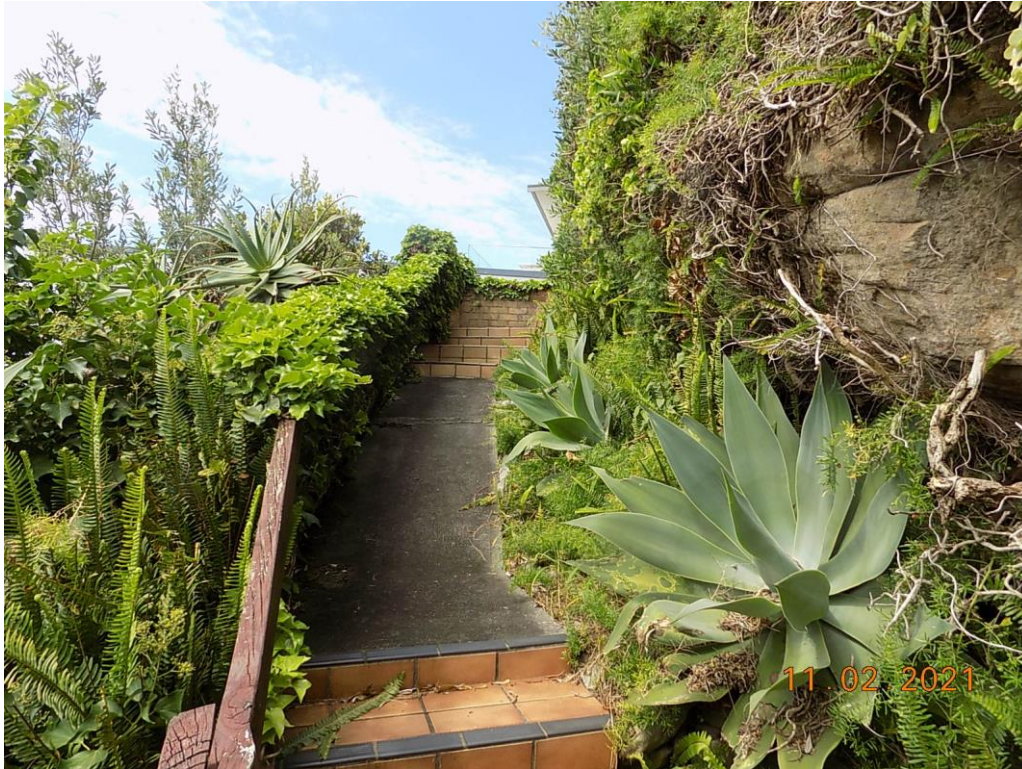
Photo 3

(Photo 2). The steep slope between the garage and the downhill side of the house is naturally terraced with sandstone rock faces and has a dense covering of vegetation (Photo 3). Some portions of the rock faces are undercut to a maximum of ~2.0m (Photo 4). Each undercut joint block has a thick cantilever arm in relation to its overhang length and display no signs of cracking as viewed from below. Thus, they are considered stable. An inclined lift runs up the N boundary from the garage to the uphill side of the house (Photo 5). The lift has been cut directly into the outcropping sandstone (Photo 6). The cut faces display no significant geological defects and are considered stable. Near the top of the lift, another rock face with a ~2.0m undercut was observed (Photo 7). Similarly, the undercut joint block has a thick cantilever arm in relation to its overhang length and display no signs of cracking as viewed from above or below. Thus, it is considered stable. The part two-storey brick house is supported on brick walls and piers (Photo 8). The supporting walls display no significant signs of movement and the supporting piers stand vertical. Most of the supporting walls and piers were observed to be supported directly onto outcropping Medium Strength Sandstone. A concrete-paved fill extends off the uphill side of the house. The fill is supported by a stable ~1.5m high brick retaining wall (Photo 9). A gently sloping lawn extends into the SW corner of the property (Photo 10). Sandstone bedrock outcrops through this lawn and below the lawn at additional stable rock faces (Photo 11).

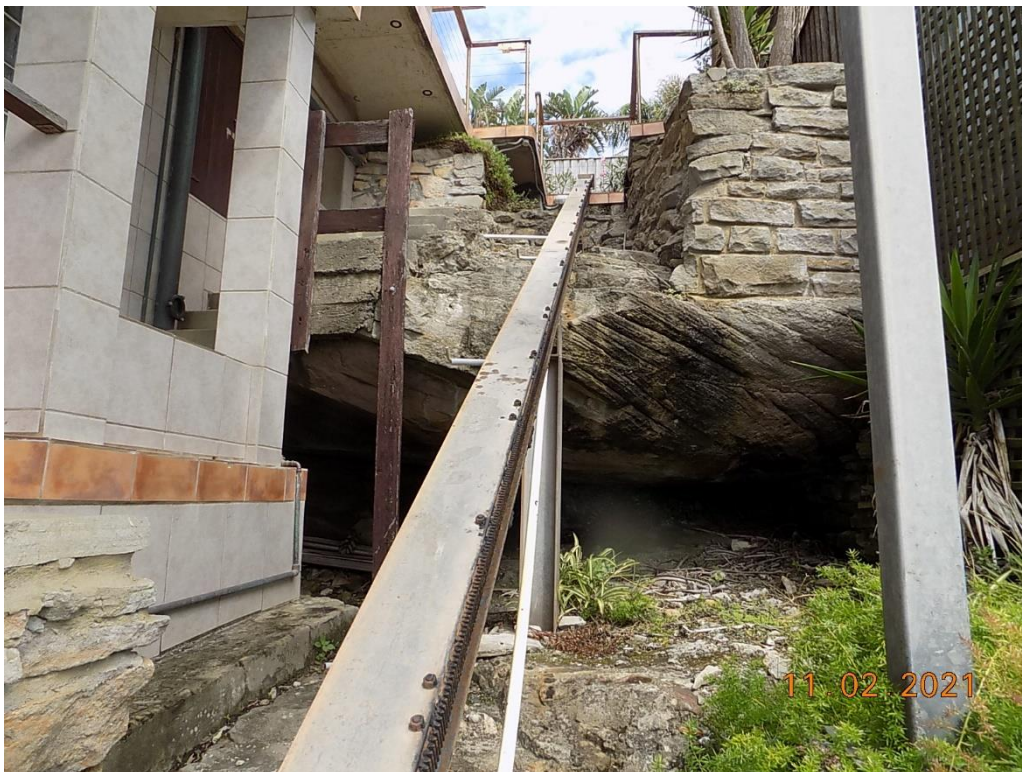
Photo 7

The excavation for the extension to the S side of the house will come close to flush with the S supporting wall of the subject house (Photo 7). However, apart from a thin layer of soil over the rock, the excavations will be taken almost entirely through Medium Strength Sandstone and any nearby structures are already supported on the rock. As such, no structures or boundaries will be within the zone of influence of the excavations.

During the excavation process for the extension to the S side of the house, the geotechnical consultant is to inspect the excavation as it approaches a distance of 1.0m from the S supporting wall of the house to confirm the suitability of the cut to go flush with the footings.

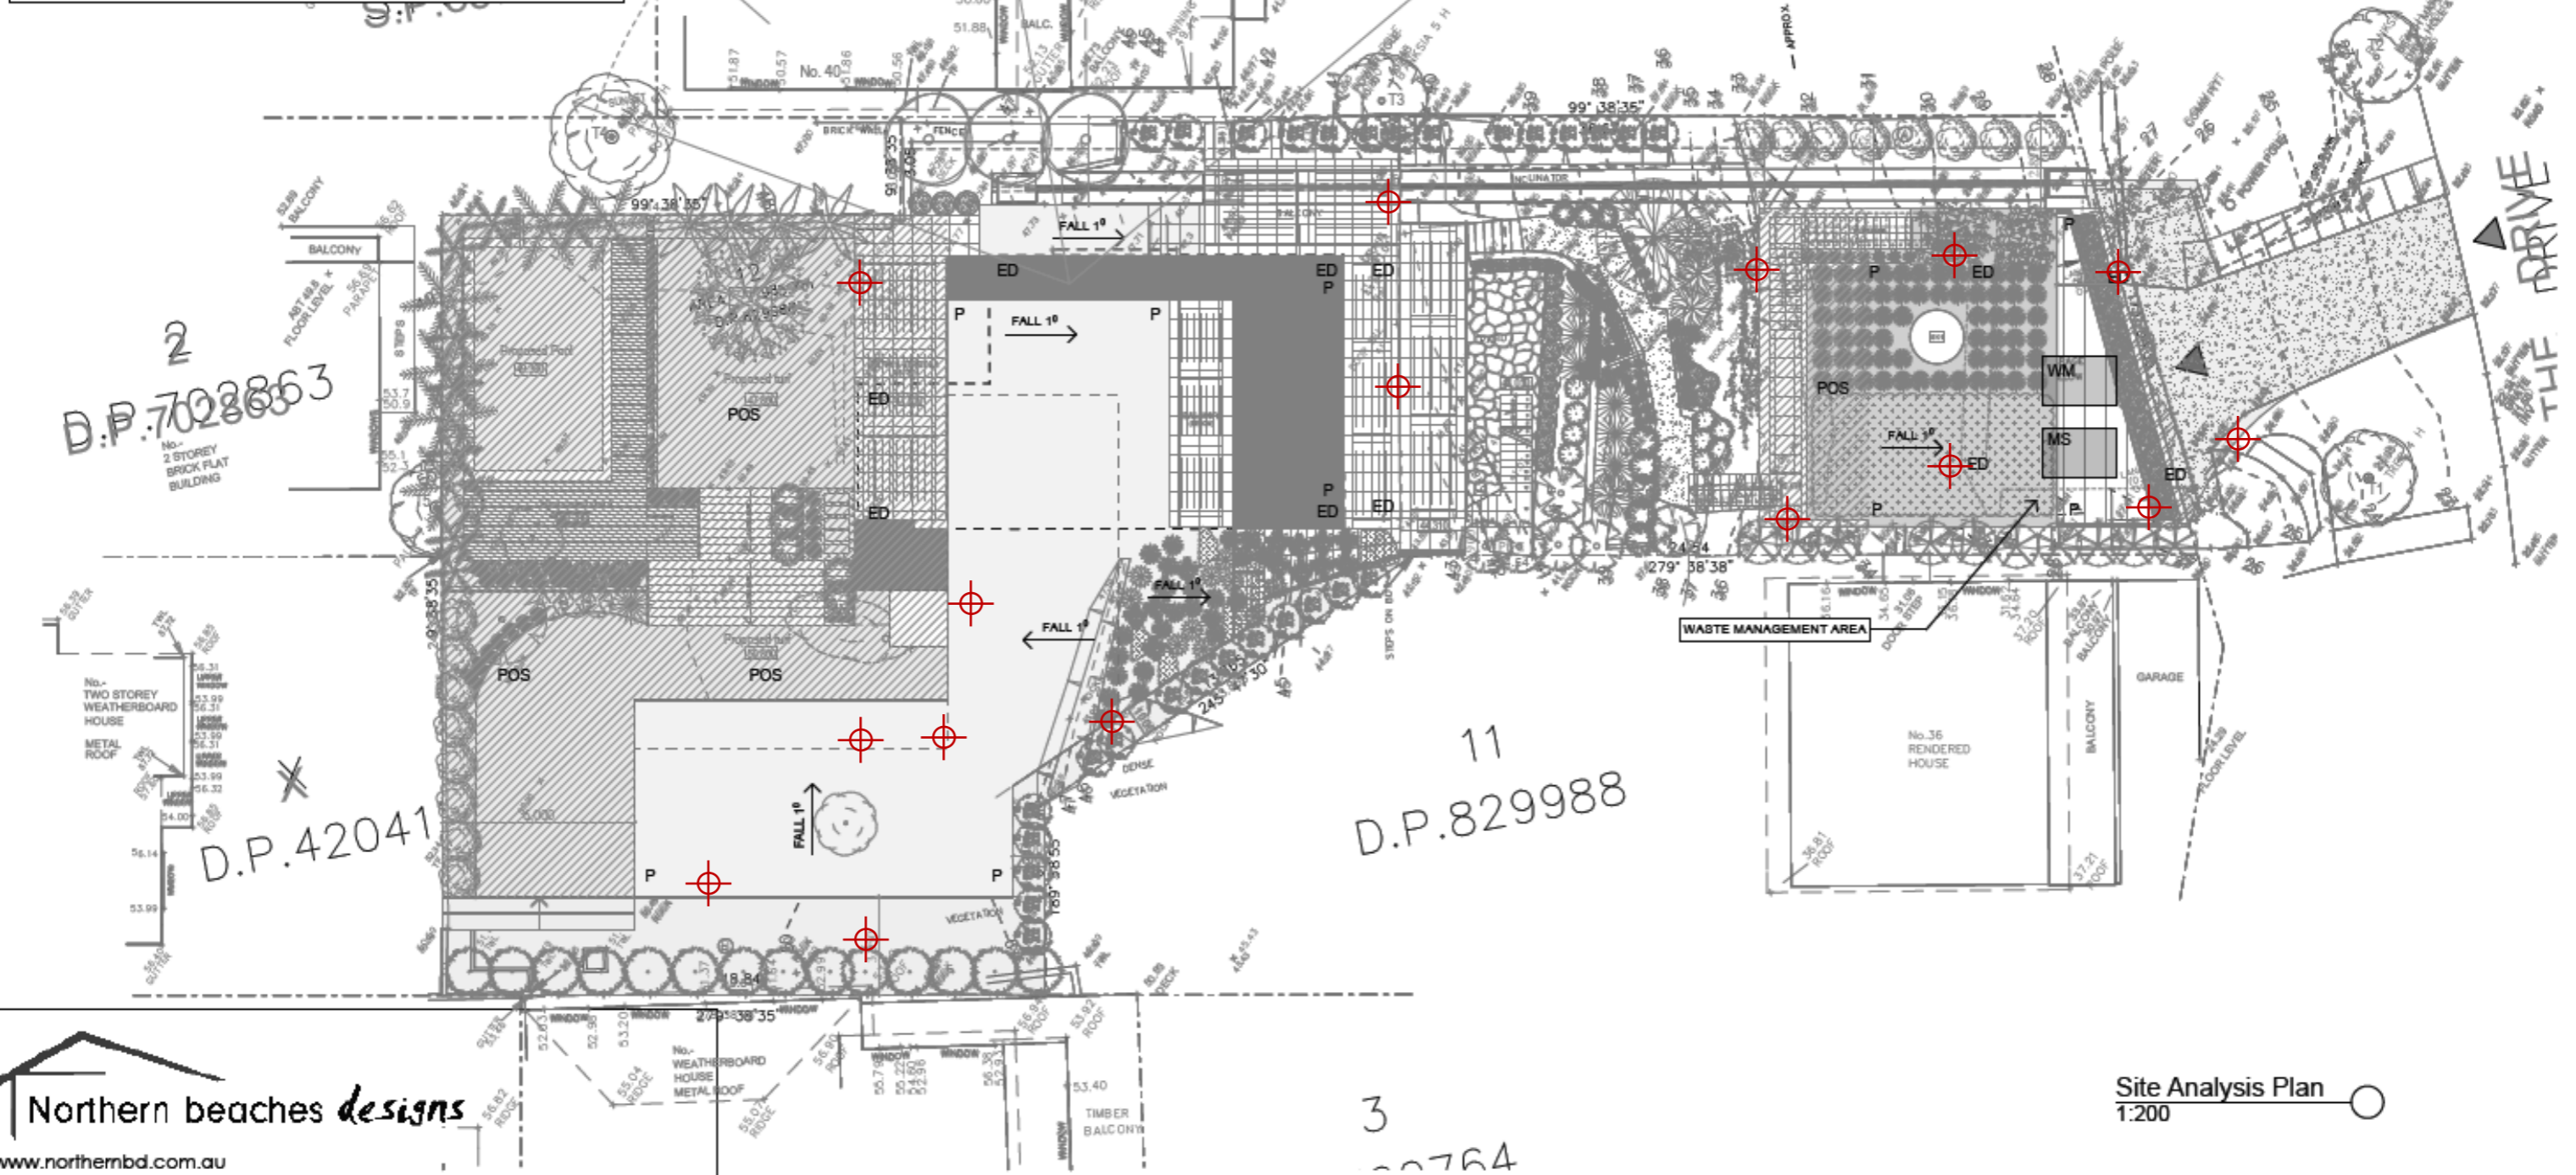
SITE PLAN – showing locations where bedrock was observed to be outcropping

As sandstone bedrock was observed to be outcropping and stepping up the entire property, no subsurface investigation was carried out. See the attached site plan for key locations where bedrock was observed to be outcropping.

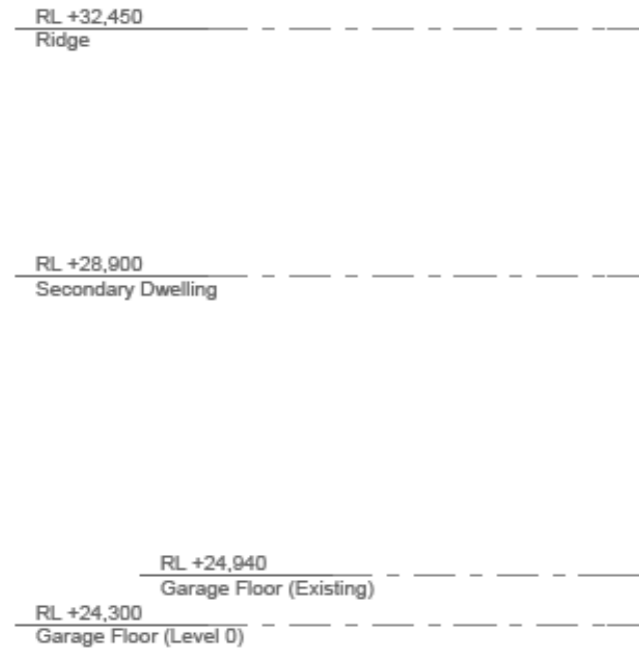
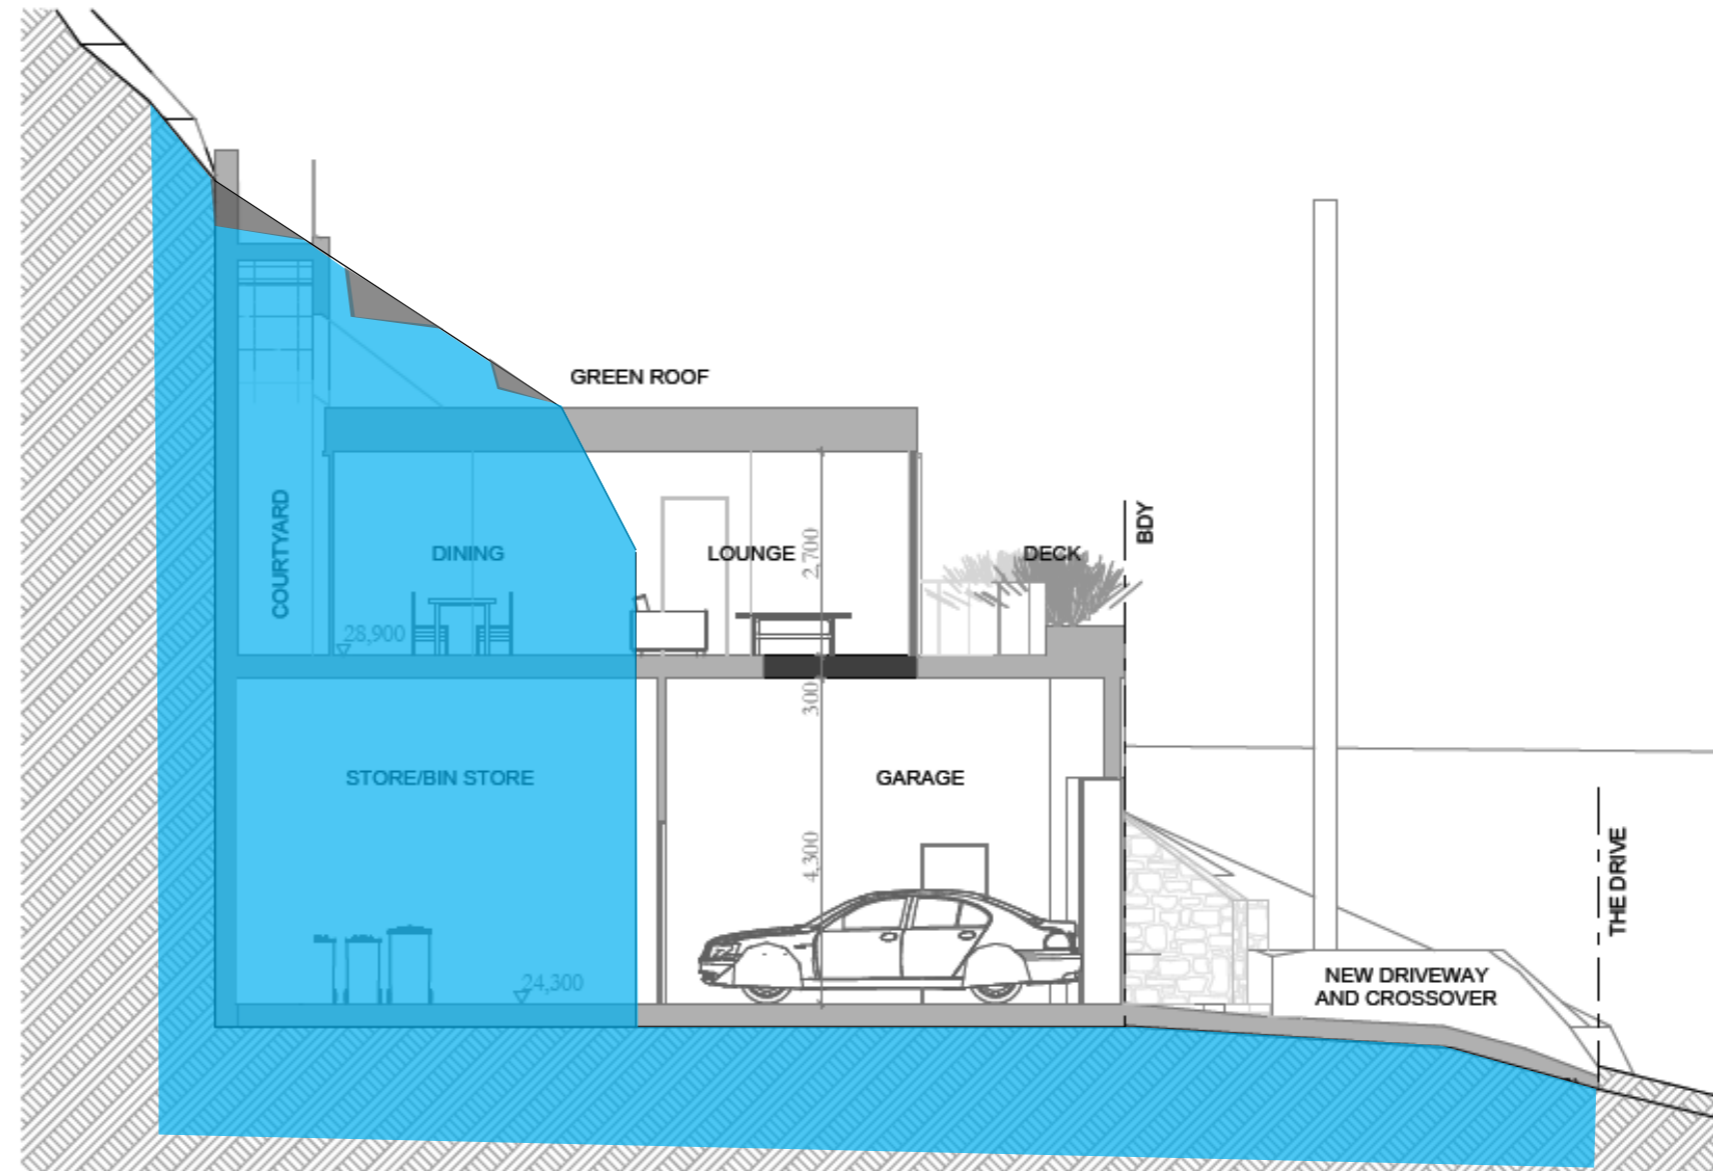
TYPE SECTION – Diagrammatical Interpretation of expected Ground Materials

The surface features of the block are controlled by the outcropping and underlying sandstone bedrock that steps up the property forming sub-horizontal benches between the steps. Where the grade is steeper, the steps are larger, and the benches narrower. Where the slope eases, the opposite is true. The rock is exposed across the majority of the property and in the locations of the proposed works. The exposed sandstone across the site is estimated to be Medium Strength and a similar strength rock is expected to underly the entire site. See Type Section attached for a diagrammatical representation of the expected ground materials.
