# SCHEDULE OF CONSERVATION WORKS

*Façades of*

6 The Corso and 50 East Esplanade, Manly NSW

September 2023 | J5235

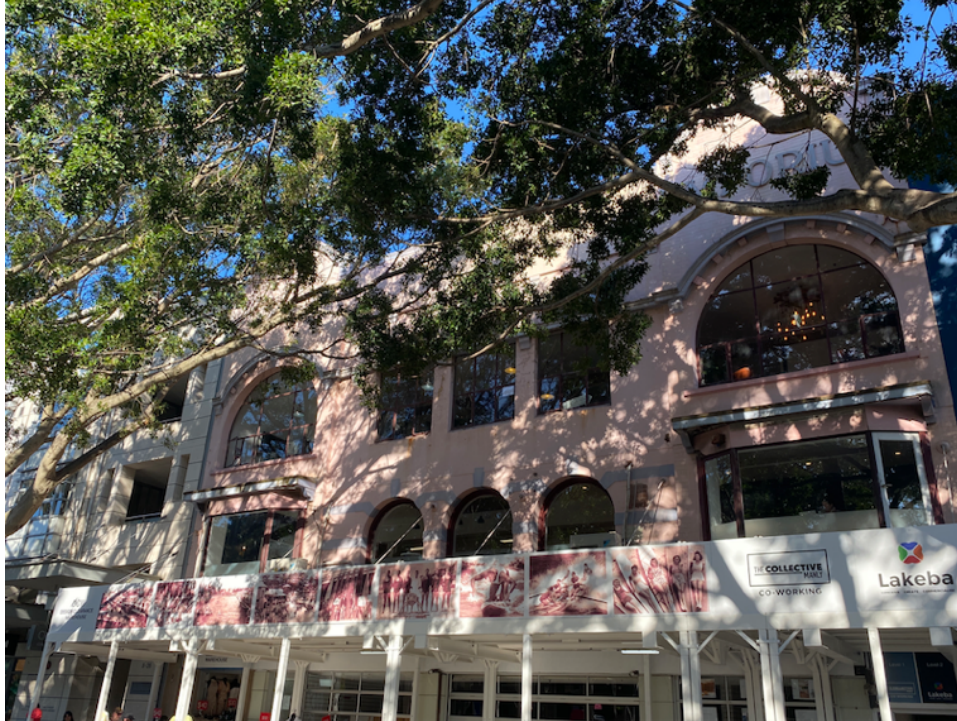
The façades of 6 The Corso and 50 East Esplanade, Manly are in a serviceable condition with areas of deterioration requiring conservation work. The following schedule is a list of work that is required to correct damage and deterioration to these façades.

**Figure 1:** The façade of 6 The Corso, Manly

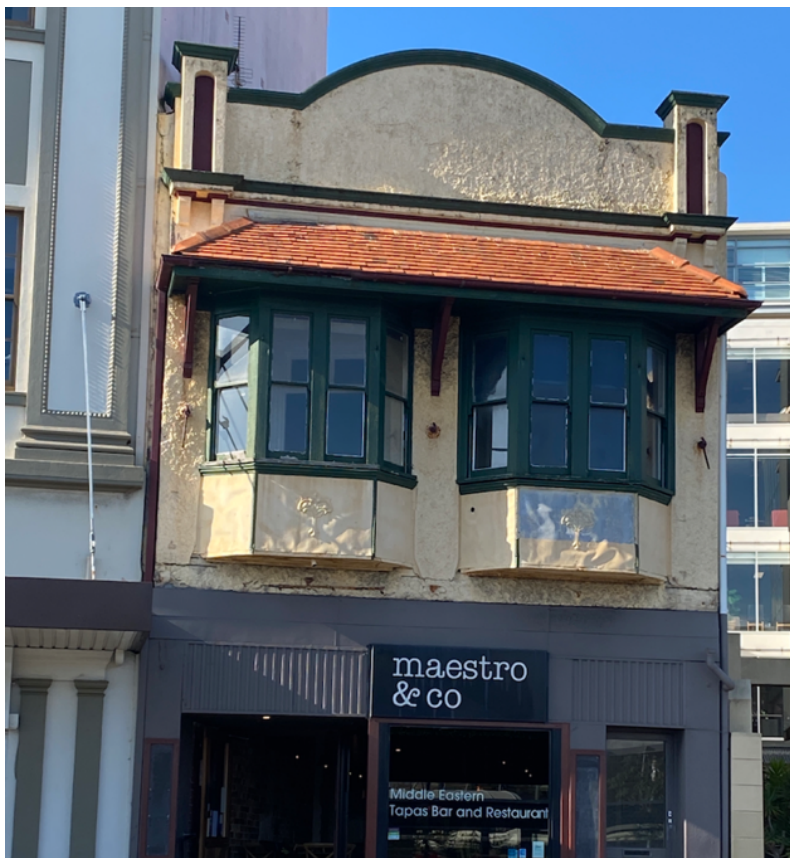
**Figure 2:** The façade of 50 East Esplanade, Manly.
