## ARBORICULTURAL IMPACT REPORT

## 191 WHALE BEACH ROAD WHALE BEACH NSW

# ADDITIONAL REPORT 10<sup>TH</sup> NOVEMBER 2021

## PREPARED FOR SARAH AND DAVID ROTHWELL

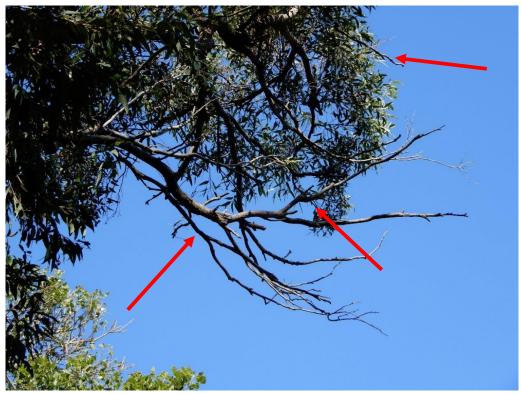
Tree	Species and	Summary							
Number	Common Name								
20	Eucalyptus umbra (Broad-leaved White	A mature, single trunked specimen approximately 8 metres in height with a canopy spread of 6 x 8 metres and a DBH of 460mm. In poor health and of moderate landscape significance.							
	Mahogany)	The tree displays signs of instability with a distinct trunk lean and canopy bias to the SW - in adverse weather conditions (e.g. under wind loading following high rainfall events) the tree will be at increased risk of failure.							
		At the time of inspection the tree was of poor health and poor vigour and exhibited high levels of dieback and epicormic growth. Strelitzia nicolai growing at base of tree. Short ULE.							
21	Eucalyptus umbra (Broad-leaved White	A mature, single trunked specimen approximately 9 metres in height with a canopy spread of 6 metres and a DBH of 340mm. In moderate health and of moderate landscape significance.

Mahogany)	At the time of inspection the tree was of moderate health and poor vigour and exhibited high levels of dieback. Short ULE.							
22	Eucalyptus umbra	A mature, twin trunked specimen approximately 8 metres in height with a canopy spread of 5 metres and DBH of							
	(Broad-leaved White	170mm and 400mm. In moderate health and of moderate landscape significance.							
	Mahogany)	The tree displays fair branch attachment with multiple regrowth following severe past reduction pruning. At the							
		time of inspection the tree was of moderate health and fair vigour and exhibited moderate levels of dieback.							
23	Callistemon salignus	A mature, multi trunked specimen approximately 8 metres in height with a canopy spread of 11 metres and DBH							
	(Pink Tips, Willow	of up to 320mm (600 x 660mm above the root flare). In declining health and of moderate landscape significance.							
	Bottlebrush)	The tree displays fair branch attachment with multiple leaders from near ground level with some evidence of poor

Photograph 1: Tree # 20 – Illustrating high levels of dieback.

Tree	Species and Common	Summary
Number	Name	
20	Eucalyptus umbra (Broad-	The tree is proposed to be removed and replaced due to moderate health, poor vigor and short
	leaved White Mahogany)	ULE
21	Eucalyptus umbra (Broad-	The tree is proposed to be removed and replaced due to moderate health, poor vigor and short
	leaved White Mahogany)	ULE
22	Eucalyptus umbra (Broad-	The tree is proposed to be removed and replaced due to the severe past reduction pruning that has
	leaved White Mahogany)	impacted its form and structural integrity.
23	Callistemon salignus (Pink	The tree will require removal to accommodate the proposed construction access requirements
	Tips, Willow Bottlebrush)

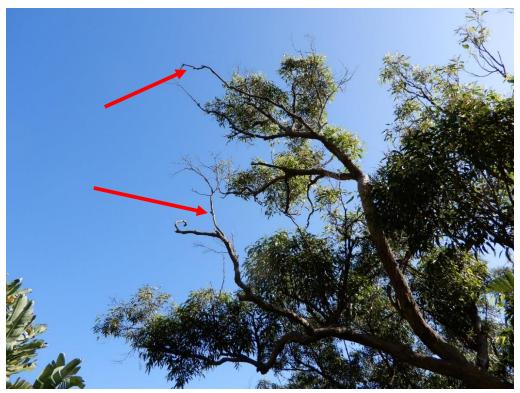
Photograph 2: Tree # 21 - Illustrating high levels of dieback.

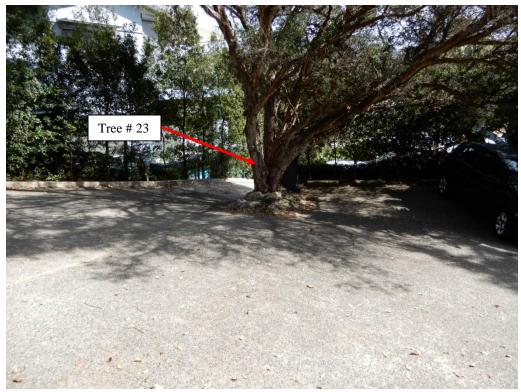
attachment at the junction - not considered at risk of failure.							
		At the time of inspection the tree was of moderate health and poor vigour and exhibited significantly reduced							
		foliage size and density and moderate to high levels of dieback. The tree is located in a very small landscape area							
		surrounded by a concrete driveway/parking area. Short ULE.

Photograph 5: Tree # 23 - Illustrating the location in a very small landscape area within the driveway and parking area.

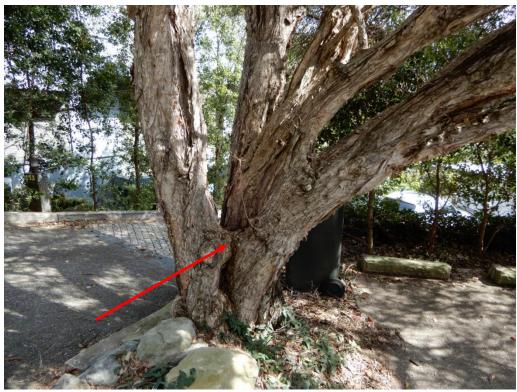
Photograph 6: Tree # 23 - Illustrating the multiple leaders from near ground level.

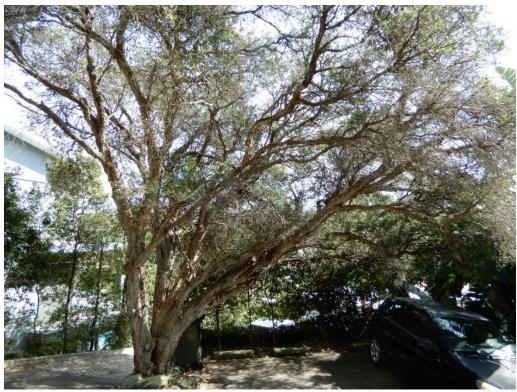
Photograph 7: Tree # 23 - Illustrating the significantly reduced foliage density.

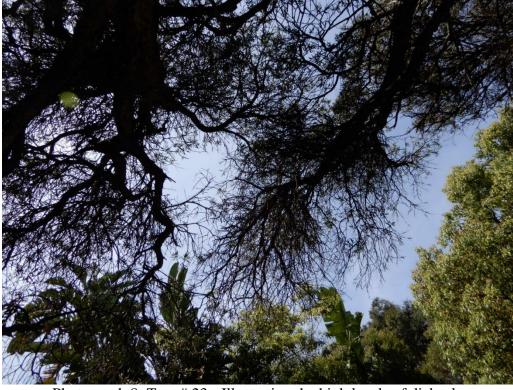
Photograph 8: Tree # 23 - Illustrating the high levels of dieback.
