## **PRELIMINARY GEOTECHNICAL ASSESSMENT:** **13 Athol Street, Frenchs Forest**

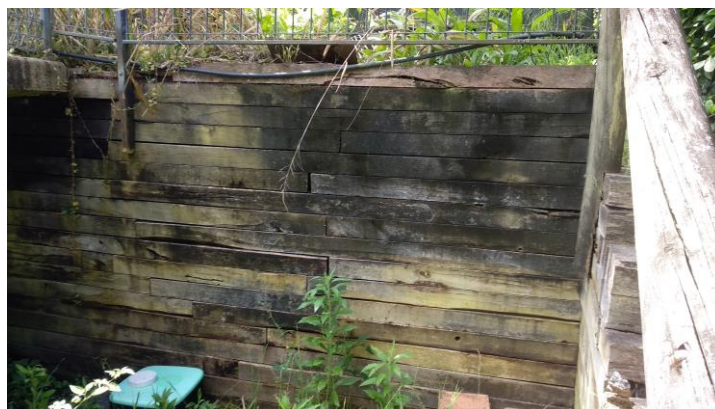
Photo 1

A pool is located near the SE corner of the property. The pool will be replaced as part of the proposed works. A timber retaining wall up to  $\sim 1.8\text{m}$  high supports a cut and fill beside the pool. The wall displays some minor bulging (Photo 1). See '**Section 5.0 Recommendations**'. The area surrounding the house is mostly lawn or garden covered with some paved areas. Apart from the tilting and bulging timber retaining walls, no signs of movement associated with slope instability were observed on the grounds. No cliffs or large rock faces were

The bulging timber retaining wall (Photo 1) is to be monitored by the owners on an annual basis or after heavy and prolonged rainfall, whichever occurs first. A photographic record of these inspections is to be kept. Should further movement occur the wall is to be remediated so it meets current engineering standards. We can carry out these inspections upon request.
