# Hazardous Materials Survey

## Balito Investments

142-146 Pitt Road, North Curl Curl NSW

**Report Title** Hazardous Materials Survey  
**Project Reference Number:** WEC121.HMS\_v1.0  
**Document Date:** 19 June 2023

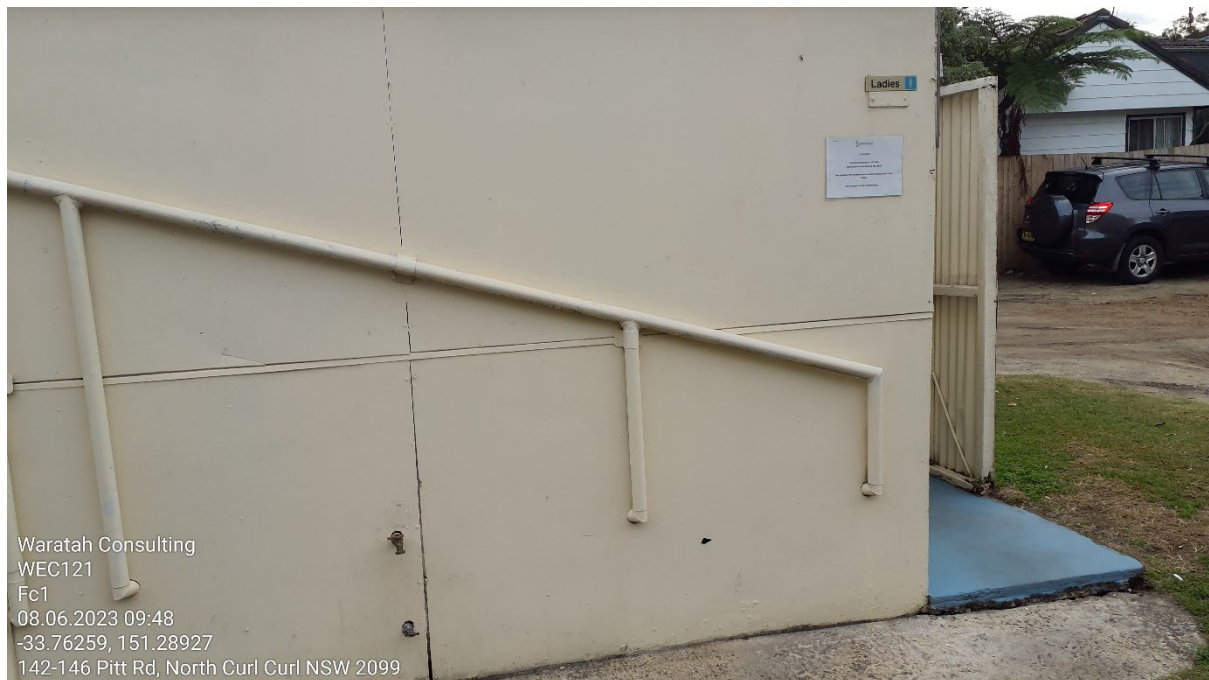
**Photograph 1:**

| Location | Material Description |
|---|---|
| External, shed / toilet block building, walls | Asbestos containing, Cement sheeting |

External, shed / toilet block building, walls, fibre cement sheeting

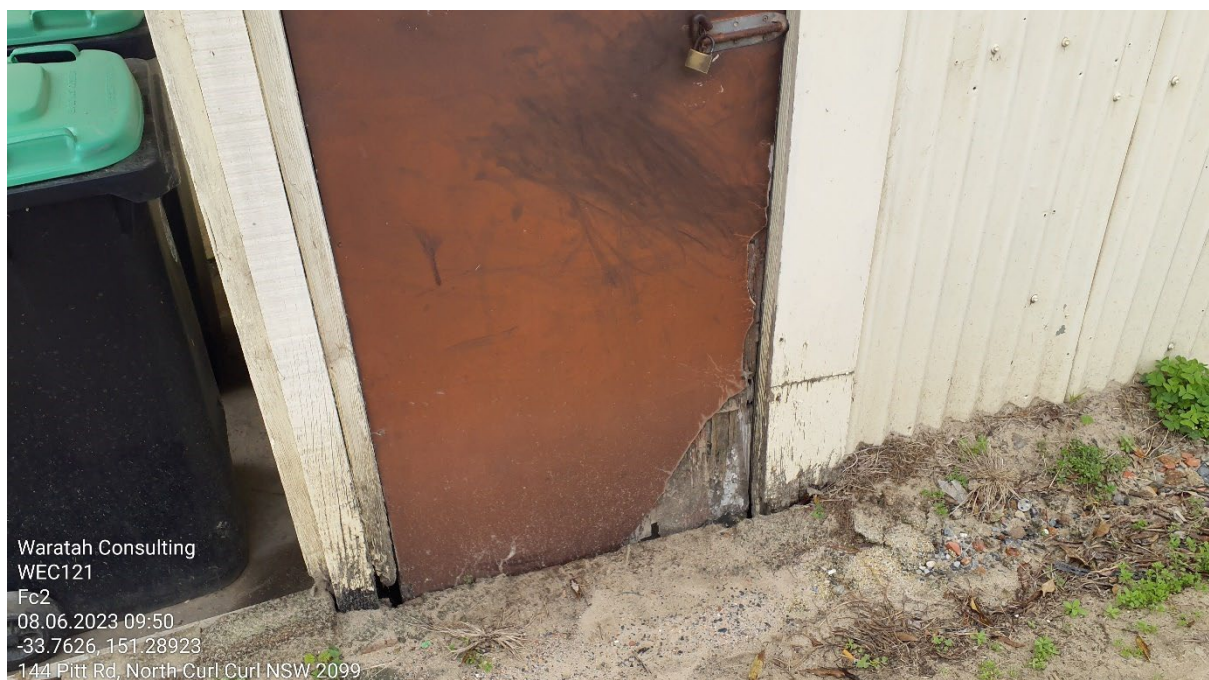
**Photograph 2:**

External, shed / toilet block building, door, fibre cement sheeting

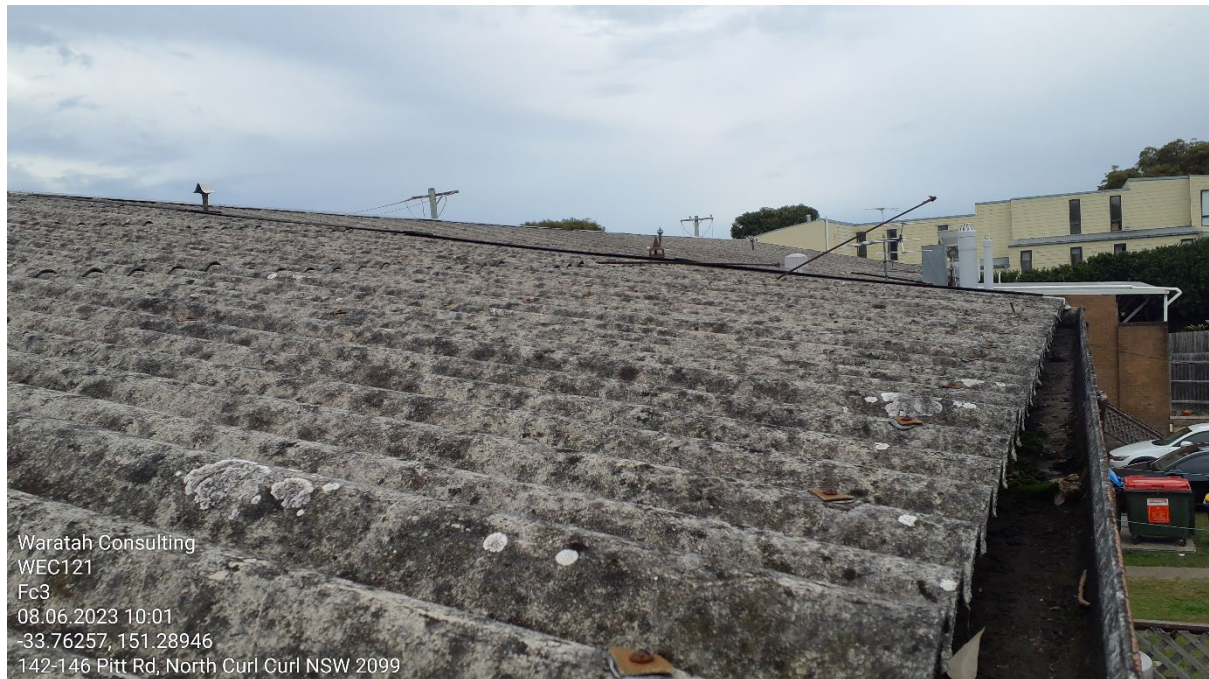
**Photograph 3:**

| Location | Material Description |
|---|---|
| External, roof | Asbestos containing, Cement sheeting |

External, roof, corrugated fibre cement sheeting.

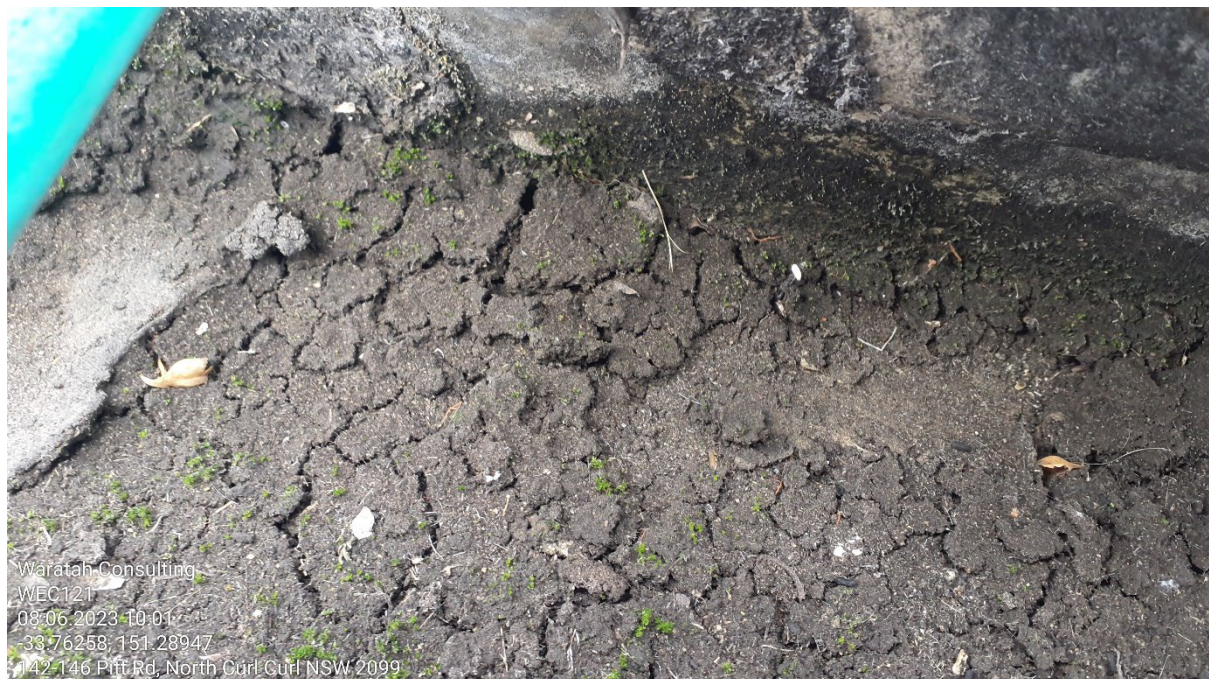
**Photograph 4:**

| Location | Material Description |
|---|---|
| External, adjacent roof, gutters | Asbestos containing, Loose fibres |

| Location Description | Material | Condition | Sample ID | Analytical Result | Estimated Quantity | Accessibility | Priority Rating | Recommendations | Photograph Register |
|---|---|---|---|---|---|---|---|---|---|
| External, adjacent roof, gutters | Loose fibres | Poor | Visual assessment | Presumed same as Fc3 | 2 m <sup>2</sup> | Maintenance only | Priority 2 – Moderate risk | Clean debris from gutters. Remove prior to demolition under friable asbestos safety controls. | Photograph 4 |

External, adjacent roof, gutters, loose fibres.

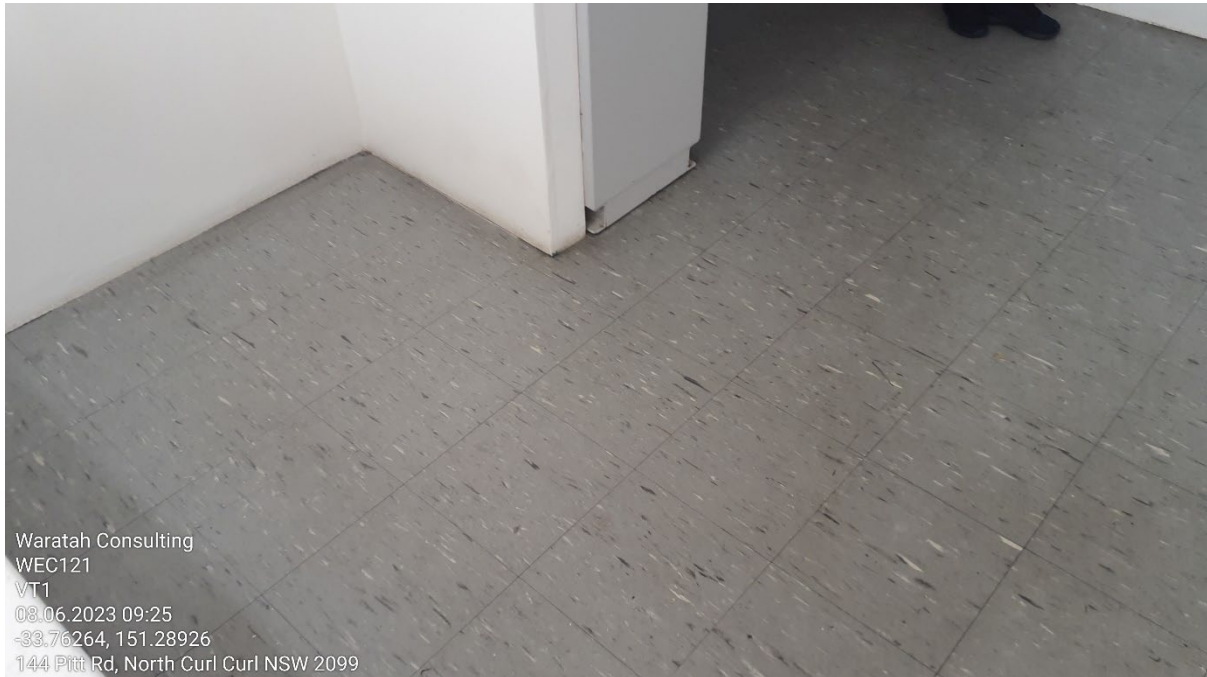
**Photograph 5:**

Internal, throughout hallways, common areas and storage closets, top of floor, vinyl tiles.

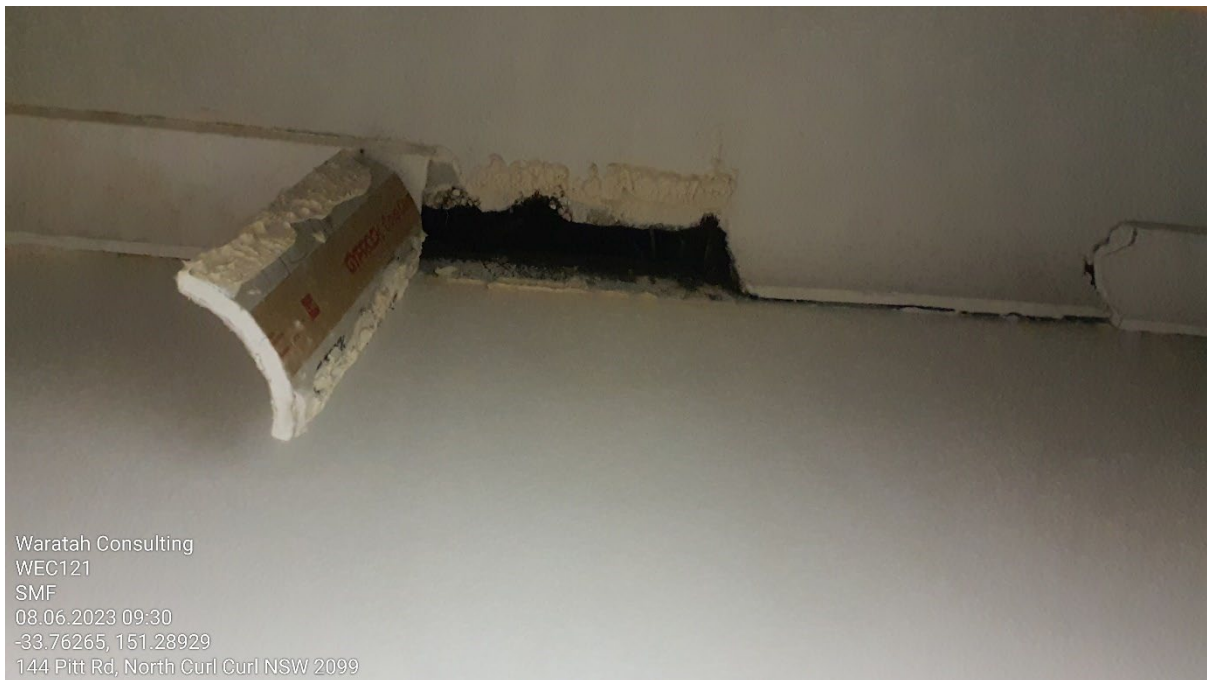
**Photograph 6:**

| Location | Material Description |
|---|---|
| Internal, throughout, ceiling | SMF, Cement sheeting |

Internal, throughout, ceiling

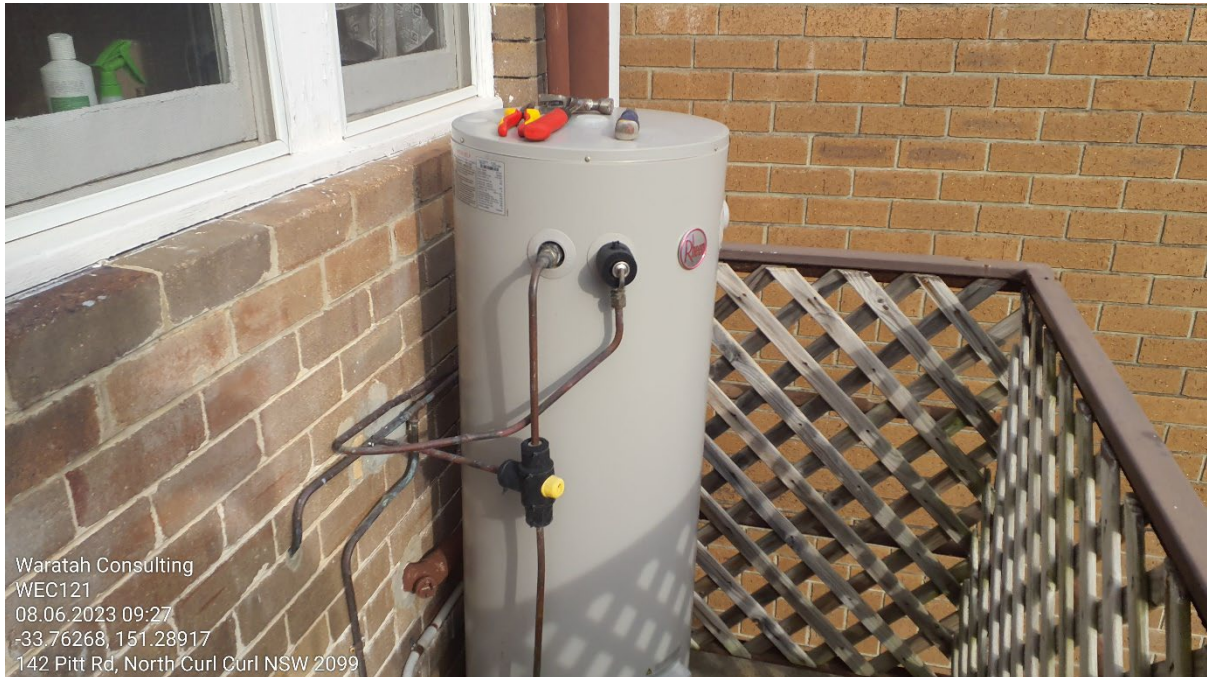
**Photograph 7:**

| Location | Material Description |
|---|---|
| External, rear of units, balcony, hot water systems | SMF lining |

External, rear of unit 2, balcony, hot water system

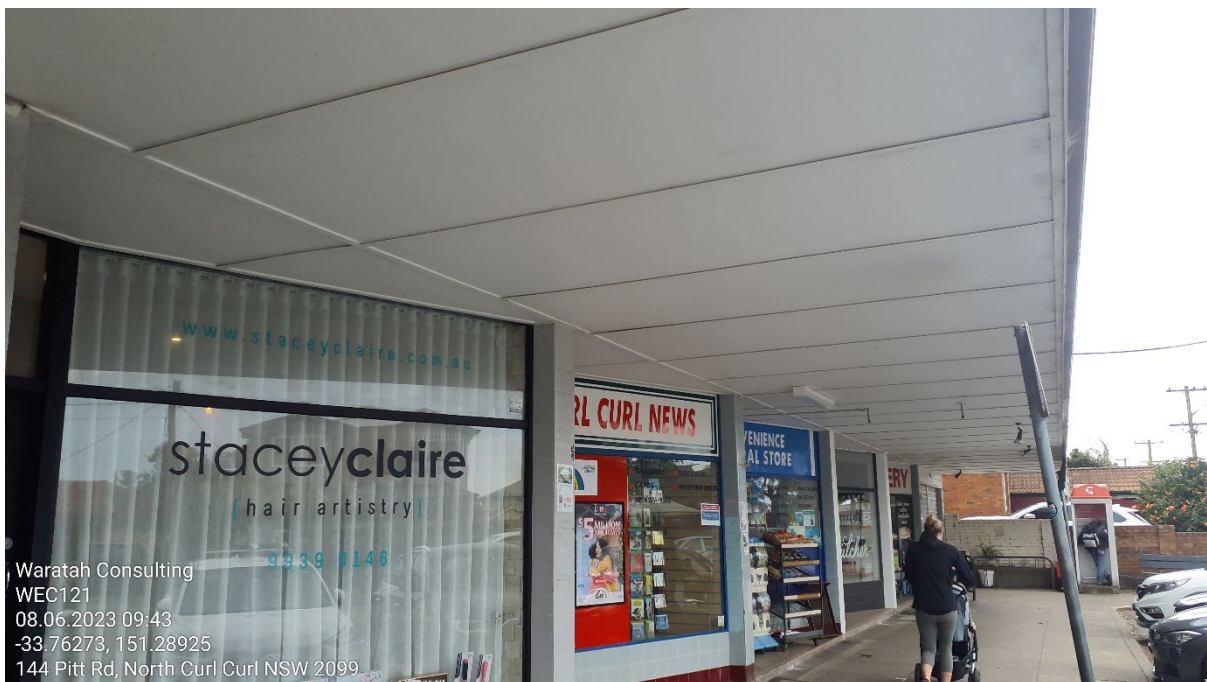
**Photograph 8:**

| Location | Material Description |
|---|---|
| External, adjacent shop fronts, eaves | Asbestos containing, Cement sheeting |
| External, adjacent shop fronts, bottom of roof, fluorescent light fittings | PCB Capacitors |

1. External, adjacent shop fronts, eaves, cement sheeting
2. External, adjacent shop fronts, bottom of roof, fluorescent light fittings, capacitors

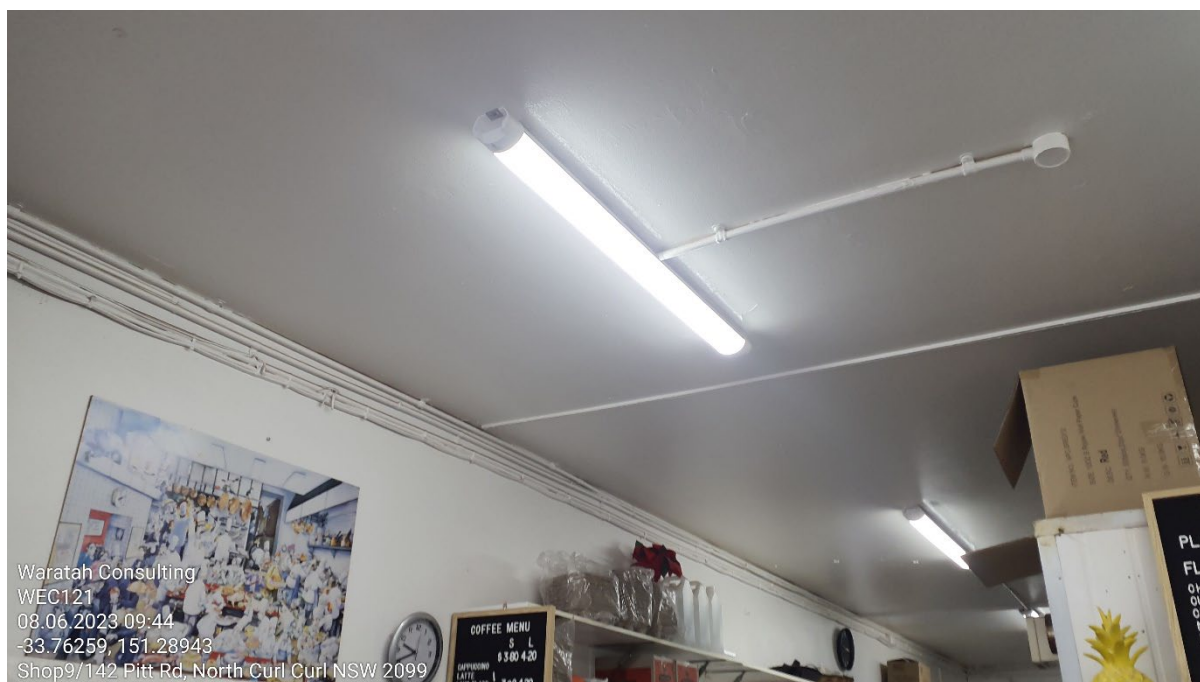
**Photograph 9:**

| Location | Material Description |
|---|---|
| Internal, Shop 4 & 5, bottom of ceiling, fluorescent light fittings | PCB Capacitors |

Internal, shop 4 & 5, bottom of ceiling, fluorescent light fittings, capacitors.

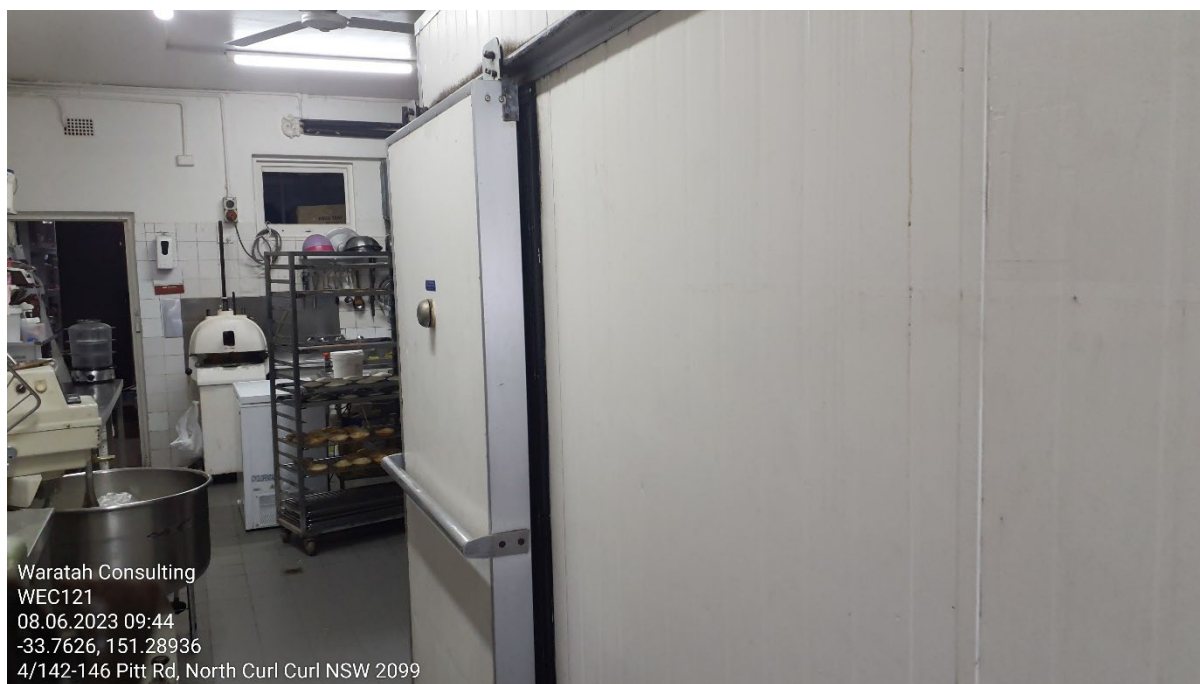
**Photograph 10:**

| Location | Material Description |
|---|---|
| Internal, shop 4, central portion of shop | SMF lining |

Internal, shop 4, central portion of shop, cool room, smf lining

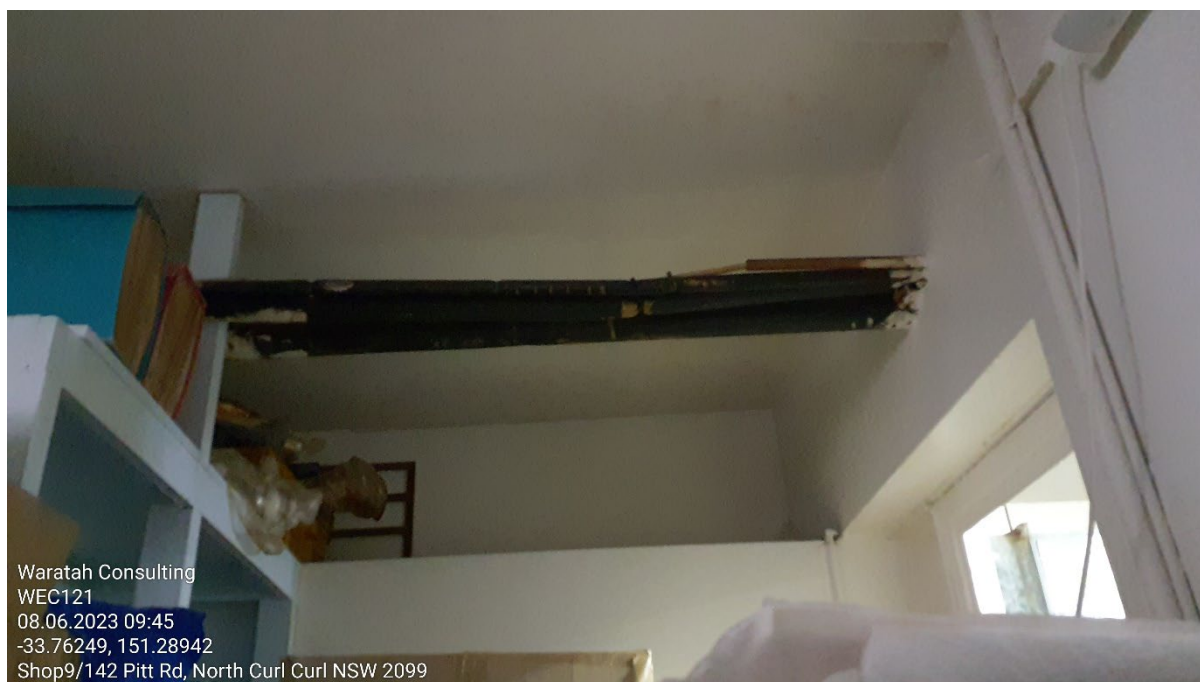
**Photograph 11:**

| Location | Material Description |
|---|---|
| Internal, shop 4, rear portion of shop, pipes | SMF lagging |

Internal, shop 4, rear portion of shop, bottom of ceiling, pipe lagging

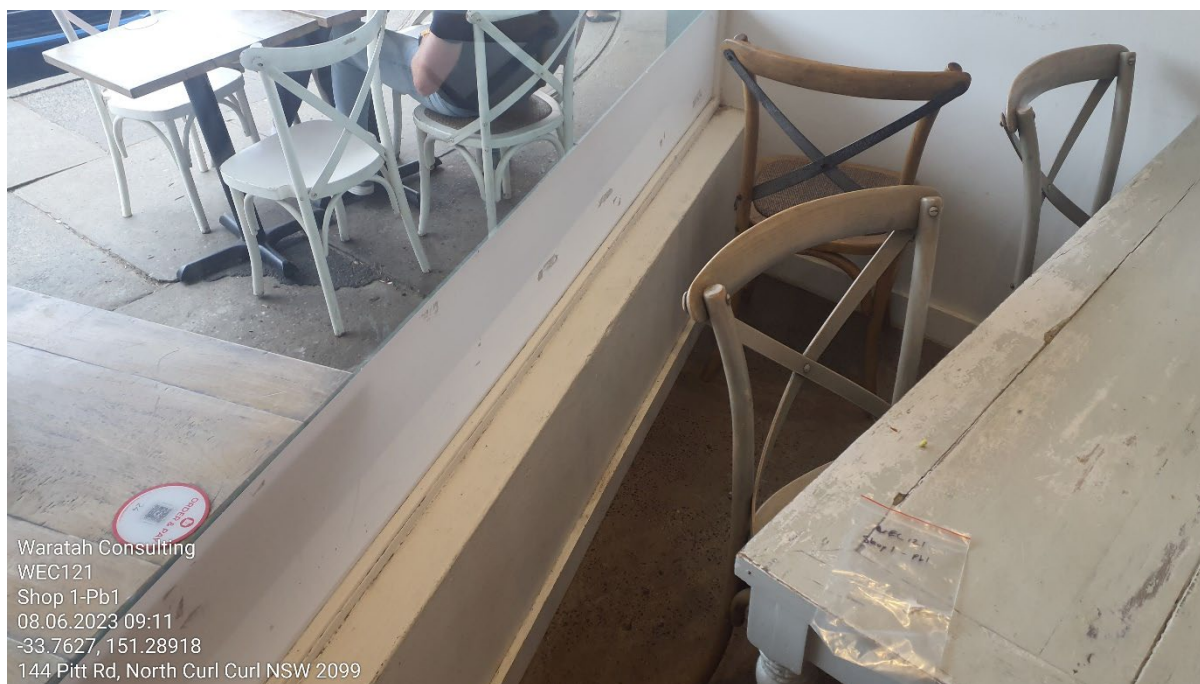
**Photograph 12:**

| Location Description | Material | Condition | Sample ID | Analytical Result | Estimated Quantity | Accessibility | Priority Rating | Recommendations | Photograph Register |
|---|---|---|---|---|---|---|---|---|---|
| Internal, Shop 1, surface of walls | White paint system | Good | Pb1 | <0.001% | 250 m <sup>2</sup> | NA | NA | NA | Photograph 12 |

Internal, shop 1, surface of walls, white paint system

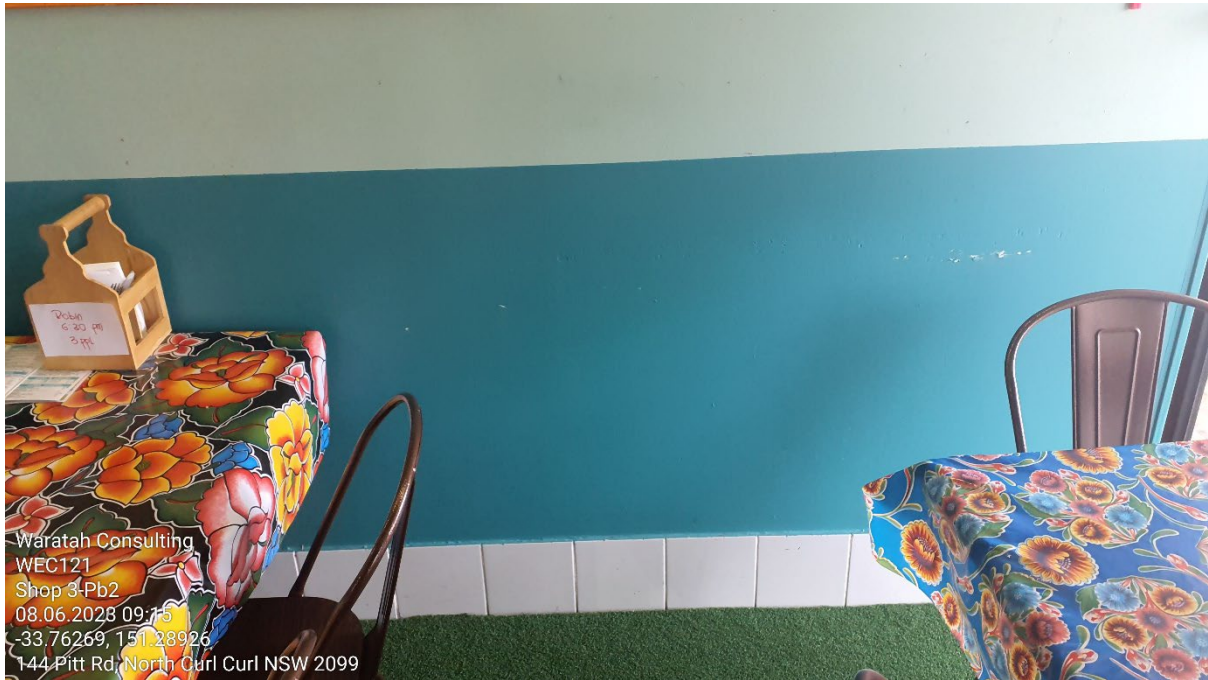
**Photograph 13:**

| Location Description | Material | Condition | Sample ID | Analytical Result | Estimated Quantity | Accessibility | Priority Rating | Recommendations | Photograph Register |
|---|---|---|---|---|---|---|---|---|---|
| Internal, Shop 1, surface of walls | Blue paint system | Good | Pb2 | <0.001% | 20 m <sup>2</sup> | NA | NA | NA | Photograph 13 |

Internal, shop 2, surface of walls, blue paint system

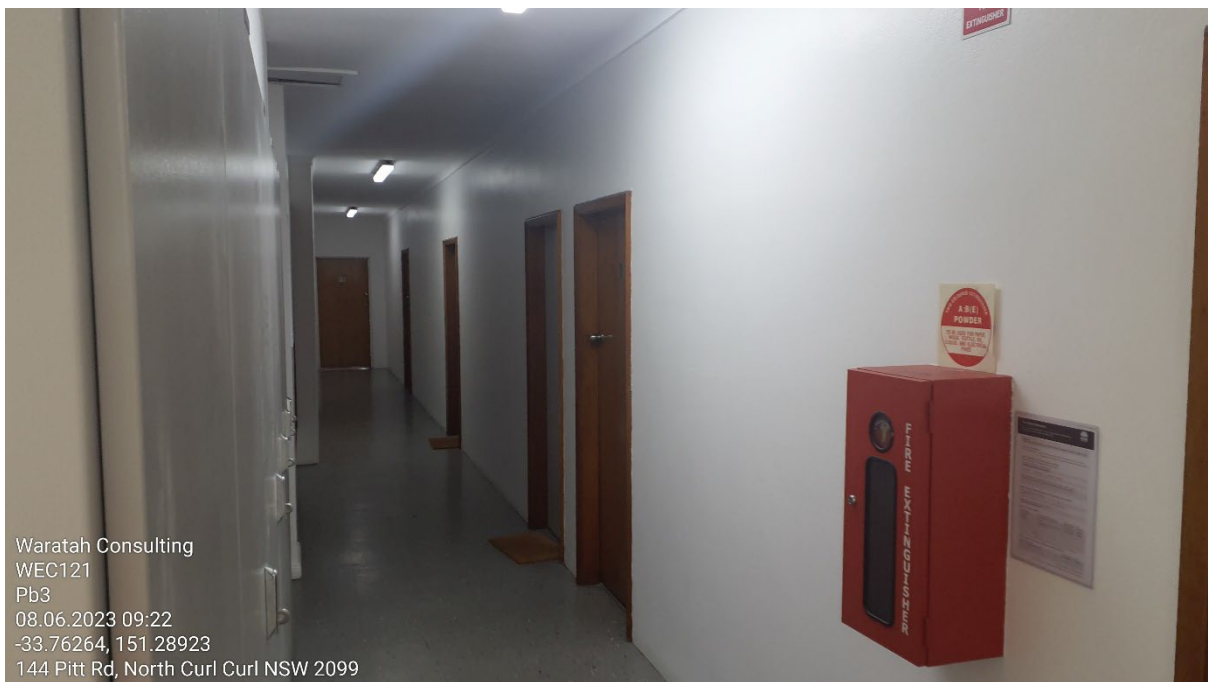
**Photograph 14:**

| Location | Material Description |
|---|---|
| Internal, second level, hallways, storage rooms and apartments, surface of walls | Lead based, White paint system |

| Location Description | Material | Condition | Sample ID | Analytical Result | Estimated Quantity | Accessibility | Priority Rating | Recommendations | Photograph Register |
|---|---|---|---|---|---|---|---|---|---|
| Internal, second level, hallways, storage rooms and apartments, surface of walls | White paint system | Good | Pb3 | 0.10% | 1,000 m <sup>2</sup> | Regular | Priority 3 – low risk | Avoid abrasive activities in vicinity of material during demolition. | Photograph 14 |

Internal, second level, hallways, storage rooms and apartments, surface of walls, white paint system

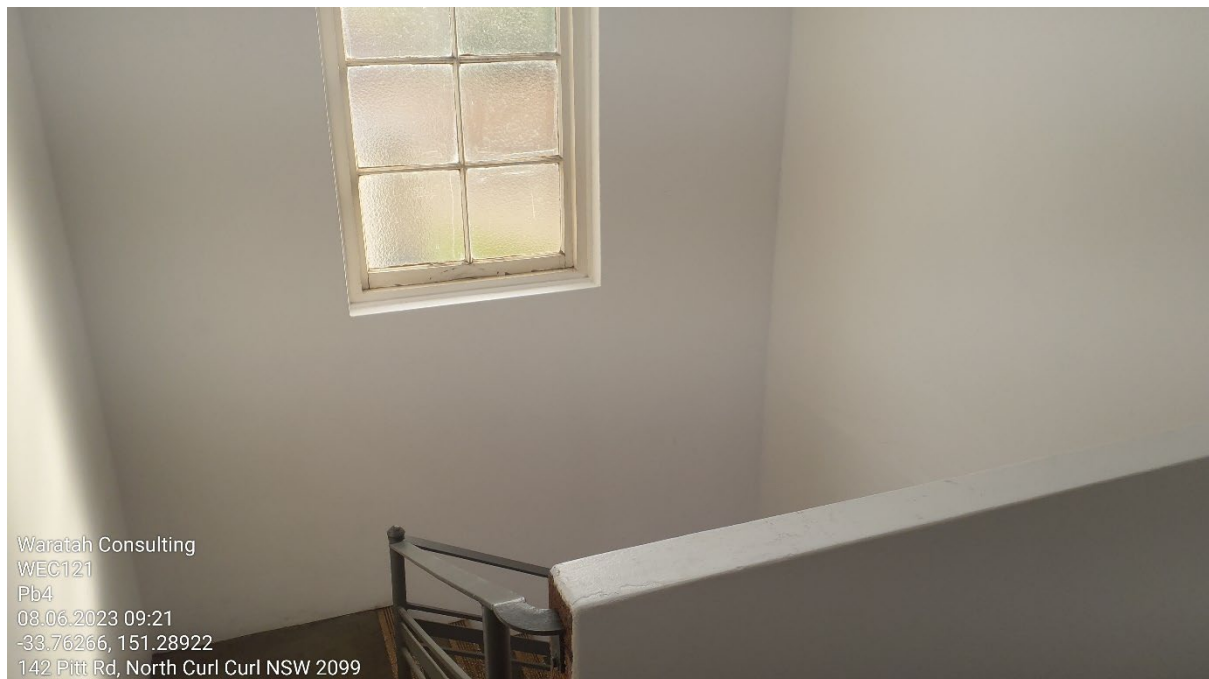
**Photograph 15:**

| Location | Material Description |
|---|---|
| Internal, throughout, surface of window frames | Lead based, White paint system |

Internal, second level, throughout, window frames, white paint system

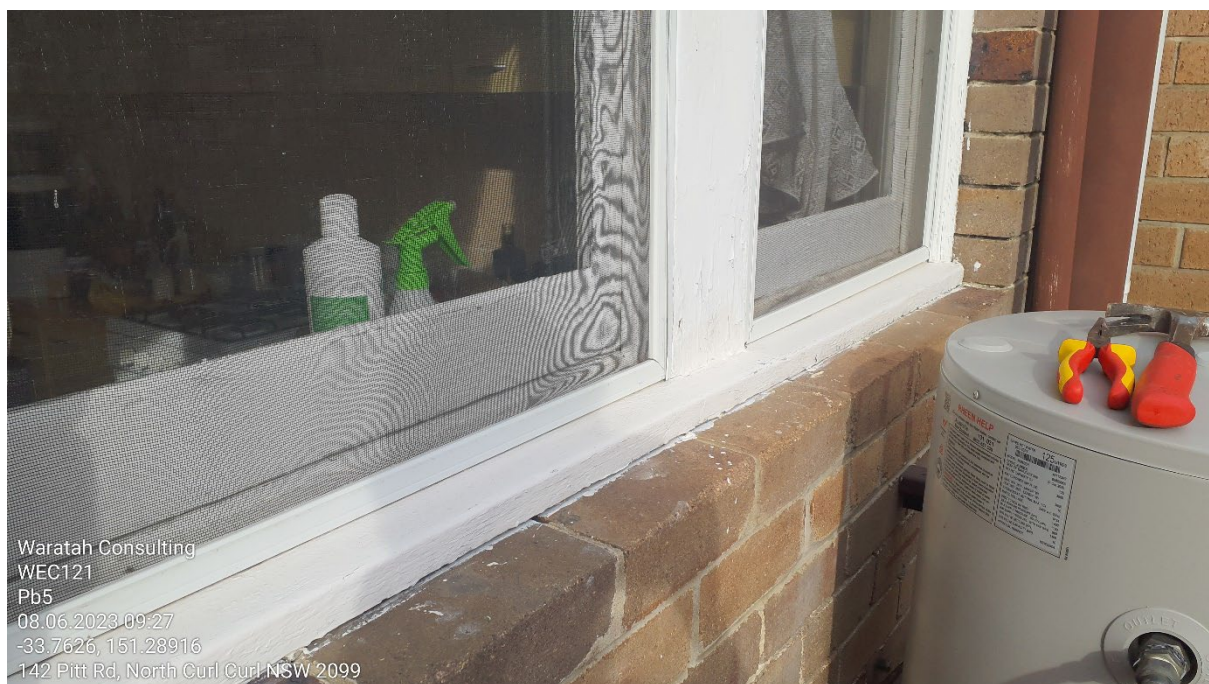
**Photograph 16:**

| Location | Material Description |
|---|---|
| External, throughout, surface of window frames | Lead based, White paint system |

External, throughout, window frames, white paint system
