## **73 Pacific Road, Palm Beach**

### Geotechnical Comments for Section 4.55

## **GEOTECHNICAL INVESTIGATION:**

### **Alterations and Additions and New Garage at 73 Pacific Road, Palm Beach**

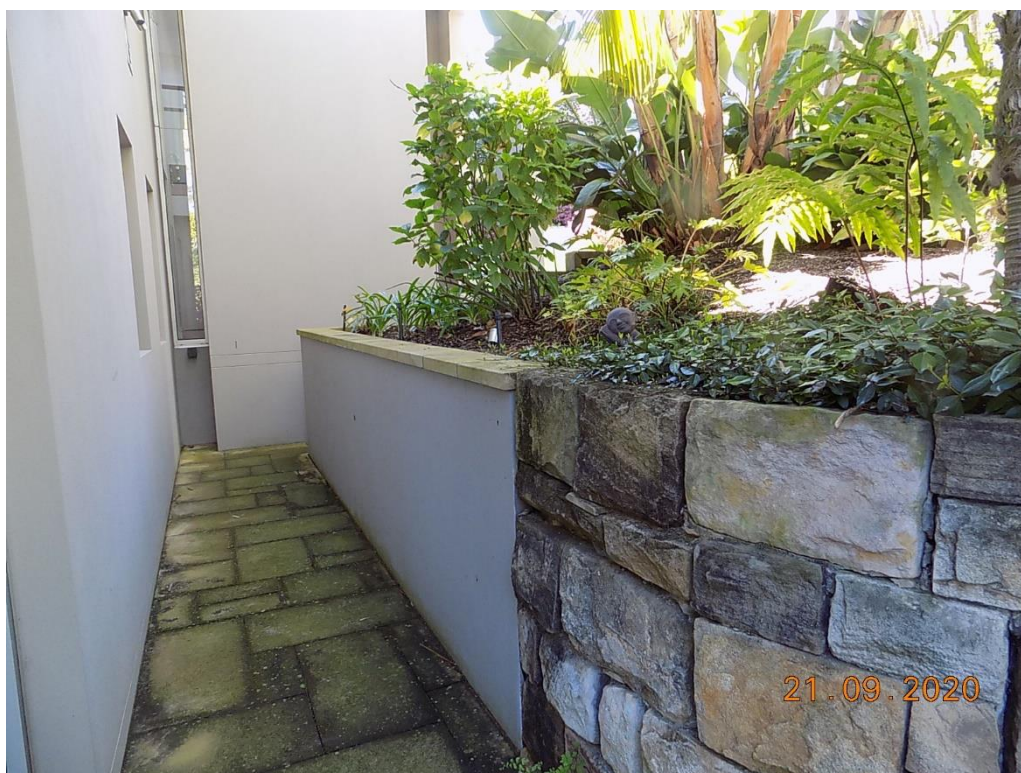
Photo 4

An excavation has been made through this slope for the uphill side of the house. The cut is supported by a stable rendered masonry retaining wall ~1.1m high (Photo 4). The part three-storey rendered brick house is supported on brick walls and brick piers (Photos 5 & 6). No significant signs of movement were observed in the supporting walls of the house and the supporting piers stand vertical. Some of the walls and piers were observed to be supported directly off competent Medium Strength Sandstone bedrock within the foundation space of the house. An excavation has been made in the slope for the lower ground floor of the house. The ~2.0m cut has been taken entirely through competent Medium Strength Sandstone (Photo 7). No significant geological defects were observed in the cut face and it is considered stable. A pool has been constructed on the downhill side of the house (Photo 8). The water level of the pool indicates no ground movement has occurred in the shell of the pool since its construction. A small terraced garden slope falls from the downhill side of the house and pool to a gently sloping lawn area below (Photo 9). The terraces are supported by stable rendered masonry retaining walls reaching ~1.4m high. At the E end, the walls were observed to be supported directly off outcropping Medium Strength Sandstone (Photo 10). The outcrop steps down the slope ~1.7m. No significant geological defects were observed in the outcrop and it is considered stable. A concrete parking area has been constructed below the outcrop and beside the lawn (Photo 11). A concrete driveway provides access to the parking area from Mitchell Road (Photo 12). Between the road frontage to Mitchell Road and the parking area and lawn is a terraced garden (Photo 13). The terraces are supported by stable sandstone block retaining walls reaching ~1.0m high.

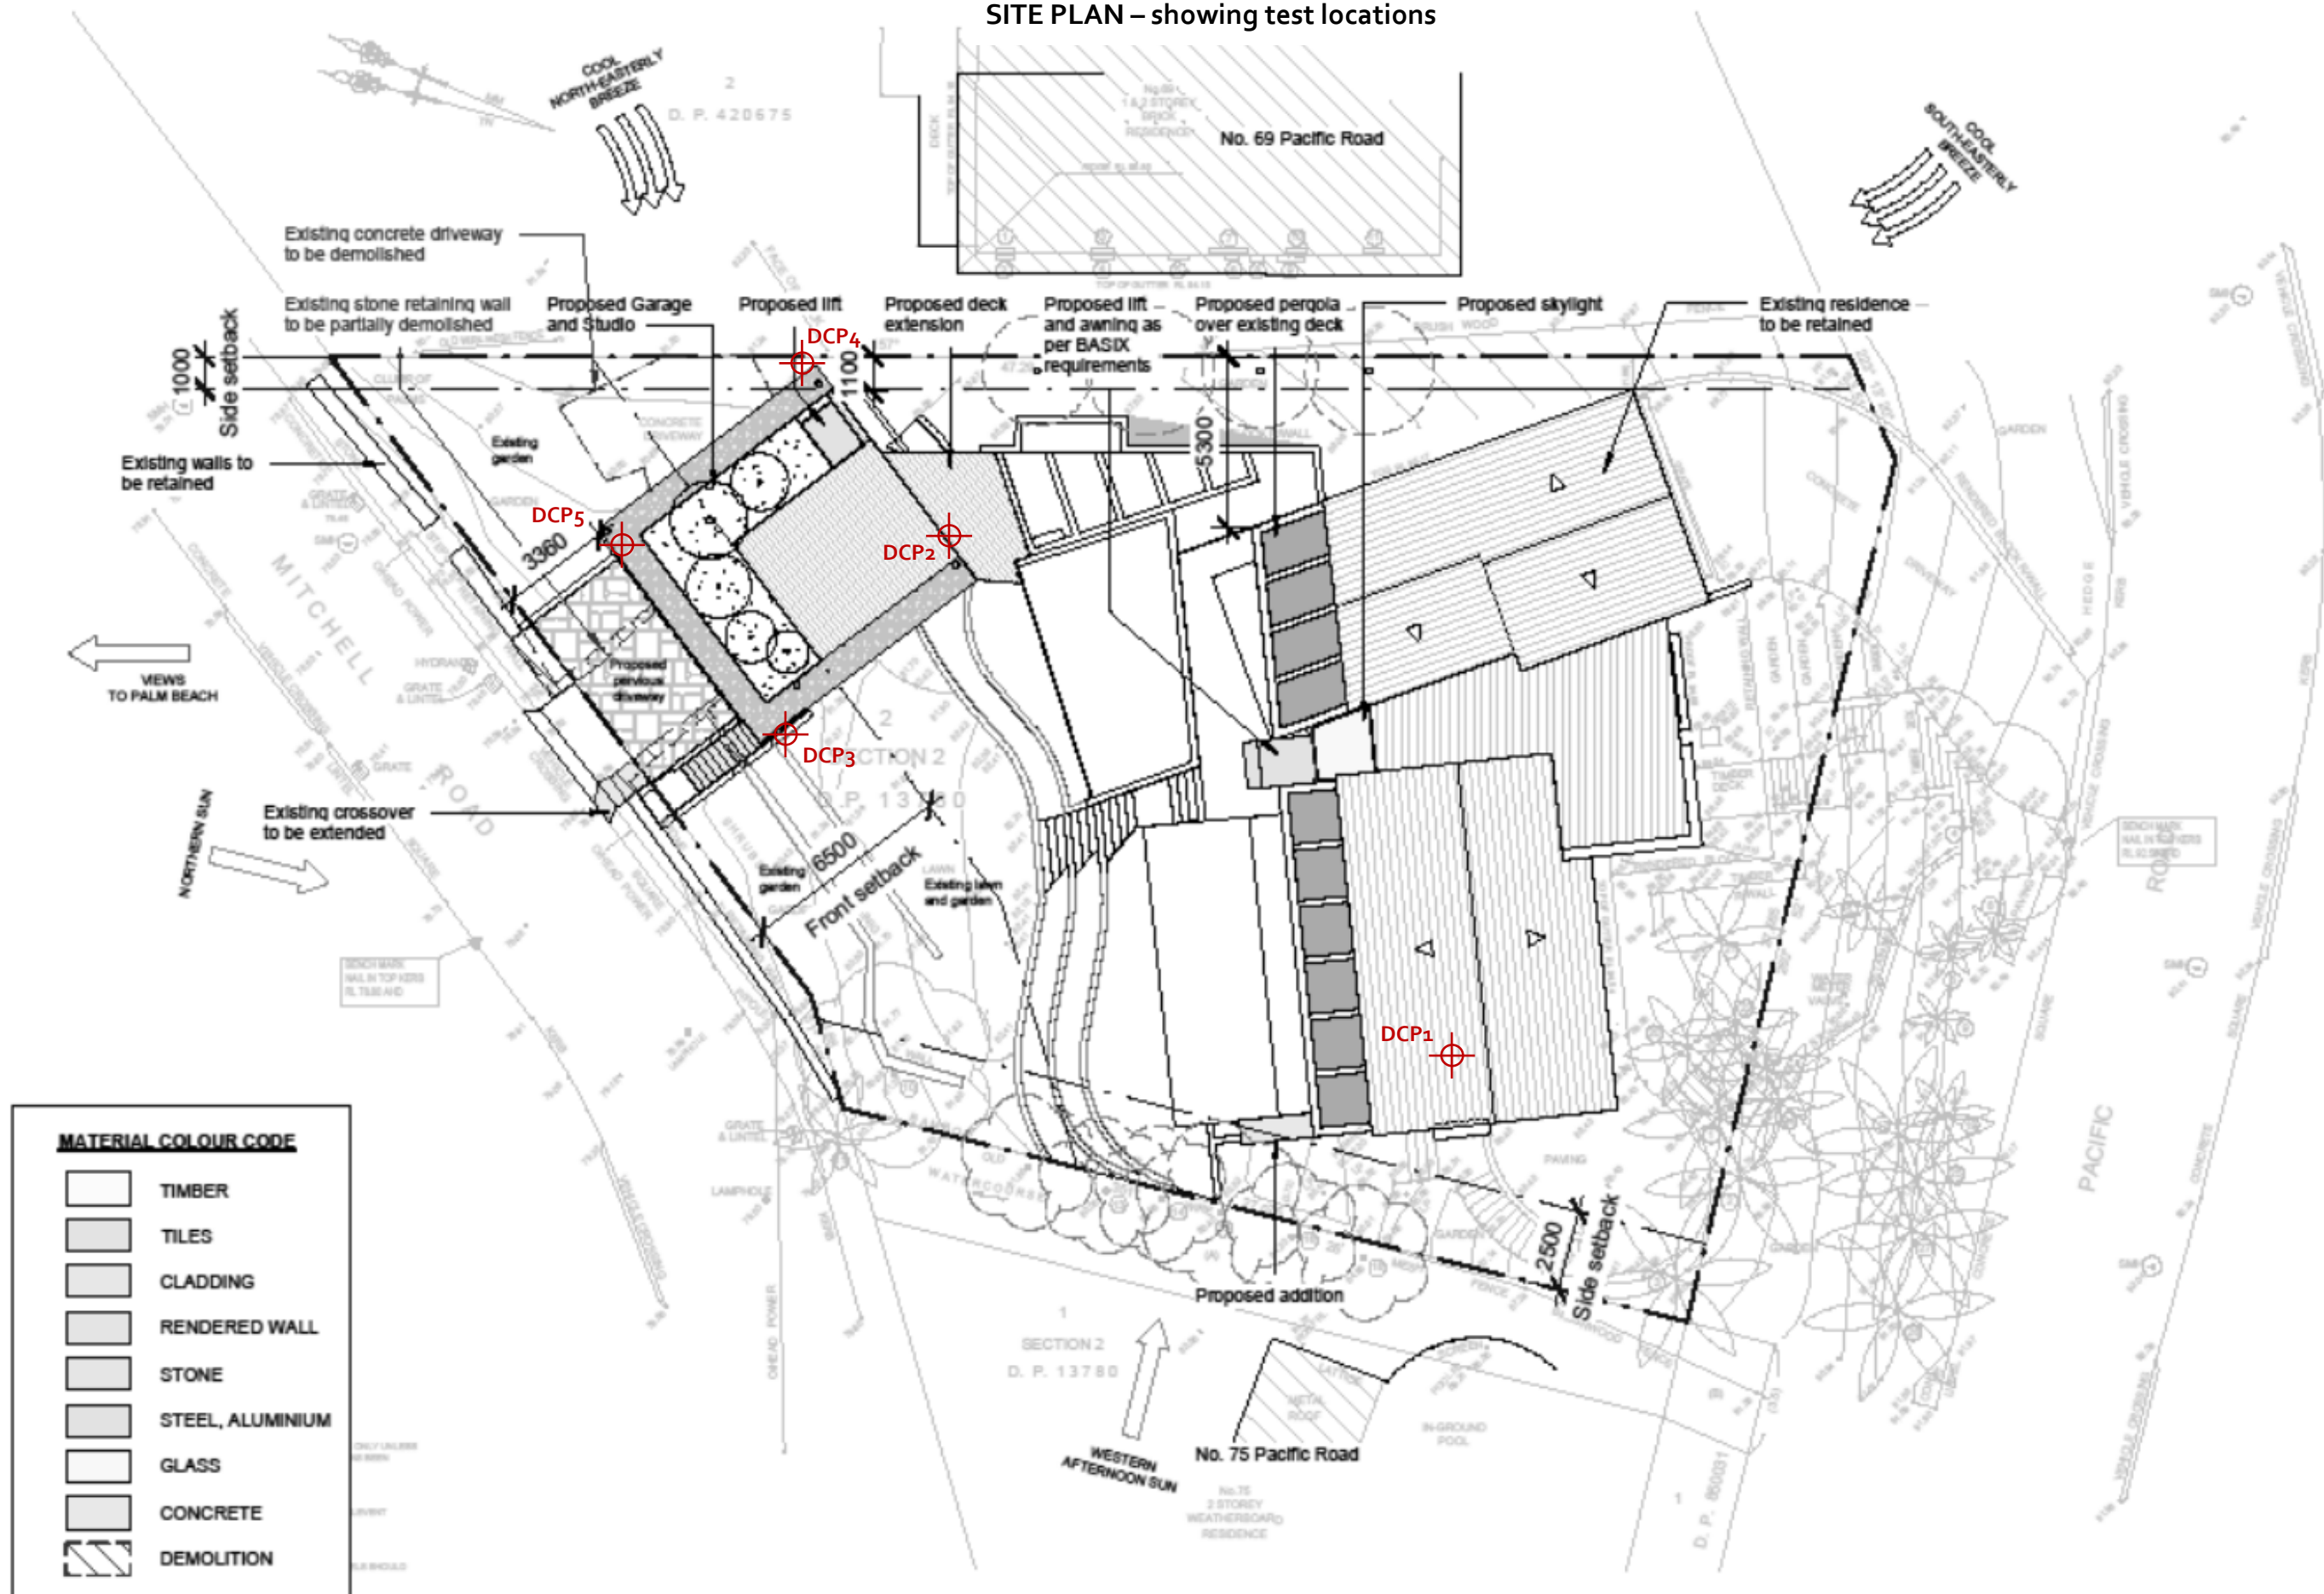
# SITE PLAN – showing test locations

Five DCP (Dynamic Cone Penetrometer) tests were carried out to determine the relative density of the overlying soil and the depth to bedrock. The locations of the tests are shown on the site plan. It should be noted that a level of caution should be applied when interpreting DCP test results. The test will not pass through hard buried objects so in some instances it can be difficult to determine whether refusal has occurred on an obstruction in the profile or on the natural rock surface. This is not expected to be an issue for the testing on this site. However, excavation and foundation budgets should always allow for the possibility that the interpreted ground conditions in this report vary from those encountered during excavations. See the appended "Important information about your report" for a more comprehensive explanation. The results are as follows:

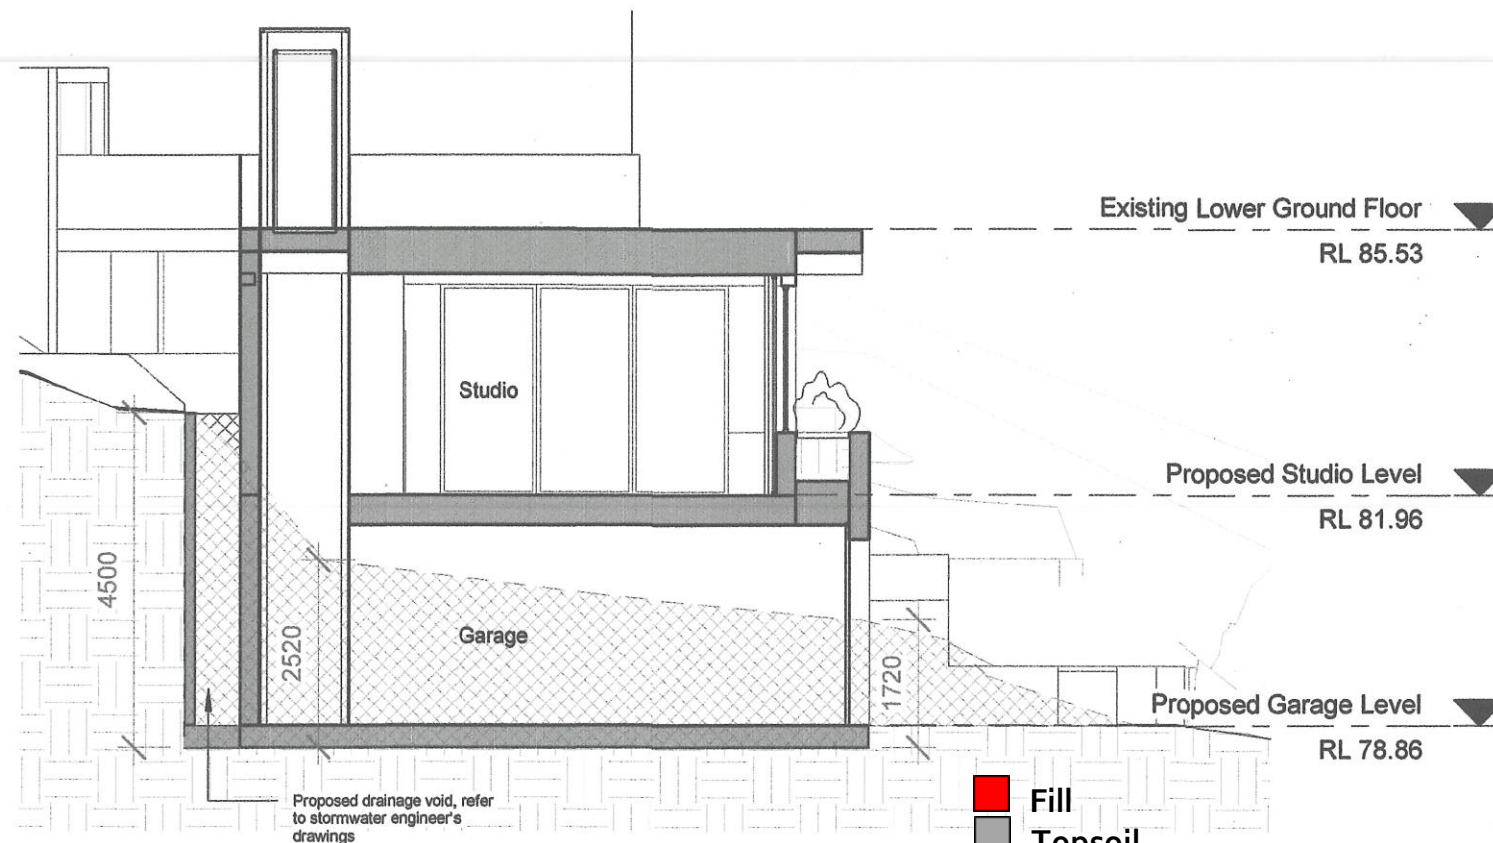
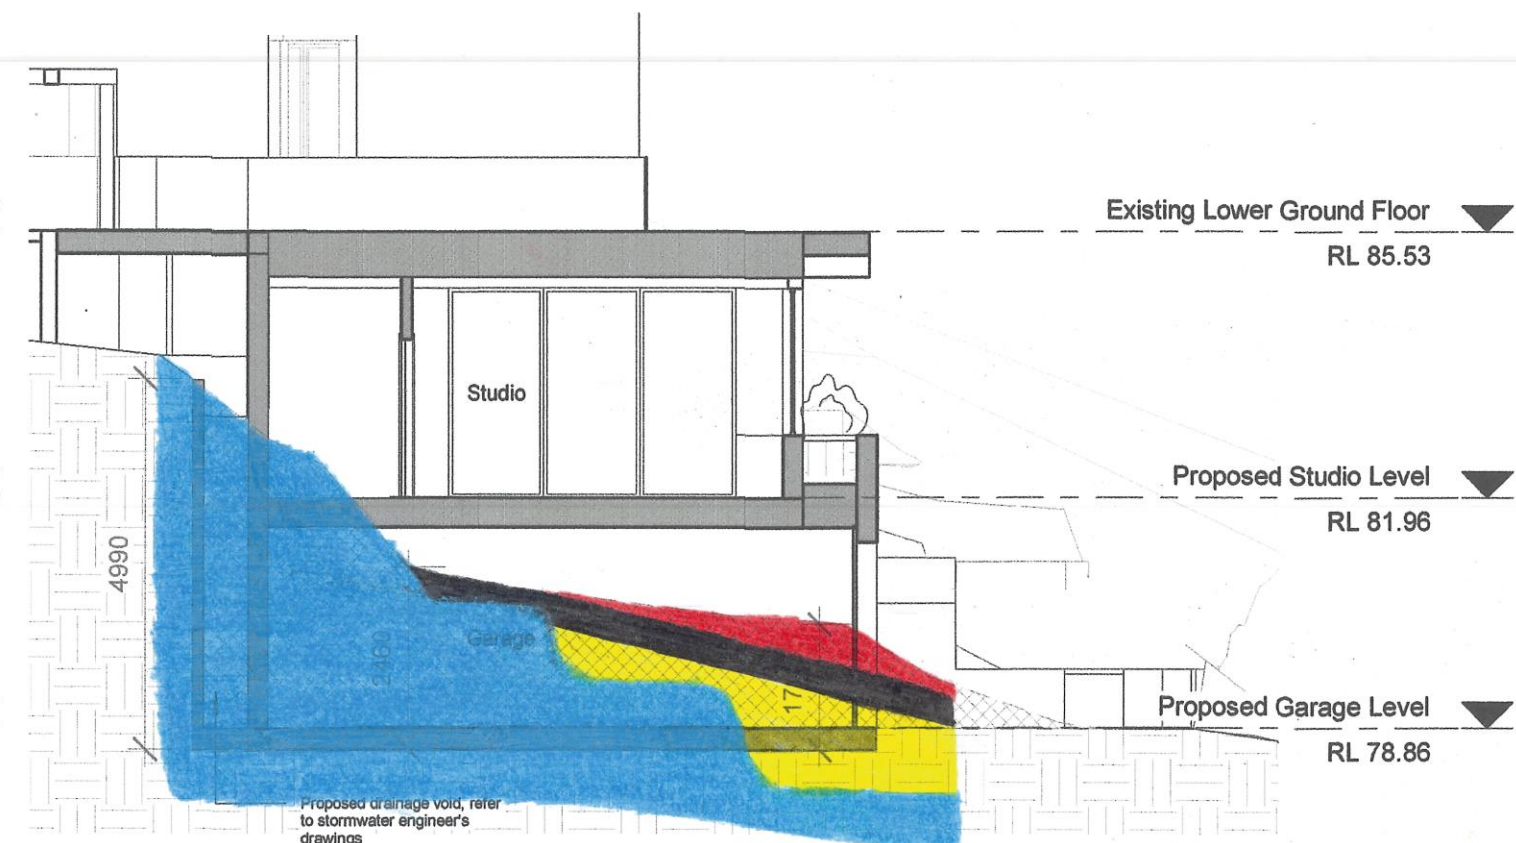
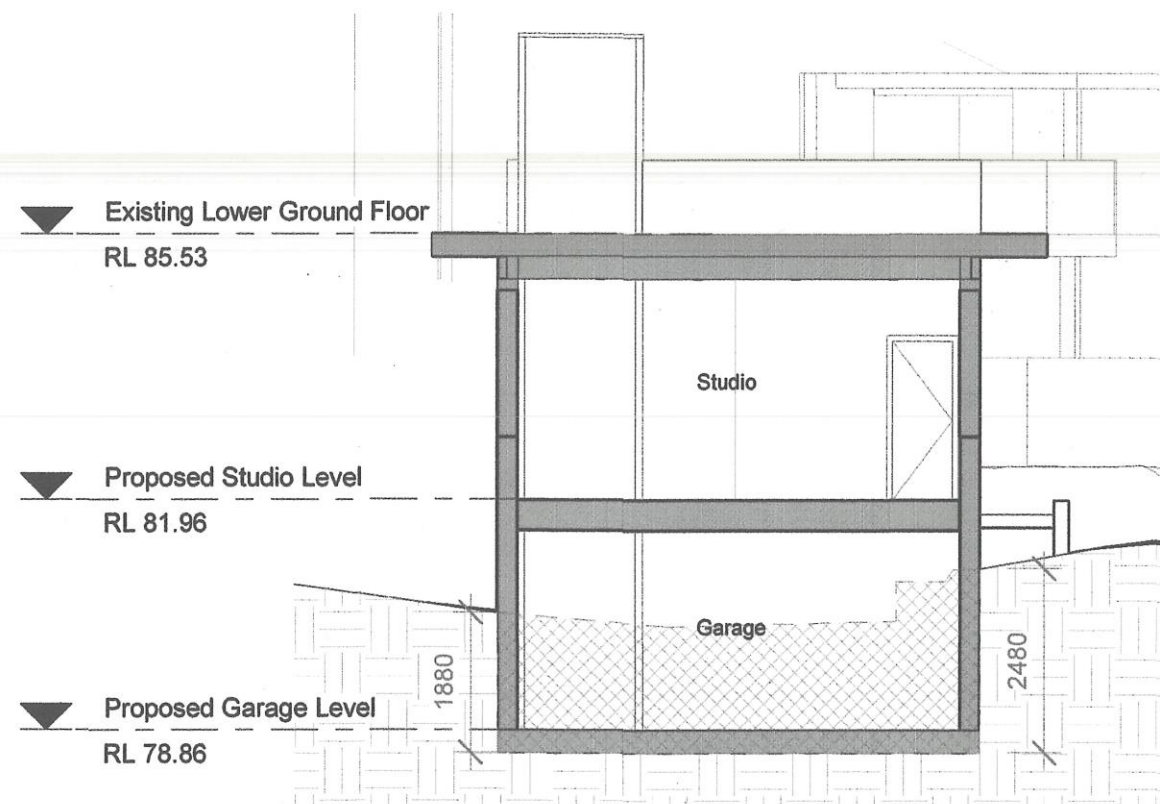
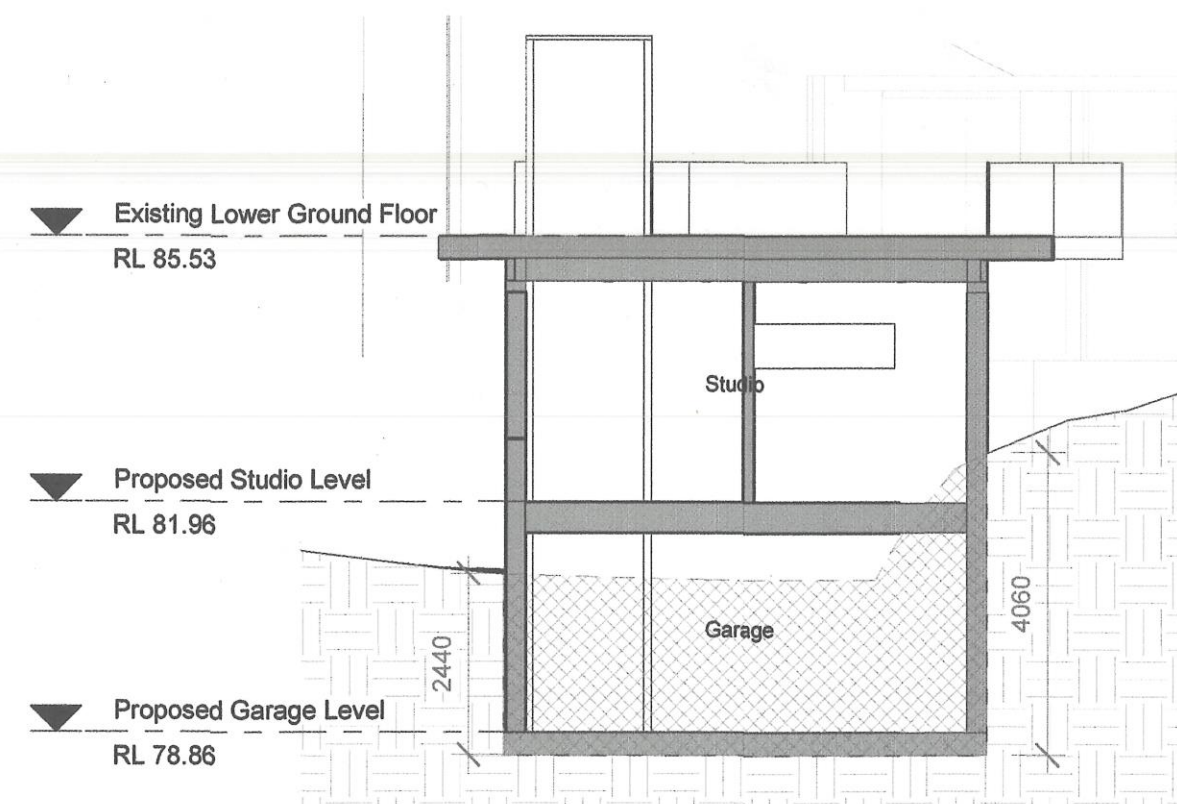
# TYPE SECTION – Diagrammatical Interpretation of expected Ground Materials

The surface features of the block are controlled by the outcropping and underlying sandstone bedrock that steps down the property forming sub-horizontal benches between the steps. Where the grade is steeper, the steps are larger and the benches narrower. Where the slope eases, the opposite is true. Manmade fill has been placed across the property for landscaping. Where the rock is not exposed, it is overlain by fill, sandy soils, and sandy clays that fill the bench step formation. In the test locations where rock was not exposed, it was encountered at depths of between 0.4 to 1.8m below the current surface, being slightly deeper due to fill encountered in DCP3 and due to the stepped nature of the underlying bedrock. It is likely DCP5 was over a joint (crack) in the rock as it reached a maximum depth of 2.7m. The outcropping sandstone on the property is estimated to be Medium Strength or better and similar strength rock is expected to underlie the entire site. See Type Section attached for a diagrammatical representation of the expected ground materials.
