Geotechnical Assessment

Project: Alterations & Additions
6 Florence Court, North Balgowlah

Ref: AG 25376
27 August 2025

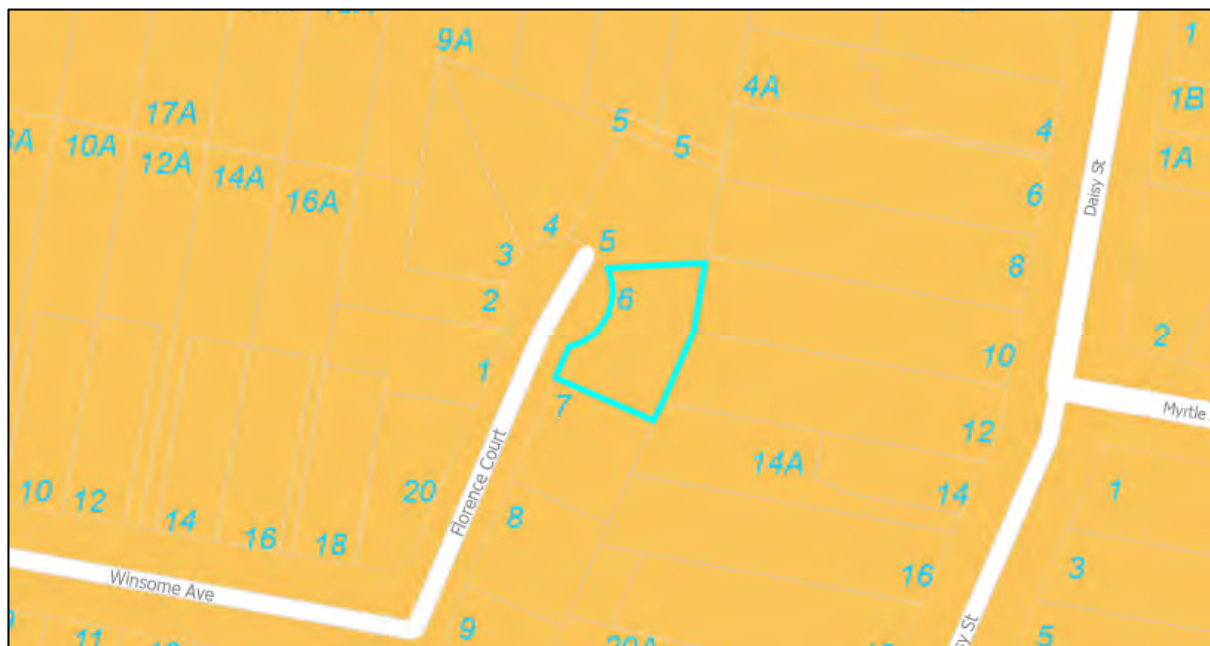
Image 2. Warringah Landslip Risk Map:
6 Florence Court, North Balgowlah (© NBC Maps)

- No evidence of significant soil creep, tension cracks or landslip instability were identified across the site or on adjacent properties as viewed from the subject site at the time of our inspection.
- The property is classified as **Area B** with reference to Northern Beaches Council WLEP – Warringah Landslip Risk Map (**Image 2**).

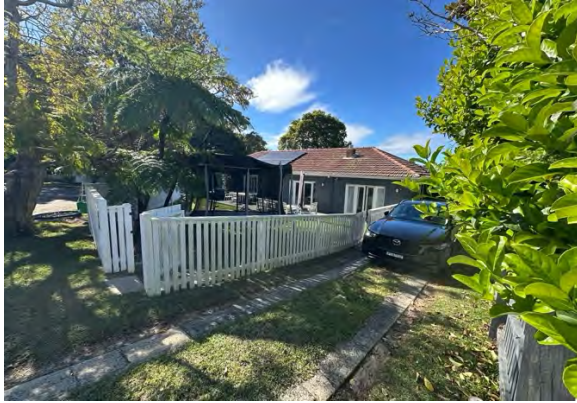
Photo 1: Site frontage, looking east.

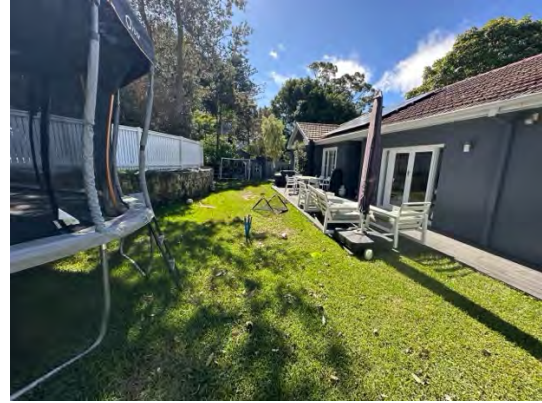
Photo 2: Photo of front yard, looking north.

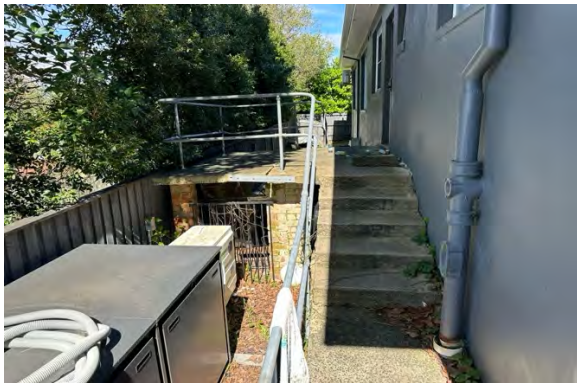
Photo 3: Photo of rear yard, looking south.

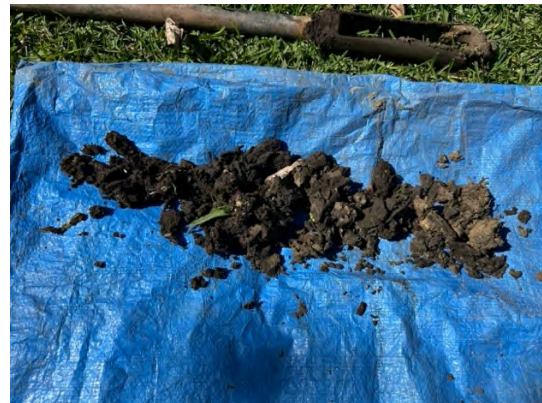
The soil profile consists of shallow uncontrolled fill and silty topsoil (O & A Horizons), silty sand (B Horizon) and weathered bedrock (C Horizon). Based on our observations and the results of testing on site, we would expect weathered sandstone bedrock to be found within 0.3 to 0.6 metres below current surface levels across the area of the proposed works and potentially deeper where filling has been carried out.

Photo 4: Subsurface soil profile of BH01.
