**GEOTECHNICAL RISK MANAGEMENT POLICY FOR PITTWATER**  
**FORM NO. 1 – To be submitted with Development Application**

Address of site 31-33 Sturdee Lane, Elvina Bay

## **GEOTECHNICAL INVESTIGATION:**

New Inclined Lift at **31-33 Sturdee Lane, Elvina Bay**

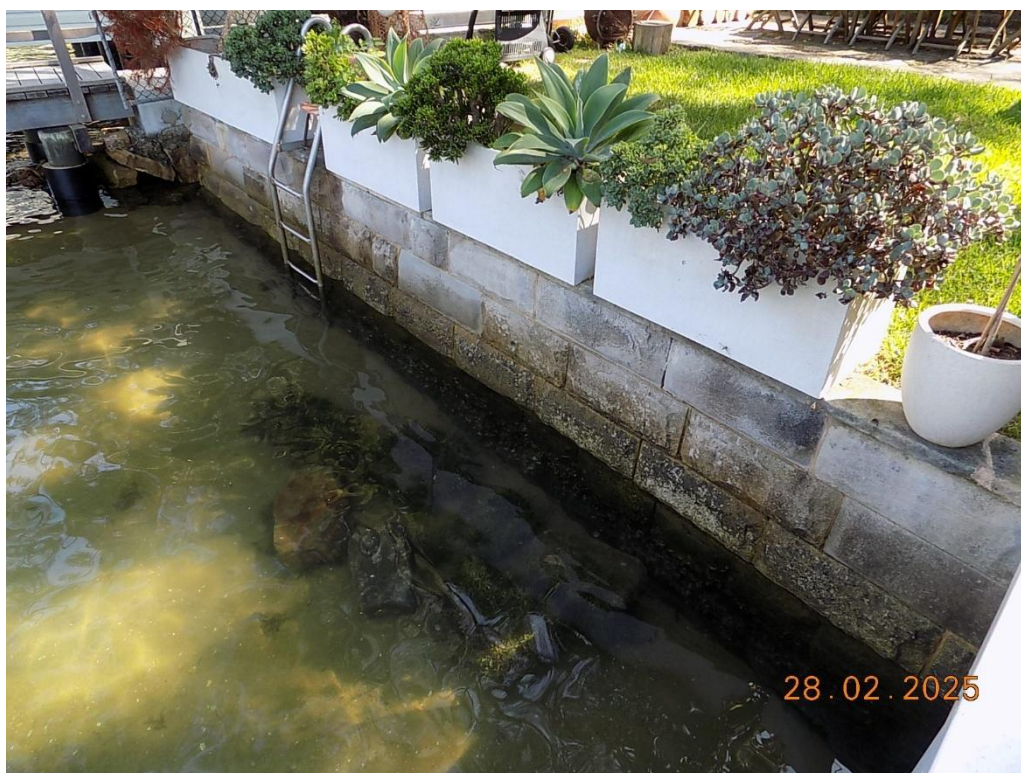
Photo 2

- 2.1** The site was inspected on the 28<sup>th</sup> February, 2025.
- 2.2** These residential properties encompass the crest and moderate to steeply graded flanks of a hillslope. The natural slope rises from the S property boundaries at the Elvina Bay waterfront at an angle of ~37° before quickly easing to gentle angles at the crest of the hillslope. The slope falls at the N side of the crest at gentle angles before increasing to steep angles near the N property boundaries above Sturdee Lane. The slope below the N property boundaries decreases in grade to the waterfront.
- 2.3 31 Sturdee Lane** - At the waterfront, a stable timber jetty runs to stable timber clad boat shed (photo 1). The concrete piers for the boat shed stand vertical. Fill for a level lawn at the boat shed is supported by a stable mortared sandstone block seawall

reaching ~1.5m high (Photo 2). The lower portion of the very steeply graded slope between the boat shed and the house is terraced with stable timber retaining walls of mortared sandstone block and timber construction and reaching a combined height of ~2.5m (Photos 3 & 4). Where the slope is not supported above, it is well vegetated. The grade of the slope eases immediately below the house (Photo 5). The two-story timber clad house is supported on sandstone and concrete block walls and steel posts. No significant signs of movement were observed in the visible supporting walls, and the supporting post stands vertical. The land surface surrounding the house is lawn covered.

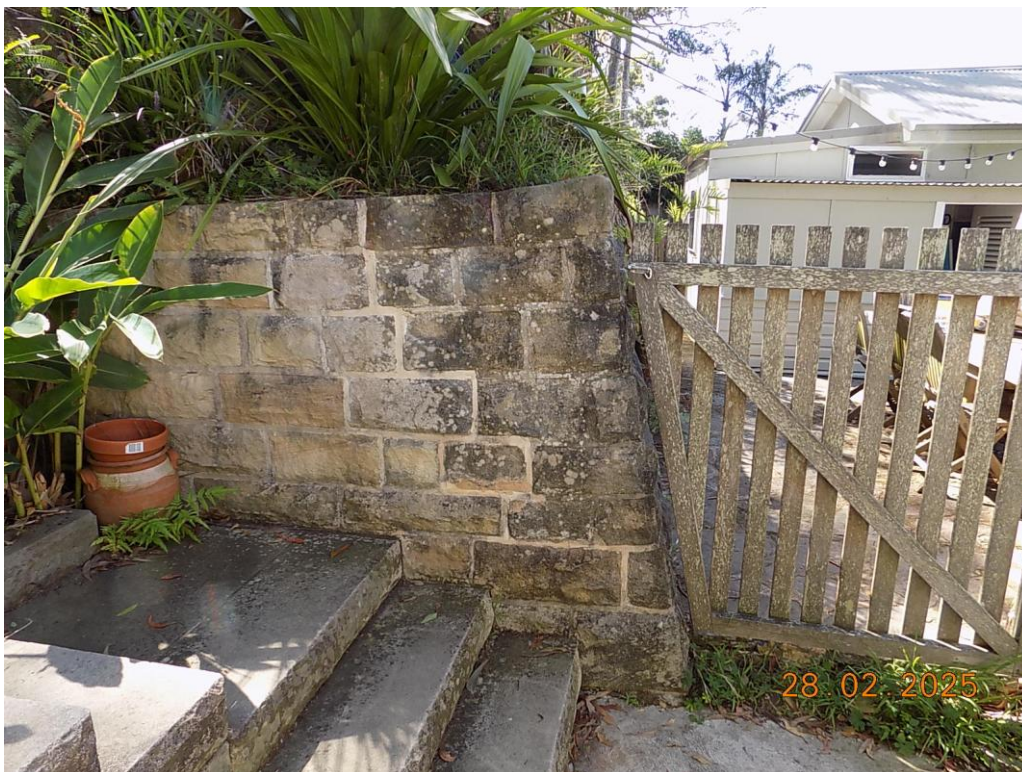
Photo 4

The sandstone block retaining wall (Photo 4) that supports the cut for the boat shed for No.31 is to be partially demolished on the W end as part of the proposed works. This will expose a

~1.5m cut batter and undercut the timber retaining wall and stairs upslope. The demolition is to be carried out from the top down in an orderly manner. Due to the grade of the slope and proximity to the structures above, the fill, soil, clay and Extremely Low to Very Low Strength Shale behind the wall will need to be permanently supported prior to the excavation/demolition process, or during the demolition/excavation process in a staged manner, so cut batters are not left unsupported. See the site plan attached for the minimum extent of the required shoring. The support will need to be designed/approved by the structural engineer in consultation with the Geotechnical Consultant.

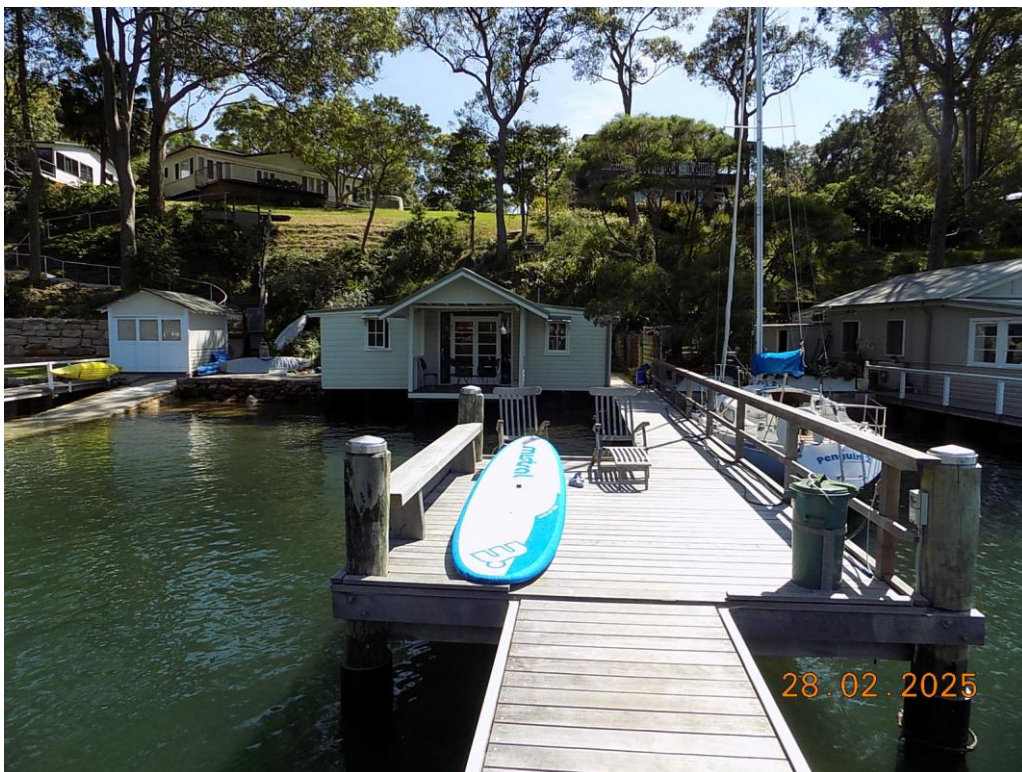
Photo 6

**2.4 33 Sturdee Lane** - At the waterfront, a stable timber jetty runs to stable timber clad boat shed (Photo 6). The concrete piers for the boat shed stand vertical. Fill for a level platform at the boat shed is supported by a stable dry stack sandstone seawall reaching ~1.0m high. The cut for the boat shed and toe of the very steeply graded slope above has been braced with ~1.0m high timber boards (Photo 7). This bracing will be replaced with a new retaining wall as part of the proposed works. The very steep slope above is well vegetated (Photo 7) and continues for ~10.0m before decreasing in grade towards the crest of the hillslope. The house has been constructed beyond the crest on the moderately graded N flank (Photo 8). The part two-story timber clad house is supported on brick walls and brick piers. No significant signs of movement were observed in the visible supporting walls of the house, and the supporting brick piers stand vertical. The cut for the lower floor of the house is supported by timber retaining walls (Photo 9). Some of the timber sleepers are in the process of rotting and the star pickets are rusted. However, they currently appear stable. See '**Section 17**' for advice. The land surface surrounding the house is lawn covered. The slope begins increasing in grade to Sturdee Lane below the downhill boundary (Photo 10).

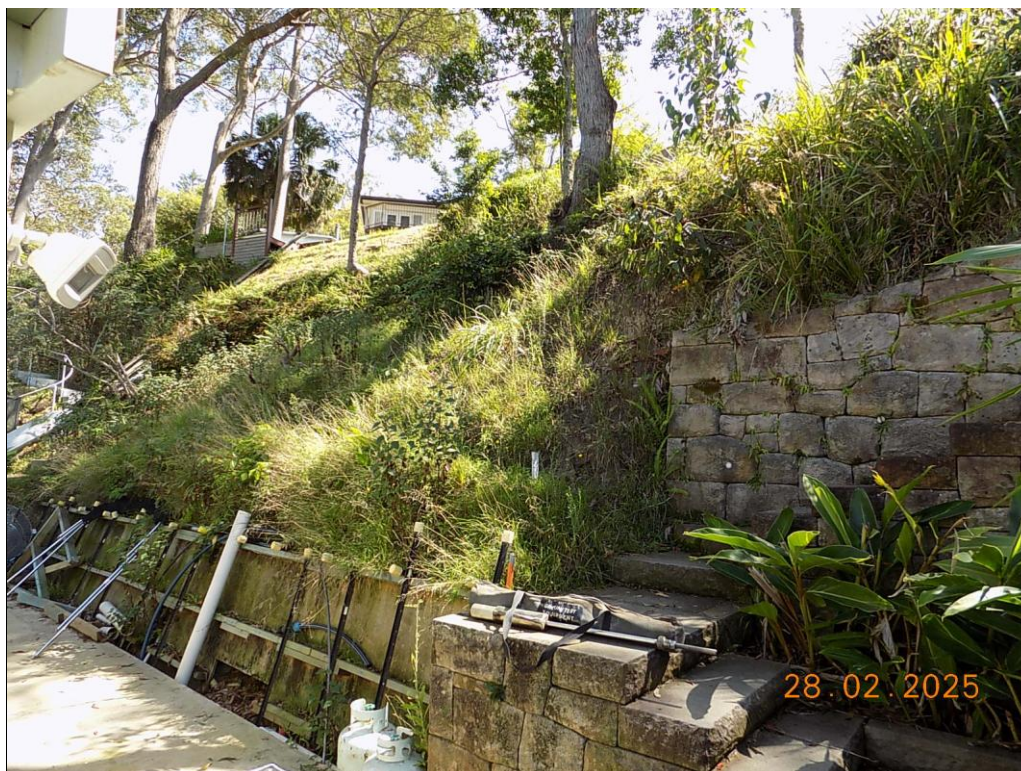
Photo 7

- ~Flush with the staircase for No. 31 on the E side of the cut (Photo 7)
- ~1.0m from a eucalyptus tree on the uphill side of the cut which is shown on the plans to remain. (Photo 12)
- ~1.1m from the staircase for No.33 on the uphill side of the cut. (Photo 13)

Because of the narrow width of the excavation face, the return cuts on either side will act as buttresses that will partially support the narrow cut. However, this also forms a deep confined working space. As such it is recommended the excavation be supported by a staged top-down sprayed concrete wall supported with anchors. Or a similar such suitable support approved by the geotechnical consultant. Maximum excavation lift depth is 1.5m before the retaining wall is installed in stages. We have supervised the construction of many of these types of walls. Our office can be contacted for more information regarding this process, if desired. The support is to be designed by the structural engineer in consultation with the Geotechnical consultant. All surcharge loads are to be considered in the design (slope and surrounding stairs).

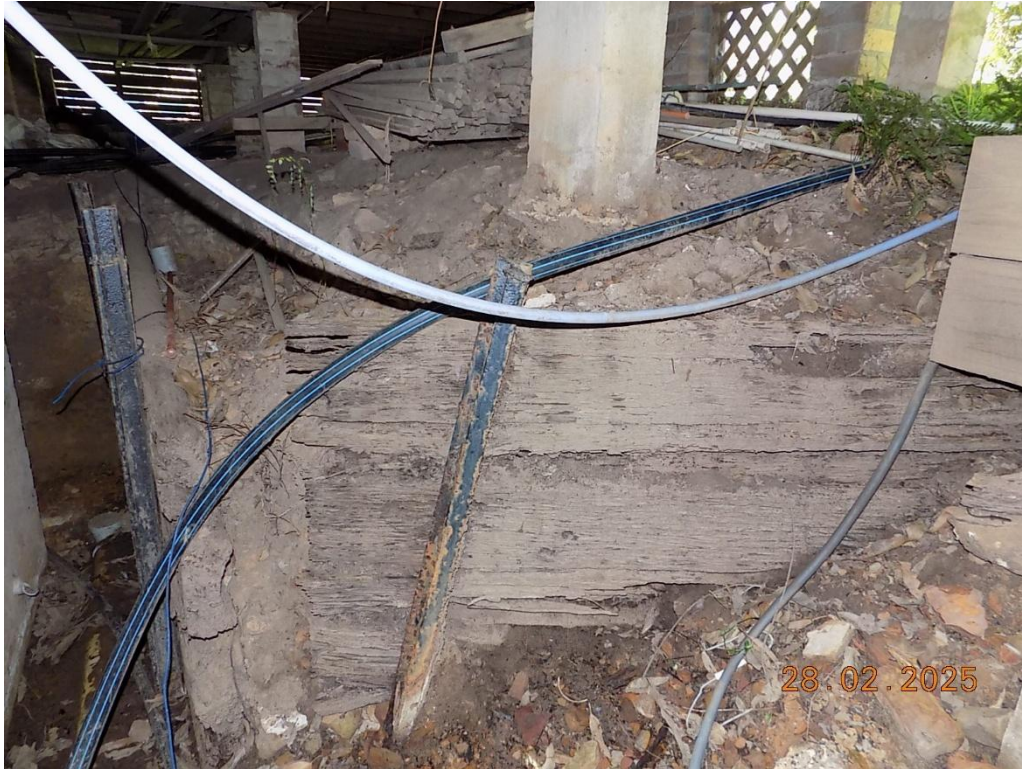
Photo 9

The timber retaining walls below the house for number 33 (Photo 9) are to be monitored by the owners on an annual basis or after heavy and prolonged rainfall events, whichever occurs first. A photographic record of these inspections is to be kept. Should further movement occur the walls are to be remediated so that they meet current engineering standards. We can carry out these inspections upon request.

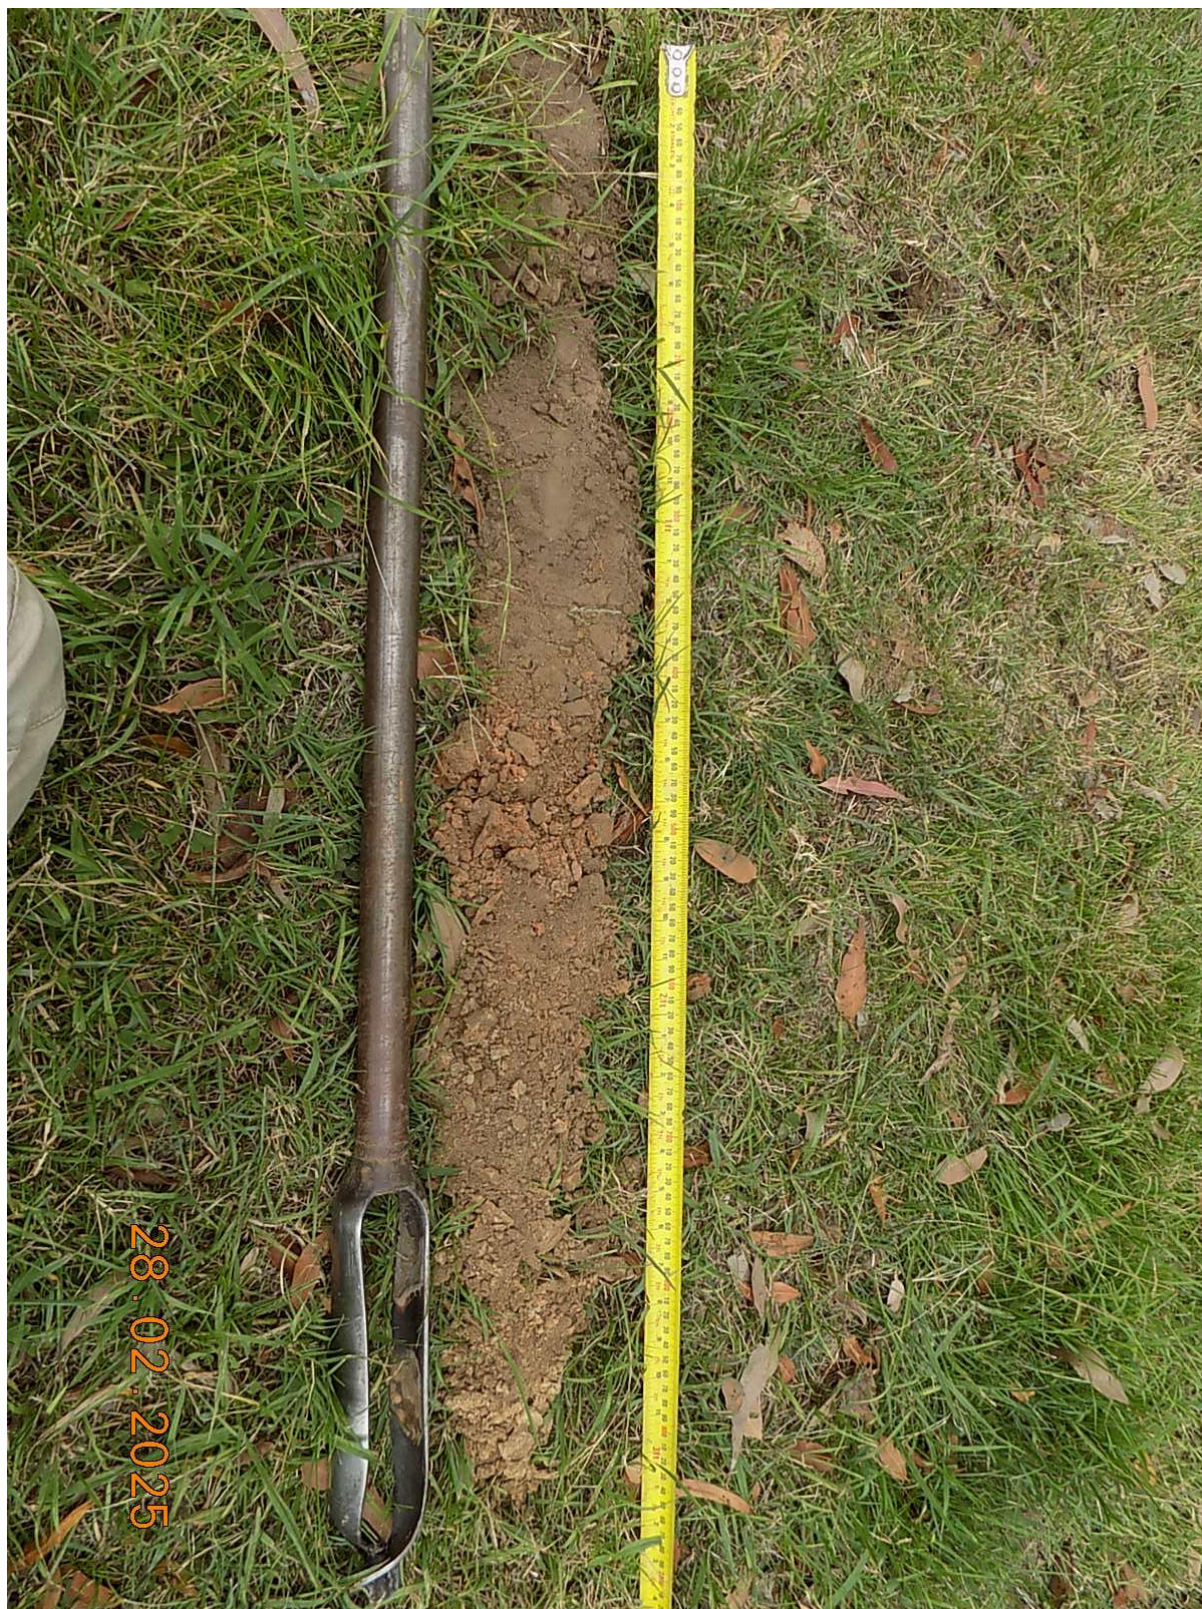
Photo 11

#### AUGER HOLE 1 (~RL8.1) – AH1 (Photo 11)

| Depth (m) | Material Encountered |
|---|---|
| 0.0 to 0.4 | <b>TOP SOIL</b> , silty loam, brown, Medium Dense to Dense, dry, fine to medium grained, red shale fragments included. |
| 0.4 to 0.9 | <b>RESIDUAL CLAY</b> – brown to maroon, Stiff, dry, fine to medium grained, mottled grey and orange shale fragments towards base of hole. |

End of test @ 0.9m. No water table encountered.

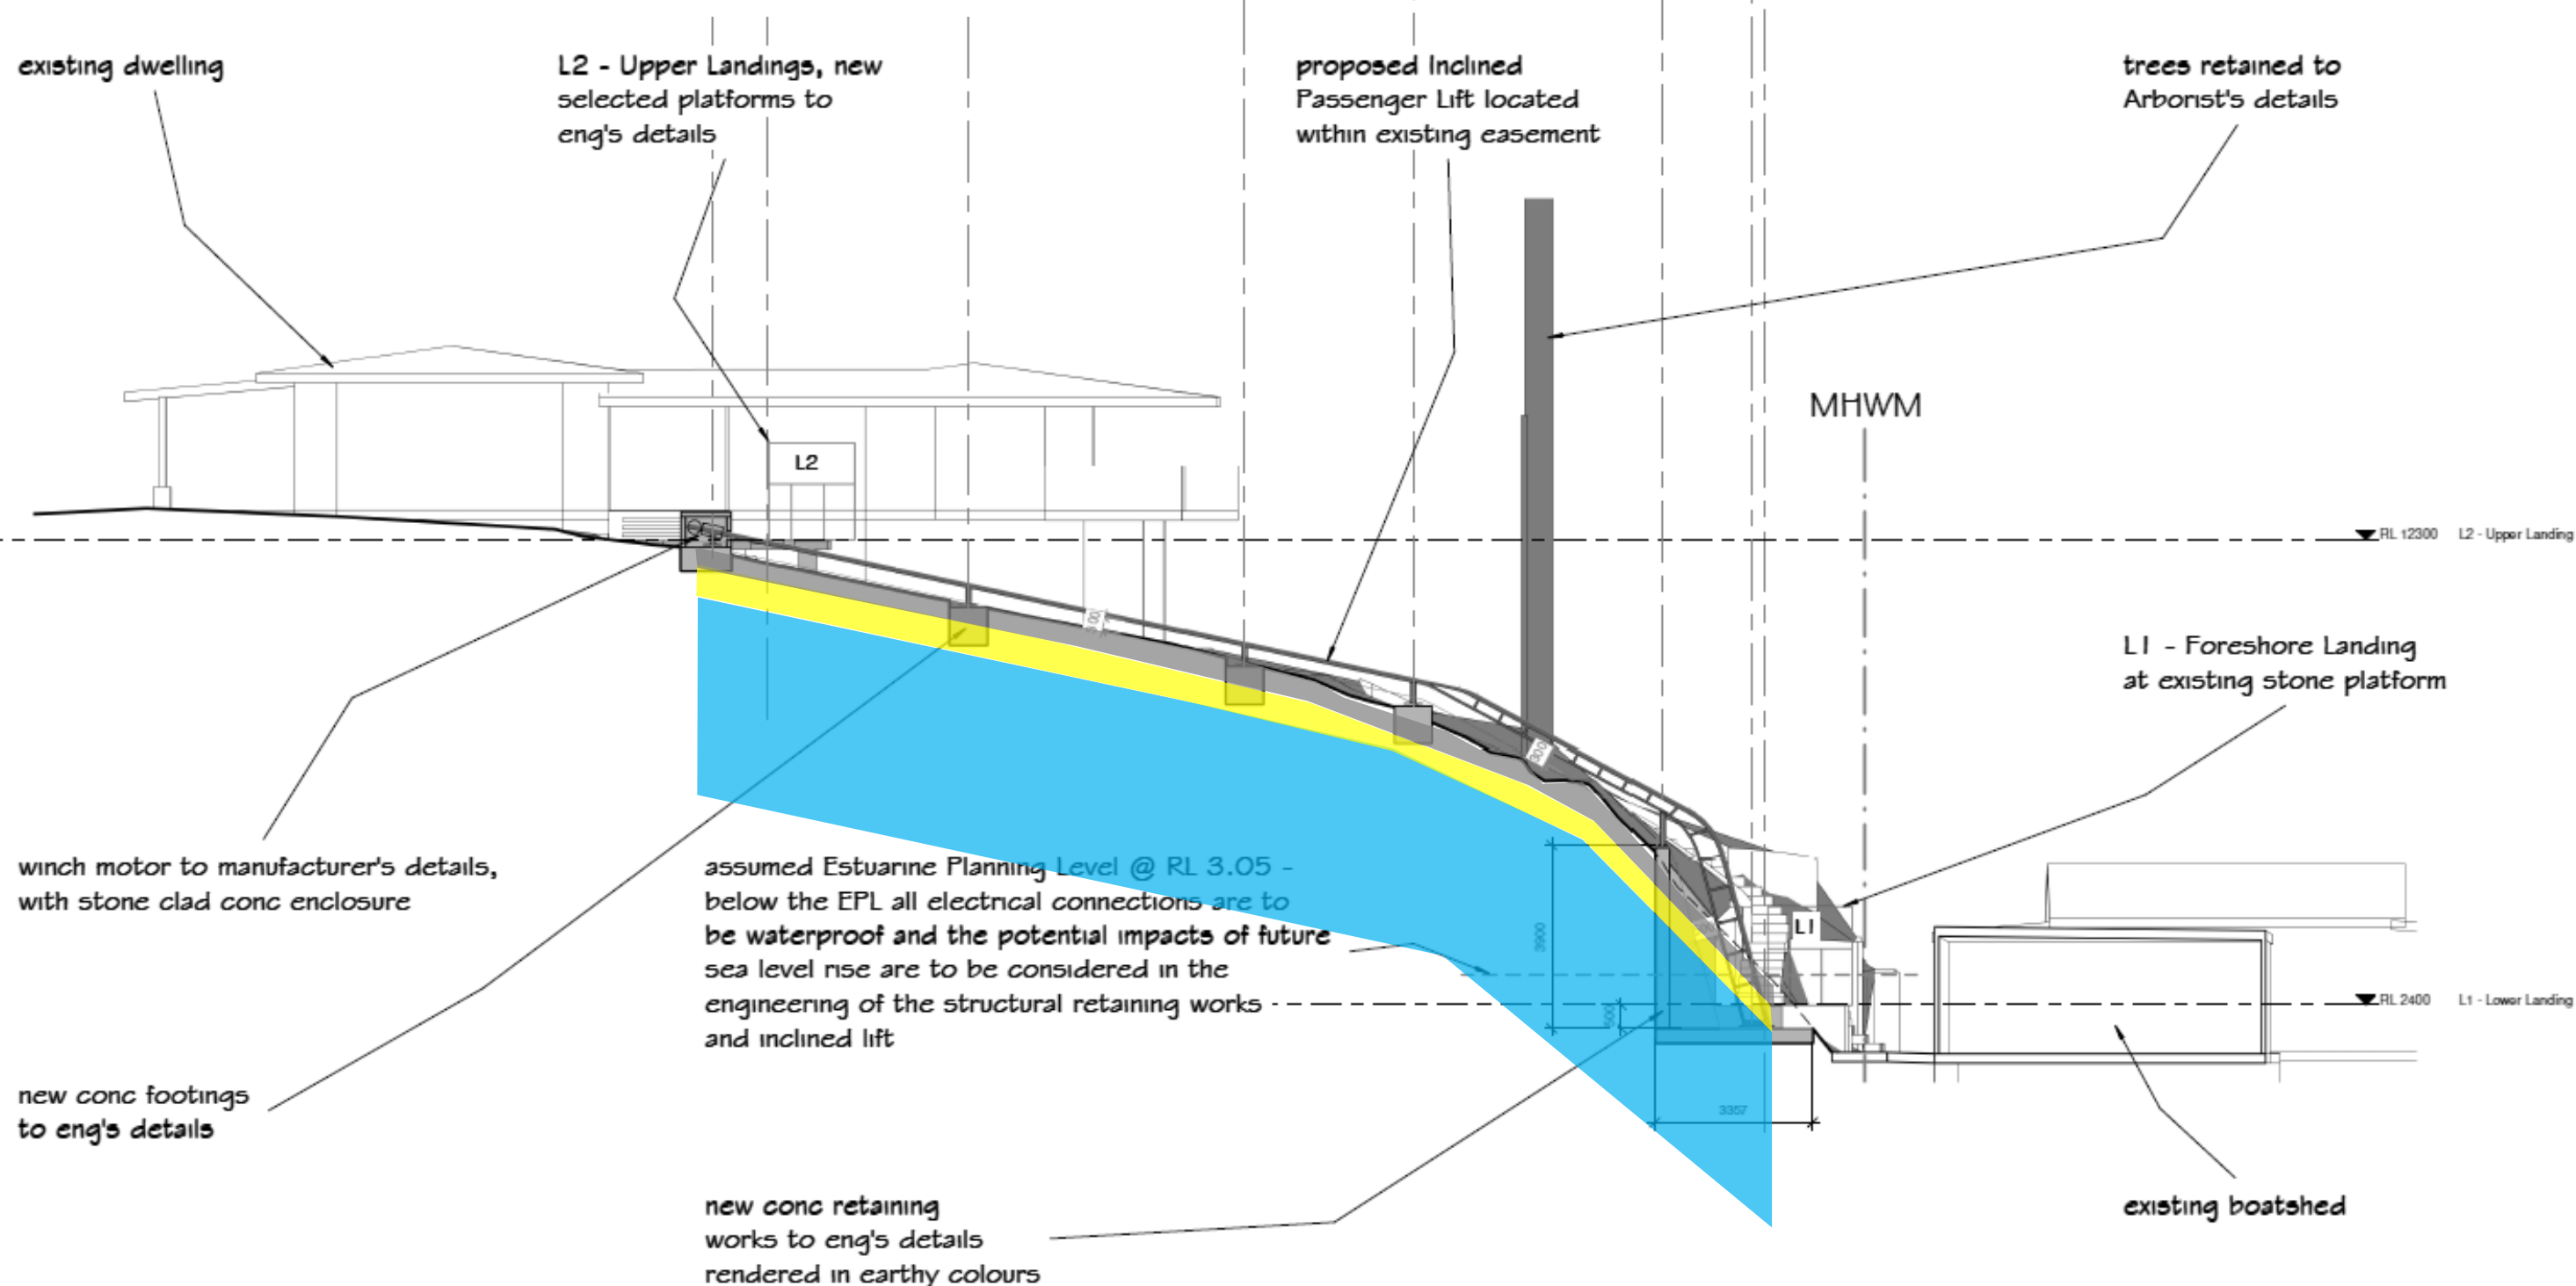
## TYPE SECTION – Diagrammatical Interpretation of expected Ground Materials

The natural slope materials are colluvial at the near surface and residual at depth. In the test locations, the ground materials consist of at least 0.4m of topsoil which is expected to overlie residual clays. The clays merge into the weathered zone of the underlying shale at depths of between 0.6m to 1.2m below the current surface, being deeper due to a variable weathering

profile. The weathered zone is interpreted as Extremely Low to Very Low Strength Shale. See Type Section attached for a diagrammatical representation of the expected ground materials.

- Topsoil
- Clay
- Narrabeen Group Rocks – Extremely Low to Very Low Strength Shale.
