#### **DILAPIDATION REPORT**

#### **COUNCIL ASSETS**

# 16 SUMMIT AVENUE, DEE WHY

**Job No 621**

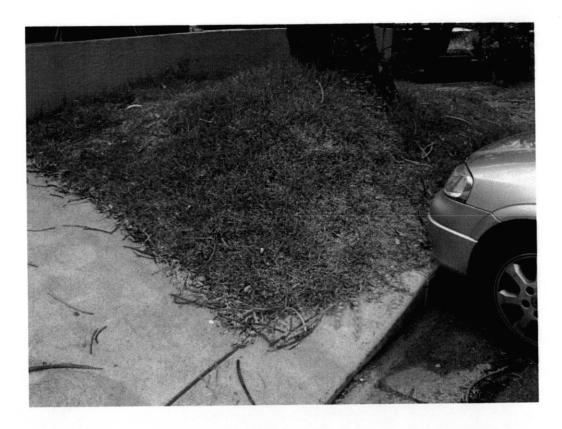
**PHOTO 15**

5.04	The lawn within the nature strip extending from the kerb to the street boundary is in poor condition. There is a large tree lifting the existing terrain. See Photos 15 to 18

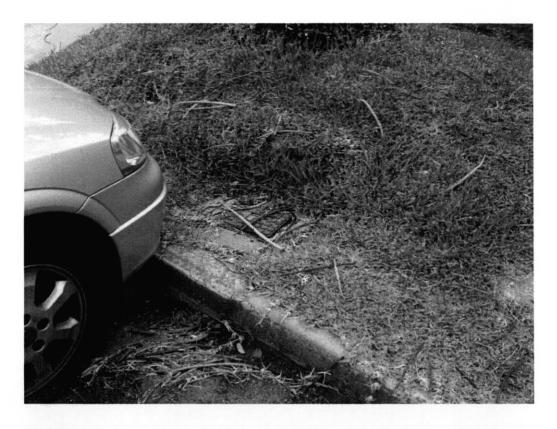
**PHOTO 17**

5.05	There are several concrete pads in the lawn area south of the existing tree in the nature strip which is in poor condition. See Photos 17 & 18
	The Hydrant lid is in reasonable condition but does not close properly. See Photo 36

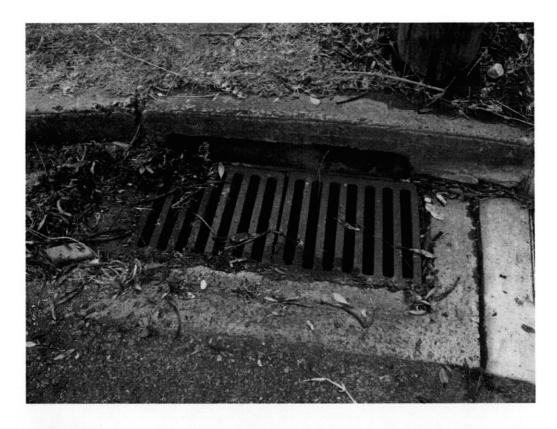
**PHOTO 19**

5.06	The lids to the grated drains in the gutters, along the southern side of the subject property are in reasonable condition. See Photos 19 & 20.
6.00	STREET TREES

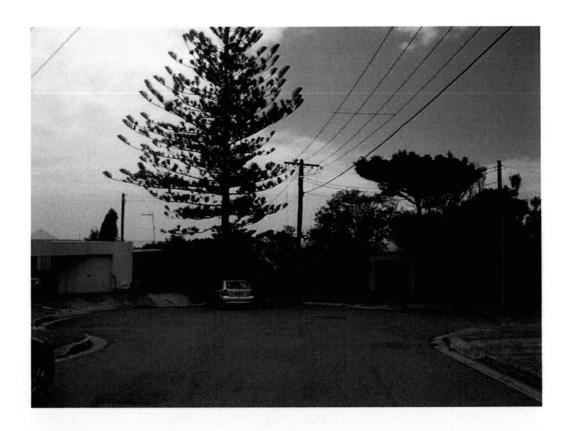
**PHOTO 1**

- 3.01 Summit Avenue is approximately 9 meters wide.
- 3.02 Summit Avenue has a standard bitumen covering and is generally in poor condition. It varies significantly in levels with quite noticeable uneven surfaces.

See Photos 1 to 5.
- 3.03 The road has tyre marks in several areas. See Photos 1 to 5.

7.02	There are no street signs in the vicinity. See Photo 1
8.00	CONCLUSION
8.01	Council Assets in the immediate vicinity of 16 Summit Avenue, Dee Why are generally in poor condition with the photos showing each asset as of 15 January 2008
	A REDUCED A4 COPY OF THE SUBJECT AREA SITE SURVEY PREPARED

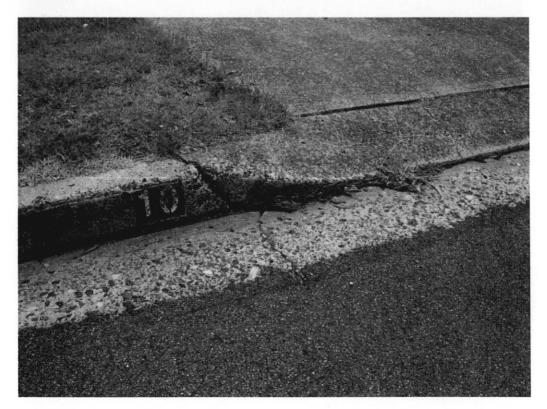
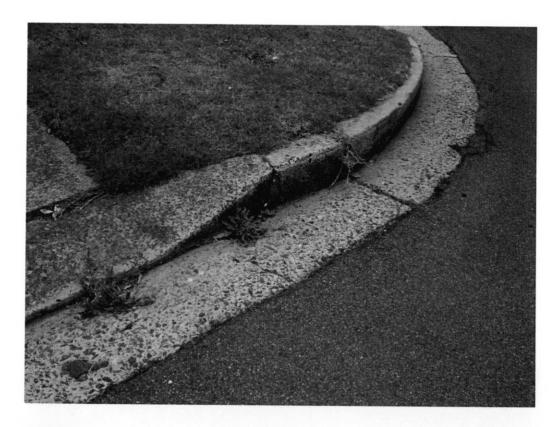
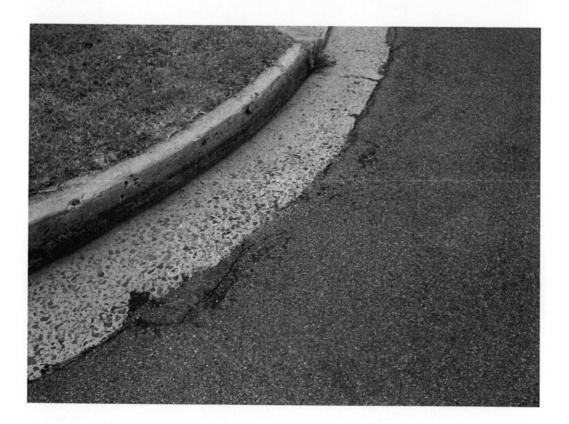
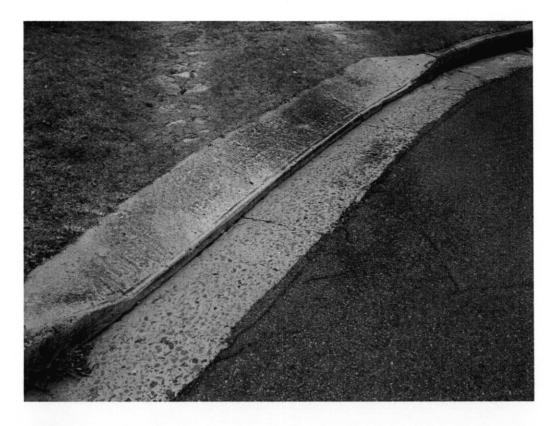
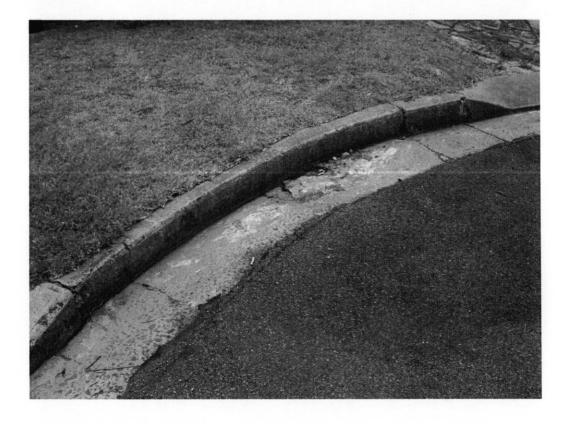
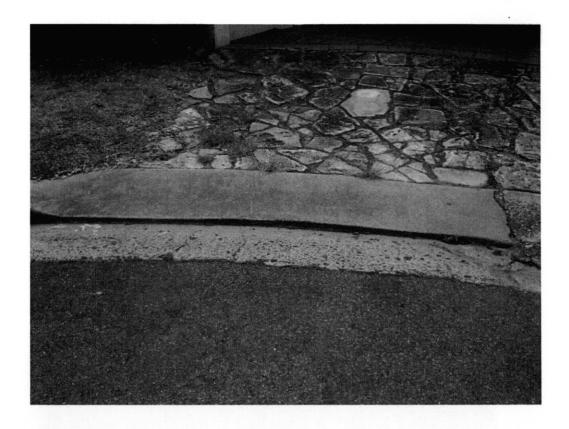
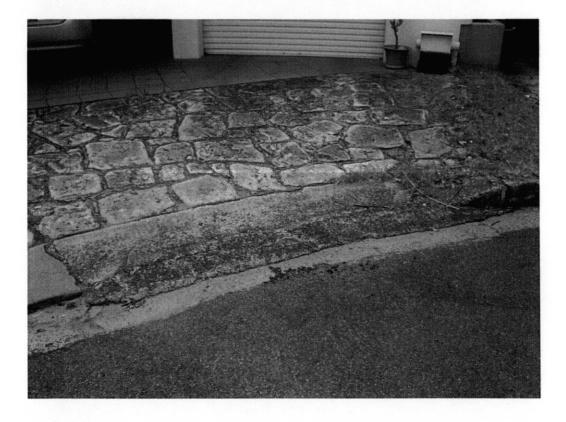
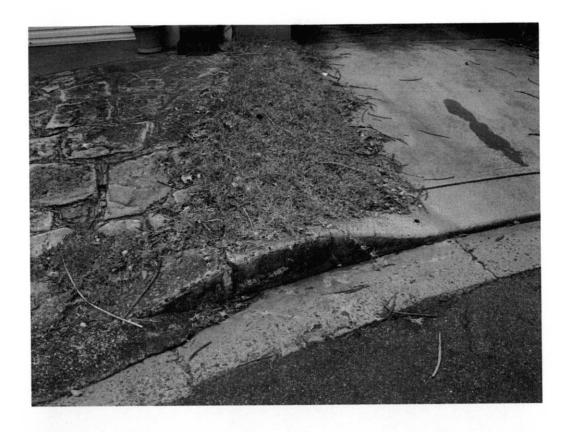
- 4.01 A small concrete kerb with exposed aggregate separates the roadway from the nature strip.
- 4.02 The kerb is broken in numerous areas along its length and is in poor condition. See Photos (majority)
- 4.03 Numerous small sections of the kerb have broken away. See Photos 6 to 28.
- 4.04 There is an existing concrete gutter between the roadway bitumen against the kerb which is generally in poor condition

See Photo 6 to 28.

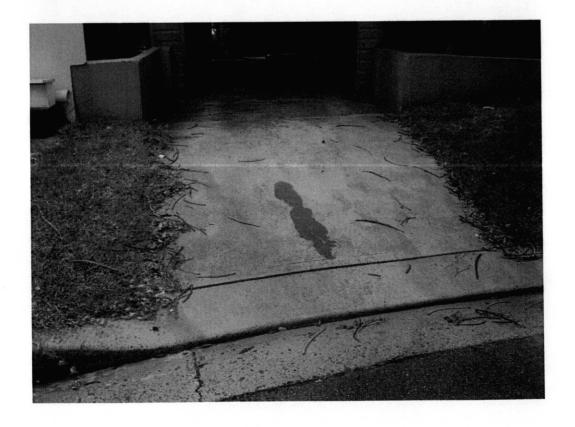
**PHOTO 14**

5.00	FOOTPATH & DRIVEWAY
5.01	No concrete footpath extends across the frontage of the property. There is a concrete driveway and crossing (approximately 2.7m wide) which provides vehicular access to the weatherboard clad garage on the site which is in reasonable condition.  See Photo 14

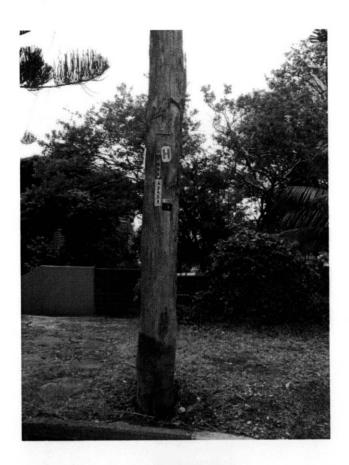
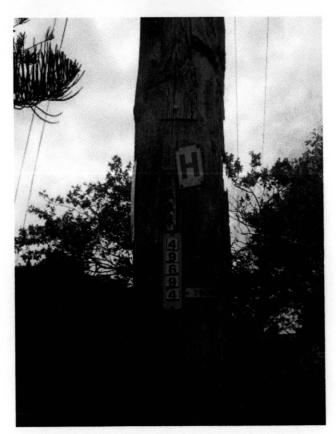
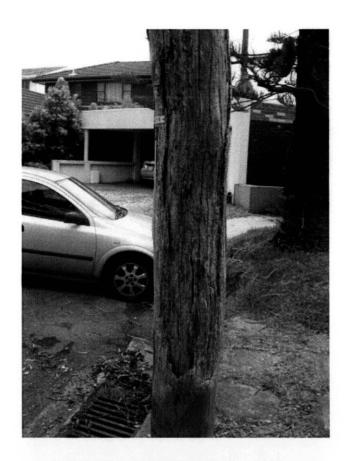
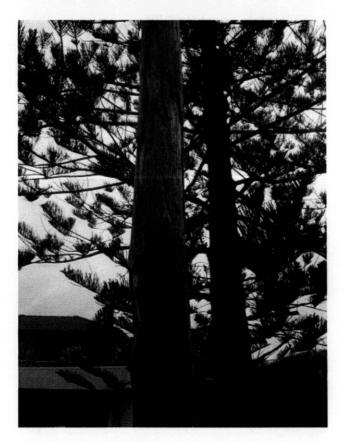
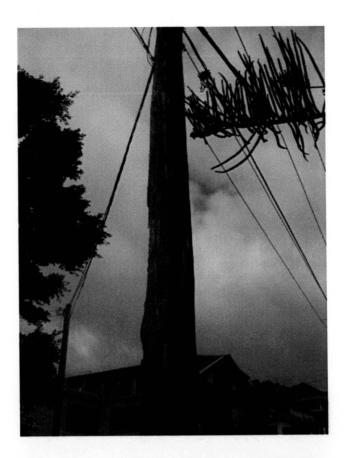
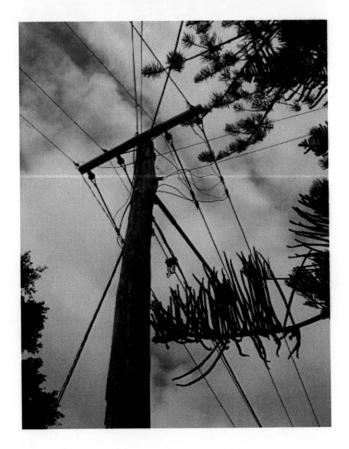
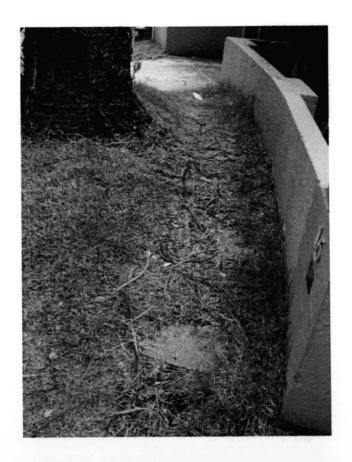
7.00	STREET SIGNS AND OTHER COUNCIL ASSETS
7.01	There is an existing power pole located on the south western corner of the subject nature strip which is in poor condition. See Photos 29 to 35
