# Arboricultural Impact Assessment Report

Mr Ray Balcomb  
At  
83 - 85 Bower St, Manly

Glenice Buck

5th March 2021

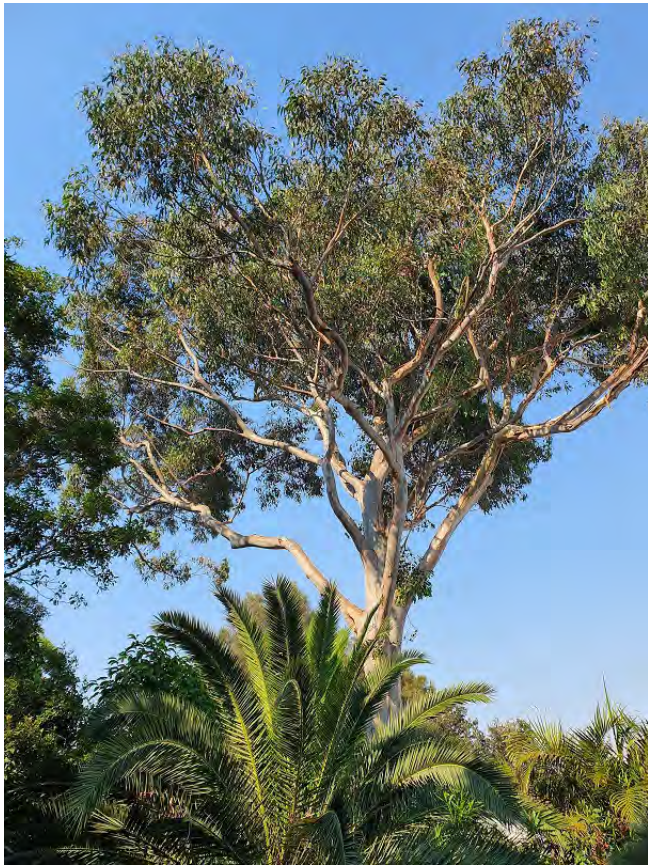
Figure Two - An overall image of Tree 1.  
Viewed from eastern side.

There are eight (8) subject trees we refer to in this report. Tree 1 is a mature *Eucalyptus saligna* (Sydney Blue Gum) which overall is in good condition and has signs of good vigour. There are some signs of hollow formation on the lowest first order branch on the southern side of the tree. There is also some interconnecting branch contact within the canopy. It will not be affected by the proposed development. Tree 2 is a large mature, *Melaleuca quinquenervia* (Paperbark) which is in good health and condition with signs of good vigour. The proposed landscape plan is to maintain the existing lawn through this area. The steps accessing this space will partly be within the TPZ of this tree. This should have little to no impact on Tree 2.

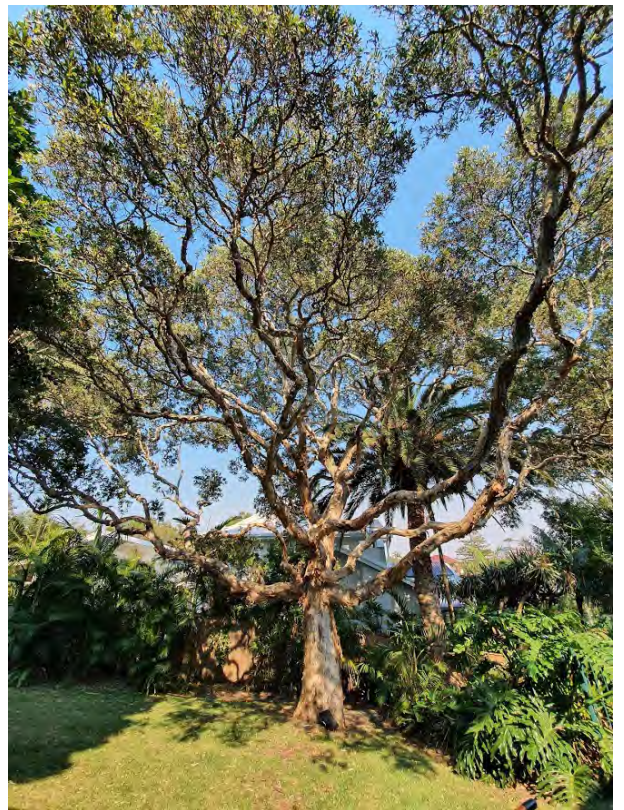
Figure Three - This image shows the overall of Tree 2 viewed  
from eastern side. This tree is in good health and condition.

Trees 2 and 5 should both have either tree protection fencing or trunk protection (as per clause 5.2.0 Tree Protection) installed prior to works commencing. This protection shall remain on the trees until works have been completed on site. Tree 3 is growing on a significant northwesterly lean. Its lower trunk is also enveloping the pathway adjacent to the trunk. This pathway could not be removed without risking the tree's stability. Due to these two (2) factors we would recommend its removal.

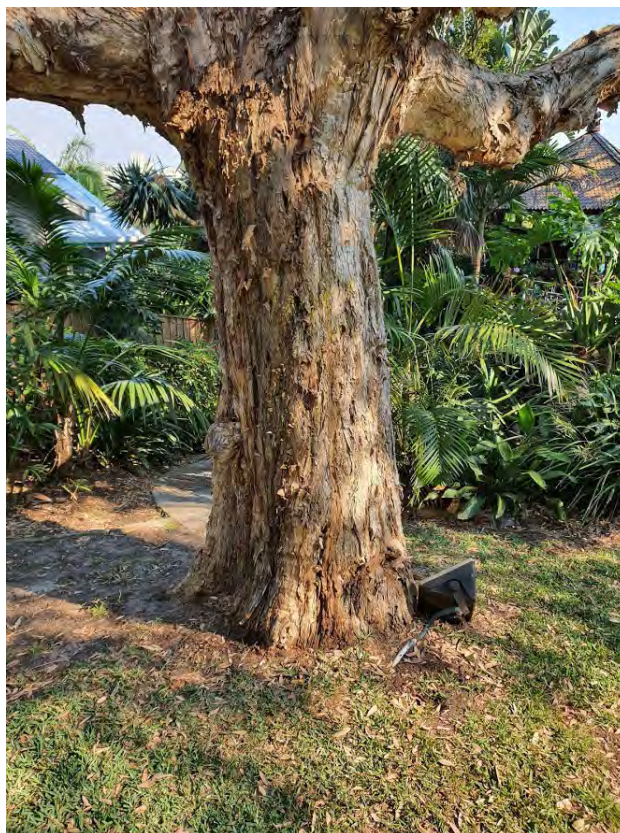
Figure Four - This image shows the base of the trunk of Tree 2  
It is growing within the lawn area.

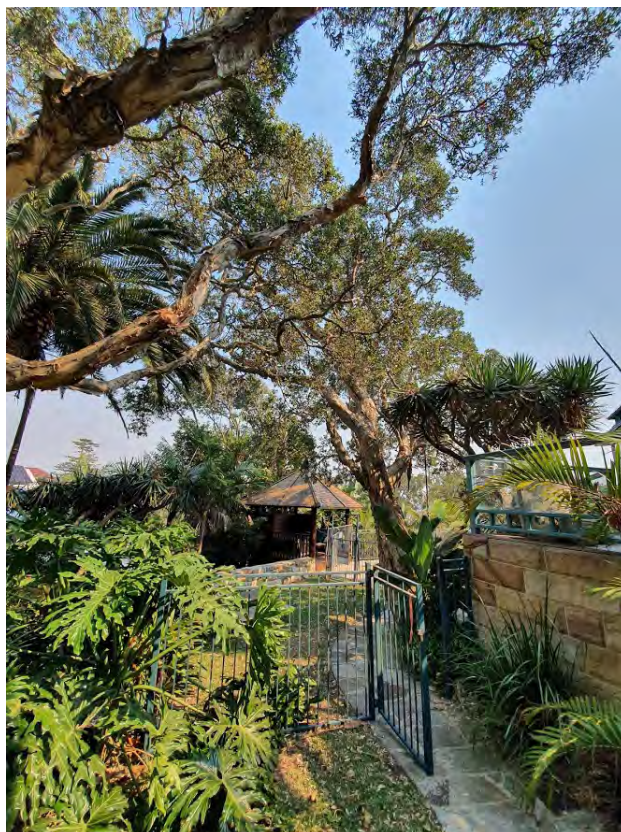
Figure Five -This image shows Tree 3 viewed from southern side. This image also shows Tree 8 on right hand side of the image.

Tree 8 is growing in close proximity to Tree 3 - we would recommend that this tree is relocated. Please refer to the Transplant Method Statement in Appendix 8. Tree 5 and 6 are both poor specimens with low retention values we would recommend that they are removed. Due to their closeness to the neighboring property they are exempt from requiring permission from Council for removal.

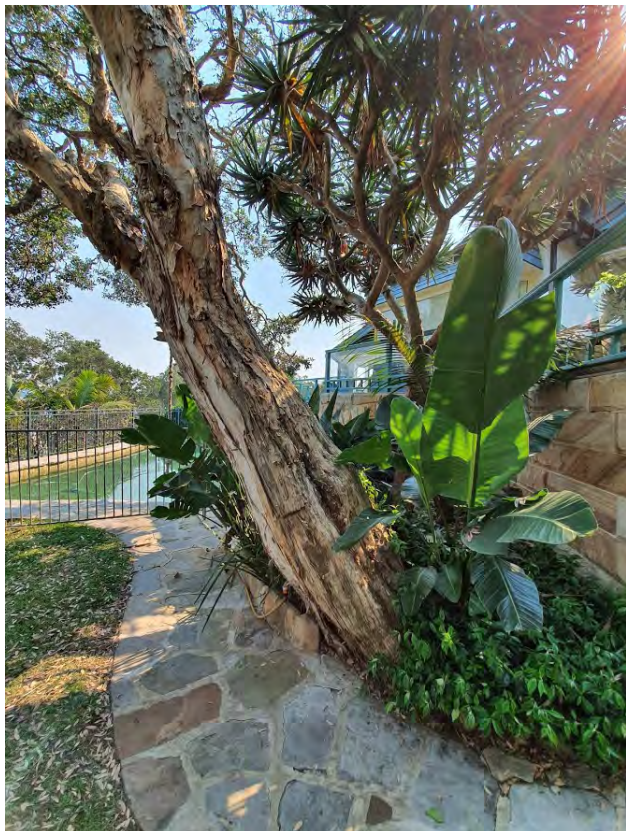
Figure Six -This image shows the base of the trunk of Tree 3 viewed from southern side . This image also shows the lean on the main trunk and how it is growing over the pathway.

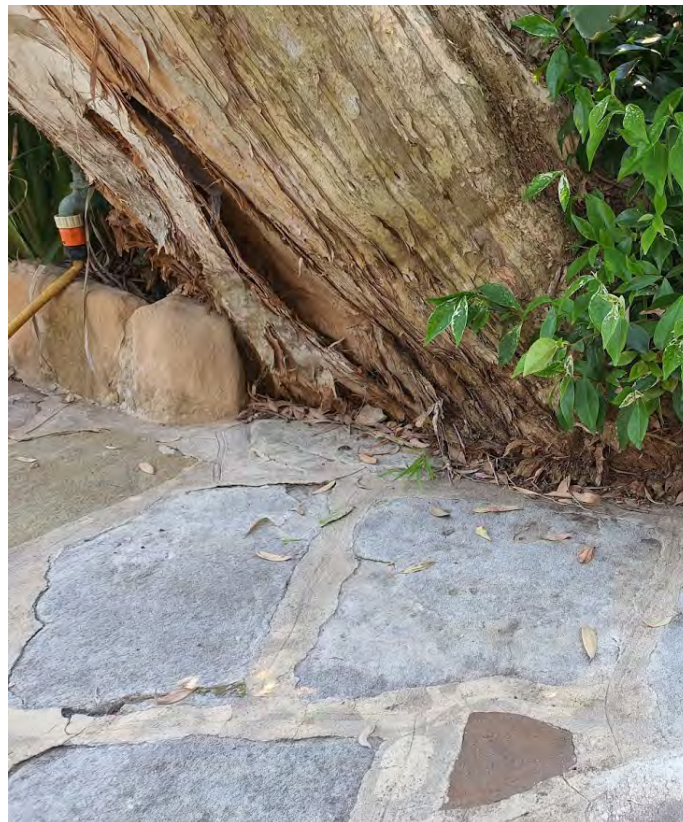
Figure Seven -This image shows the close up of the base of the trunk of Tree 3 viewed from western sde. We are unsure how reliant this trunk is on the existing pathway for support.

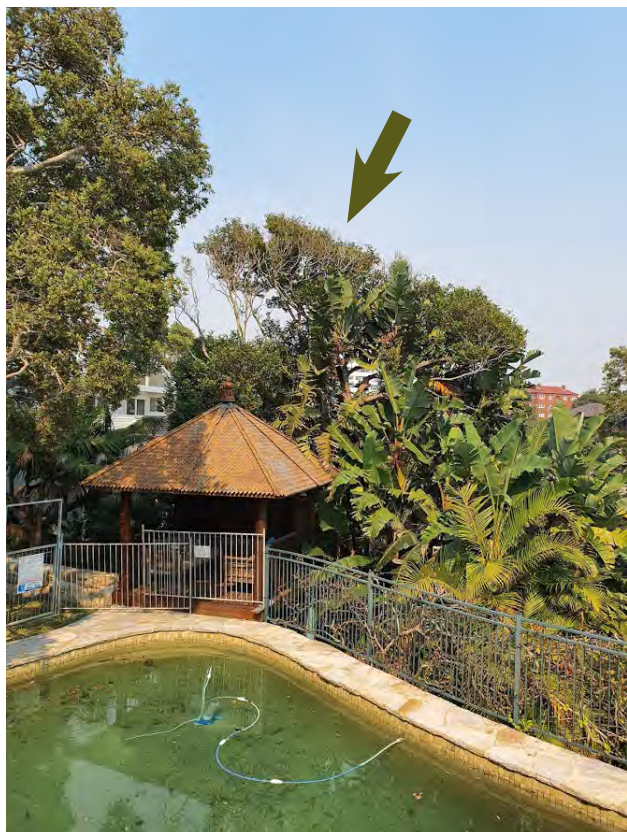
Figure Eight - This image shows Tree 4 viewed from north eastern side.

Tree 4 is a *Glochidion ferdinandi* (Cheese Tree) it is a co-dominant trunked tree which has had some significant pruning over time mainly focused on the neighbour's side of the tree. There are signs of decay in the northern co-dominant stem which should be monitored. The proposed development will have very little impact on this tree.

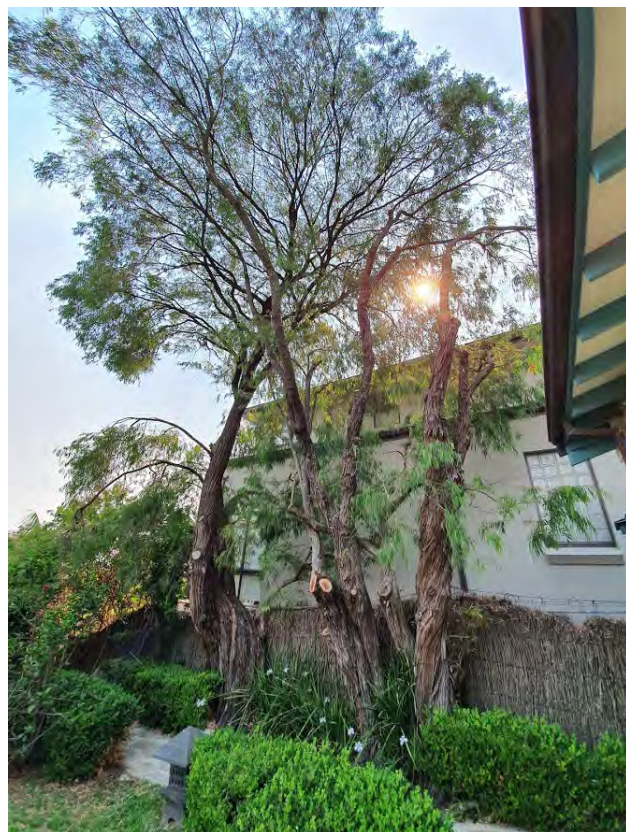
Figure Nine - This image shows Trees 6 and 5 viewed from western side (from left to right).

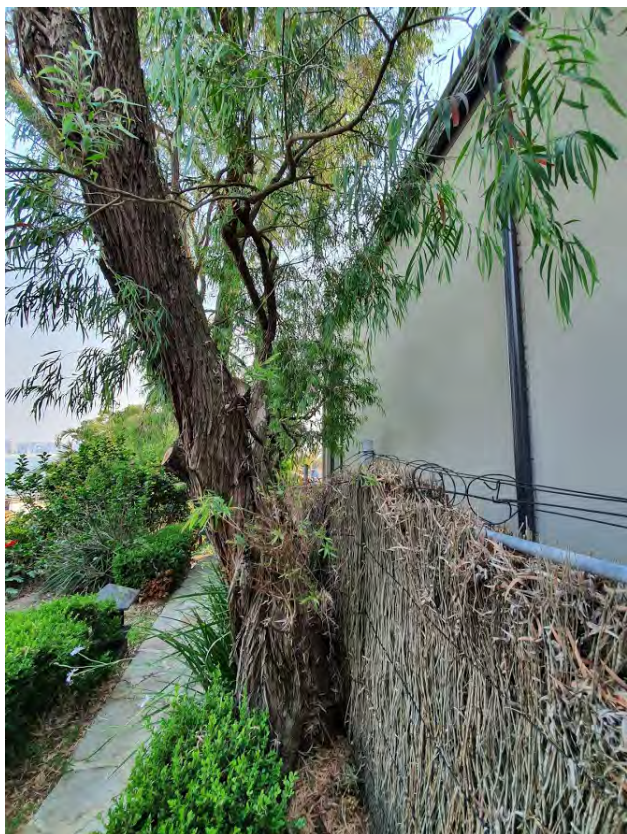
Figure Ten - This image shows the closeness of the trunks of Tree 5 and 6 to the neighboring property. Viewed from southern side.

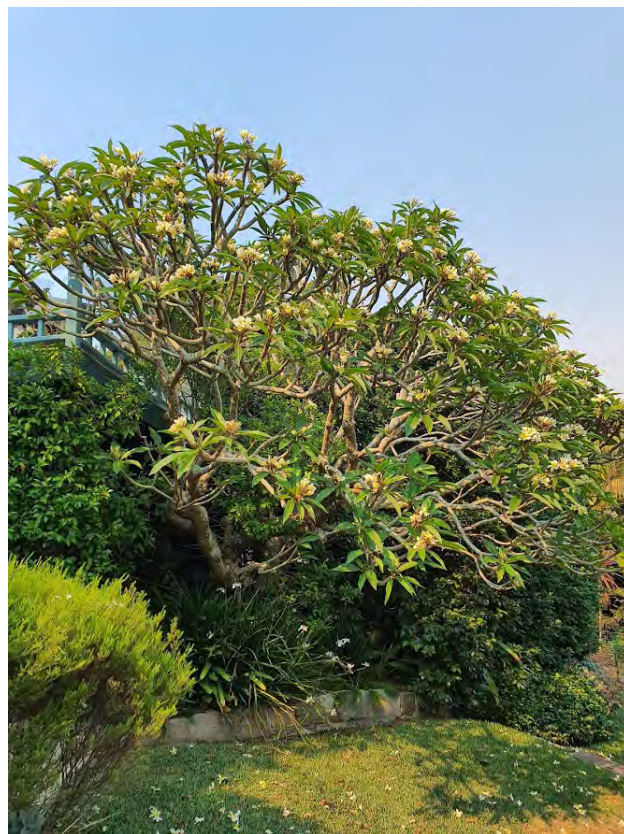
Figure Eleven - This image shows Tree 7 viewed from northern side.

Tree 7 is a mature *Plumeria* (Frangipani) which is in good condition and has good form and signs of good vigour. The proposed development in this area is to construct a veranda where this tree is located. This tree will need to be removed. It is a species which will relocate to another location. Tree 8 is a mature *Dracena draco* (Dragon Blood Tree). It has good form and signs of good vigour. The proposed development will require this tree to be removed due to changes in level and the construction of stairs. We have recommended that Tree 3 be removed due to its structural stability and as they are both growing very close together we do not think Tree 3 will be able to be removed without damaging Tree 8. This tree will relocate to another location.

We would recommend that Tree 7 be relocated. Please refer to the Transplant Method Statement in Appendix 8. If these trees are removed we would recommended that replacement trees are planted out in alternate locations. Ideally these trees should be indigenous or native as per Council's list of recommended species.
