J4772. 6th February, 2023. Page 1.

GEOTECHNICAL INVESTIGATION:

New Duplex at 6 Neild Avenue, Balgowlah

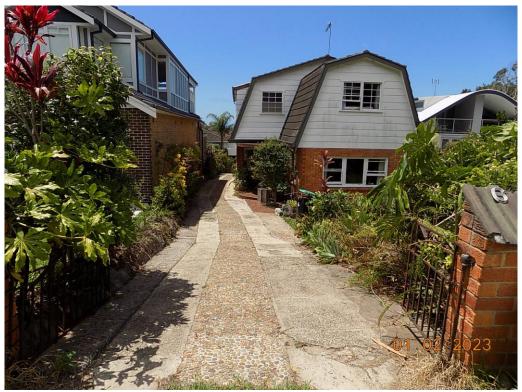
Photo 1

- 2.3 At the road frontage, a brick and concrete driveway runs down the slope past the N side of the house to a brick garage on the downhill side of the property (Photos 1 & 2). The part three-storey brick house is supported on sandstone block and brick walls, and brick piers (Photo 3). The supporting walls show no significant signs of movement and the visible brick piers appear to stand vertical. A cut has been made for the basement level of the house. The cut has been taken through competent Medium Strength Sandstone bedrock and displays no signs of geological defects (Photos 4, 5 & 6). A fill has been placed on the SE corner of the property for a level area (Photo 7). The fill is supported by a stable brick wall ~0.5m high. All the existing structures on the property will be demolished as part of the proposed works.

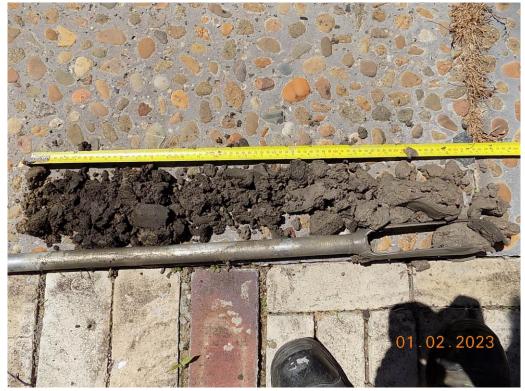
AUGER HOLE 1 (~RL33.1) – AH1 (Photo 8)

Depth (m)	Material Encountered
0.0 to 0.2	FILL , disturbed clayey sand, dark brown & yellow, medium dense, damp, medium grained with fine trace organic matter.
0.2 to 0.5	CLAYEY SAND, dark brown, loose, damp, medium grained.
0.5 to 0.7	CLAYEY SAND, grey-brown, medium dense, wet, medium grained.

Refusal @ 0.7m. Auger grinding on the rock surface. No water table encountered.

Photo 8 (AH1 - Downhole from Left to Right)
