## 48 Tatiara Crescent, North Narrabeen

Geotechnical Comments for Section 96.

## **GEOTECHNICAL INVESTIGATION:**

### **Alterations & Additions and Secondary Dwelling at 48 Tatiara Crescent, North Narrabeen**

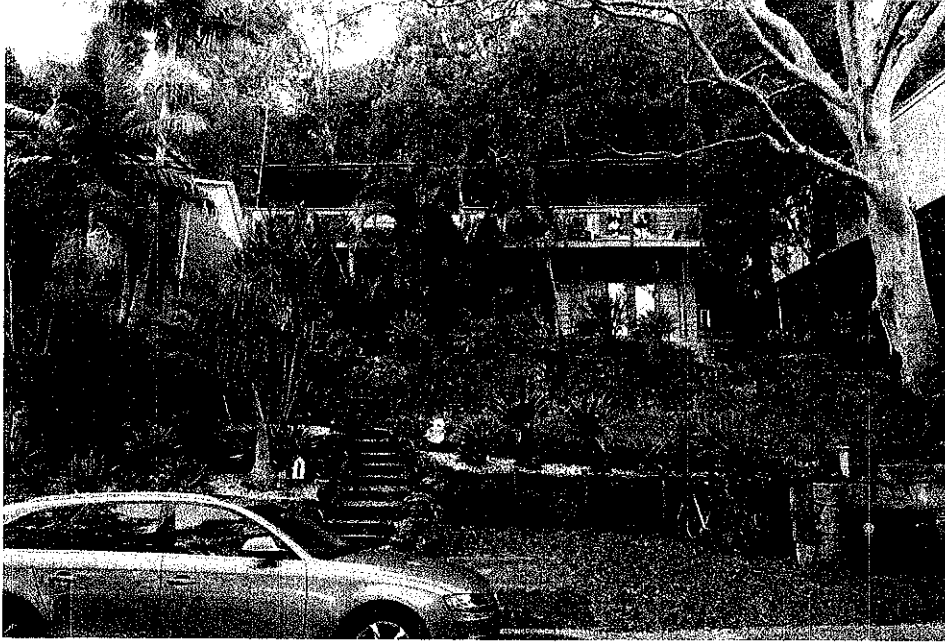
Photo 1

- 2.3 At the road frontage a gravel driveway runs to car parking area along the lower boundary (Photo 1). The cut for the road is supported by mortared rock and stack rock retaining walls that appear stable. The cut for the parking area is supported by a ~1.0m high treated pine retaining wall. Its supporting timber posts are tilting downhill to a maximum angle of ~5° (Photo 2). A cut and fill has been made into the slope to create a platform for the house. The fill batter below the house is supported by a mortared rock retaining wall that appears stable (Photo 3). The majority of the cut is through competent medium strength sandstone (Photo 4). The shallow soil and clay portions are slightly battered uphill and appear stable (Photo 5). The two storey brick and timber framed and clad house is in good condition for its age. No significant cracking or movement was observed in its external supporting walls. A concrete drainage channel has been cut into the sandstone and extends across the uphill and W sides of the house. It directs surface water from

All retaining walls on the property are to be inspected for new movement on an annual basis or after prolonged heavy rainfall, whichever occurs first by the owners of the subject property (Photo 1 & 2). Should further movement be observed a geotechnical professional is to be engaged to assess the movement and provide a plan for remediation should it be required.

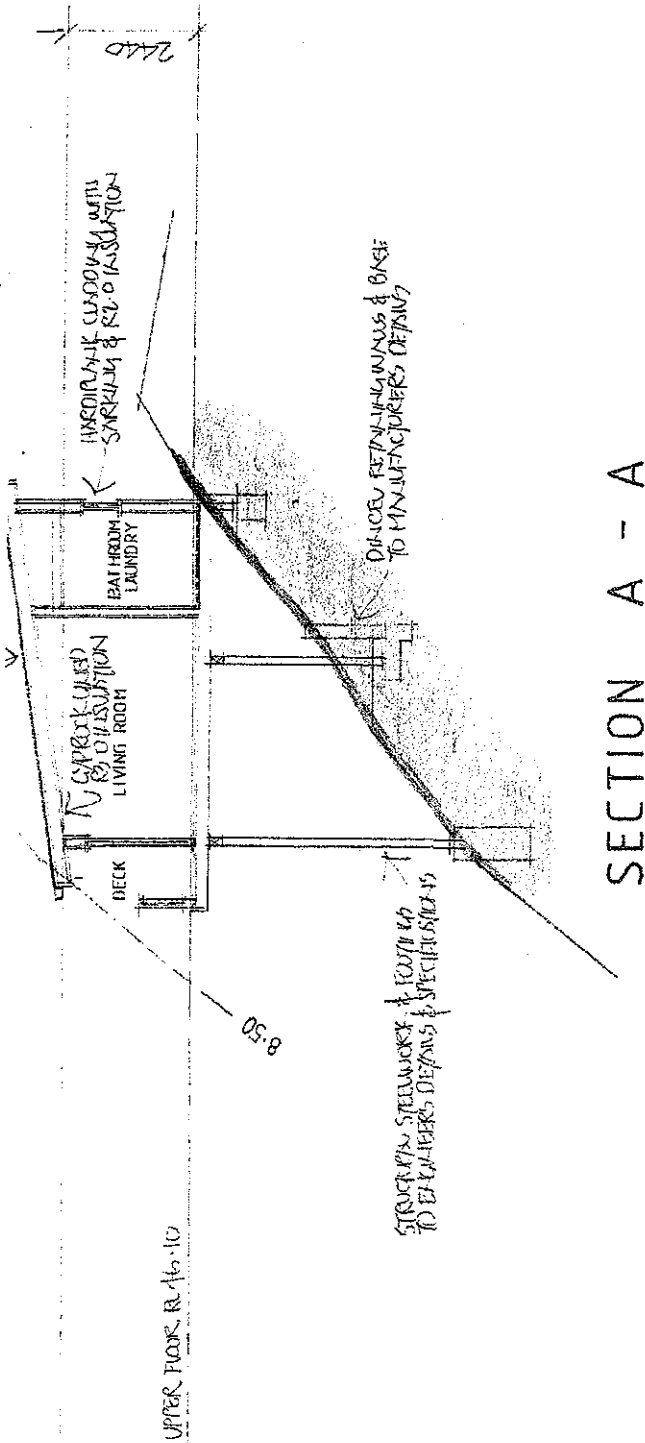
# TYPE SECTION - Diagrammatical Interpretation of expected Ground Materials

The surface features of the block are controlled by the outcropping and underlying sandstone bedrock that steps up the property forming sub horizontal benches between the steps. Where the grade is steeper the steps are larger and the benches narrower. Where the slope eases the opposite is true. Where the rock is not exposed it is overlain by manmade filling and natural sandy soils over sandy clays that cover the bench step formation. In the test locations the depth to rock ranged between 0.7 to 2.0m below the current surface, being deeper due to filling placed on the lower side of the house. The outcropping sandstone on the property is estimated to be medium strength or better and similar strength rock is expected to underlie the entire site. See the Type Section attached for a diagrammatical representation of the expected ground materials.
