## **GEOTECHNICAL INVESTIGATION:**

New House, Pool, and Rainwater Tank at **13 Morgan Road, Belrose**

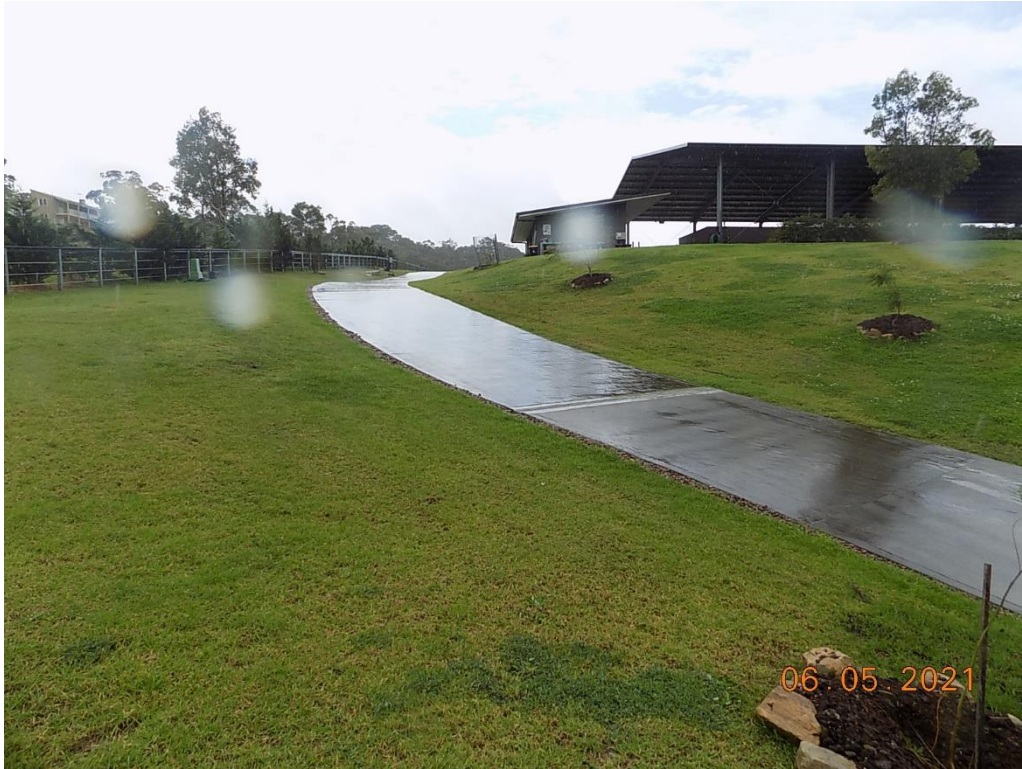
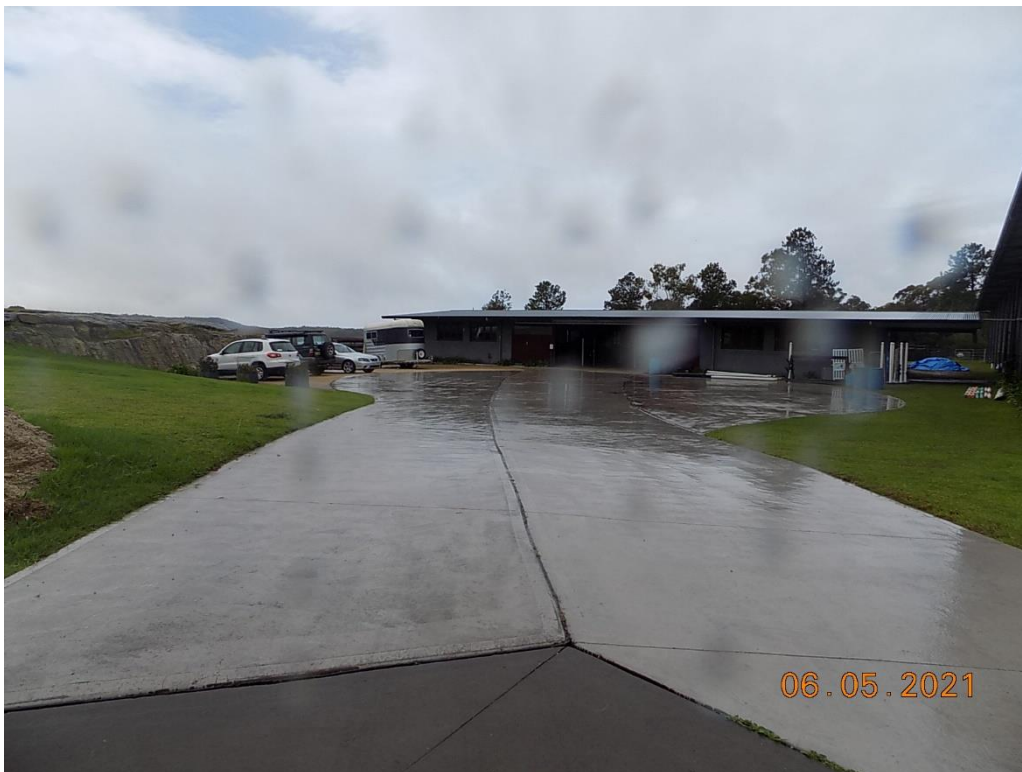
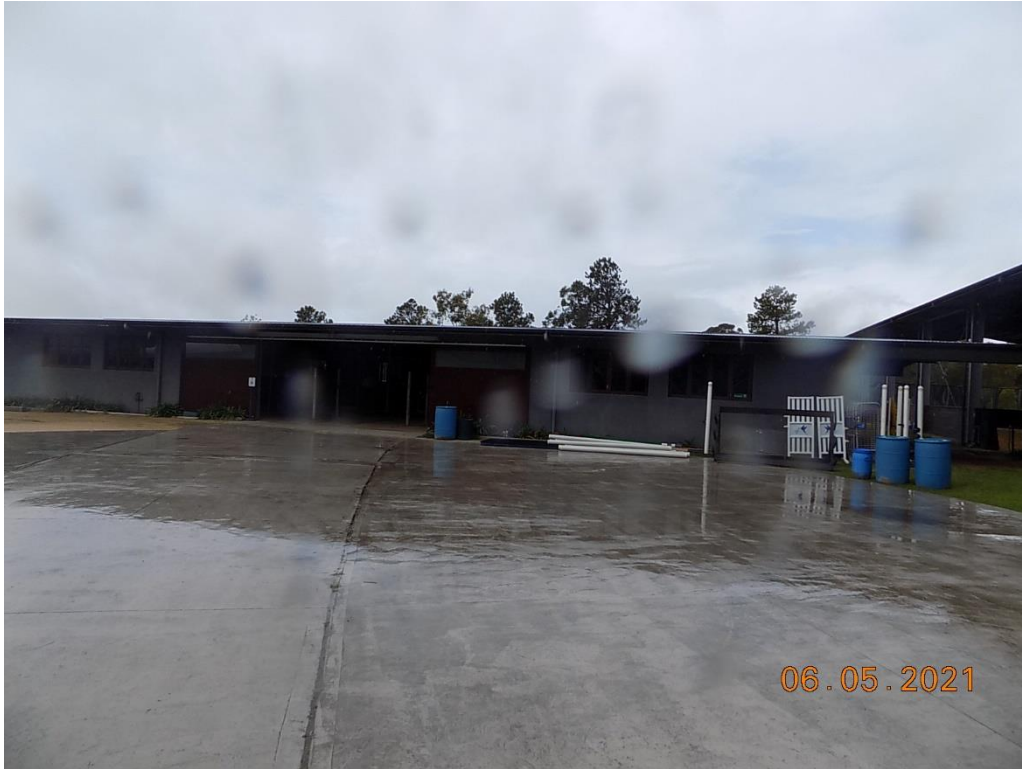
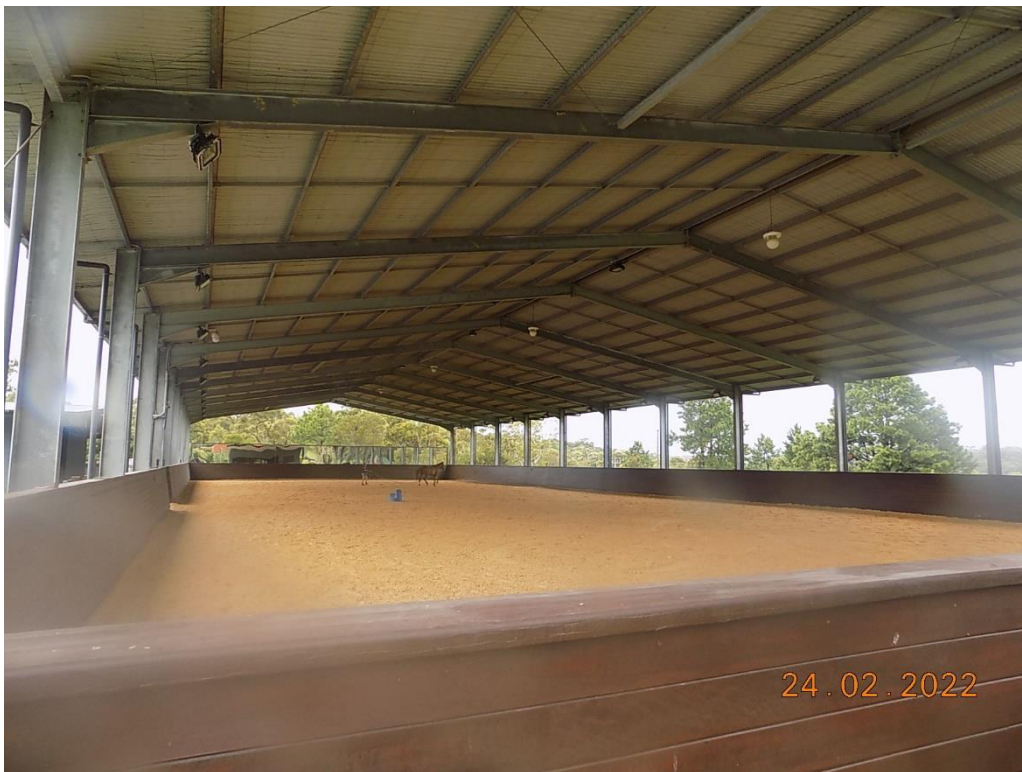
**2.3** At the road frontage, a concrete driveway runs up the slope to a parking area adjacent to a stable horse stable building and large equestrian arena with a large stable awning over (Photos 1 to 4). Another stable building has been constructed at the NW end of the equestrian arena (Photo 5). The concrete driveway continues up the slope and ends above where the house has since been demolished (Photo 6). Competent Medium Strength Sandstone outcrops between the concrete parking area and where the house was located prior to its demolition (Photo 7). An excavation has been made in the outcropping rock to level the site. The cut has been taken entirely through the sandstone bedrock and displays no significant geological defects. As such, the rock is considered stable. The demolition of the house revealed an existing excavation through the rock (Photo 8). These cut faces also display no significant signs of movement and are considered stable. The area surrounding the equestrian arena, outbuildings, and driveways mostly consists of gentle to moderately sloping paddocks (Photos 9 & 10). No signs of slope instability were observed in these paddocks.

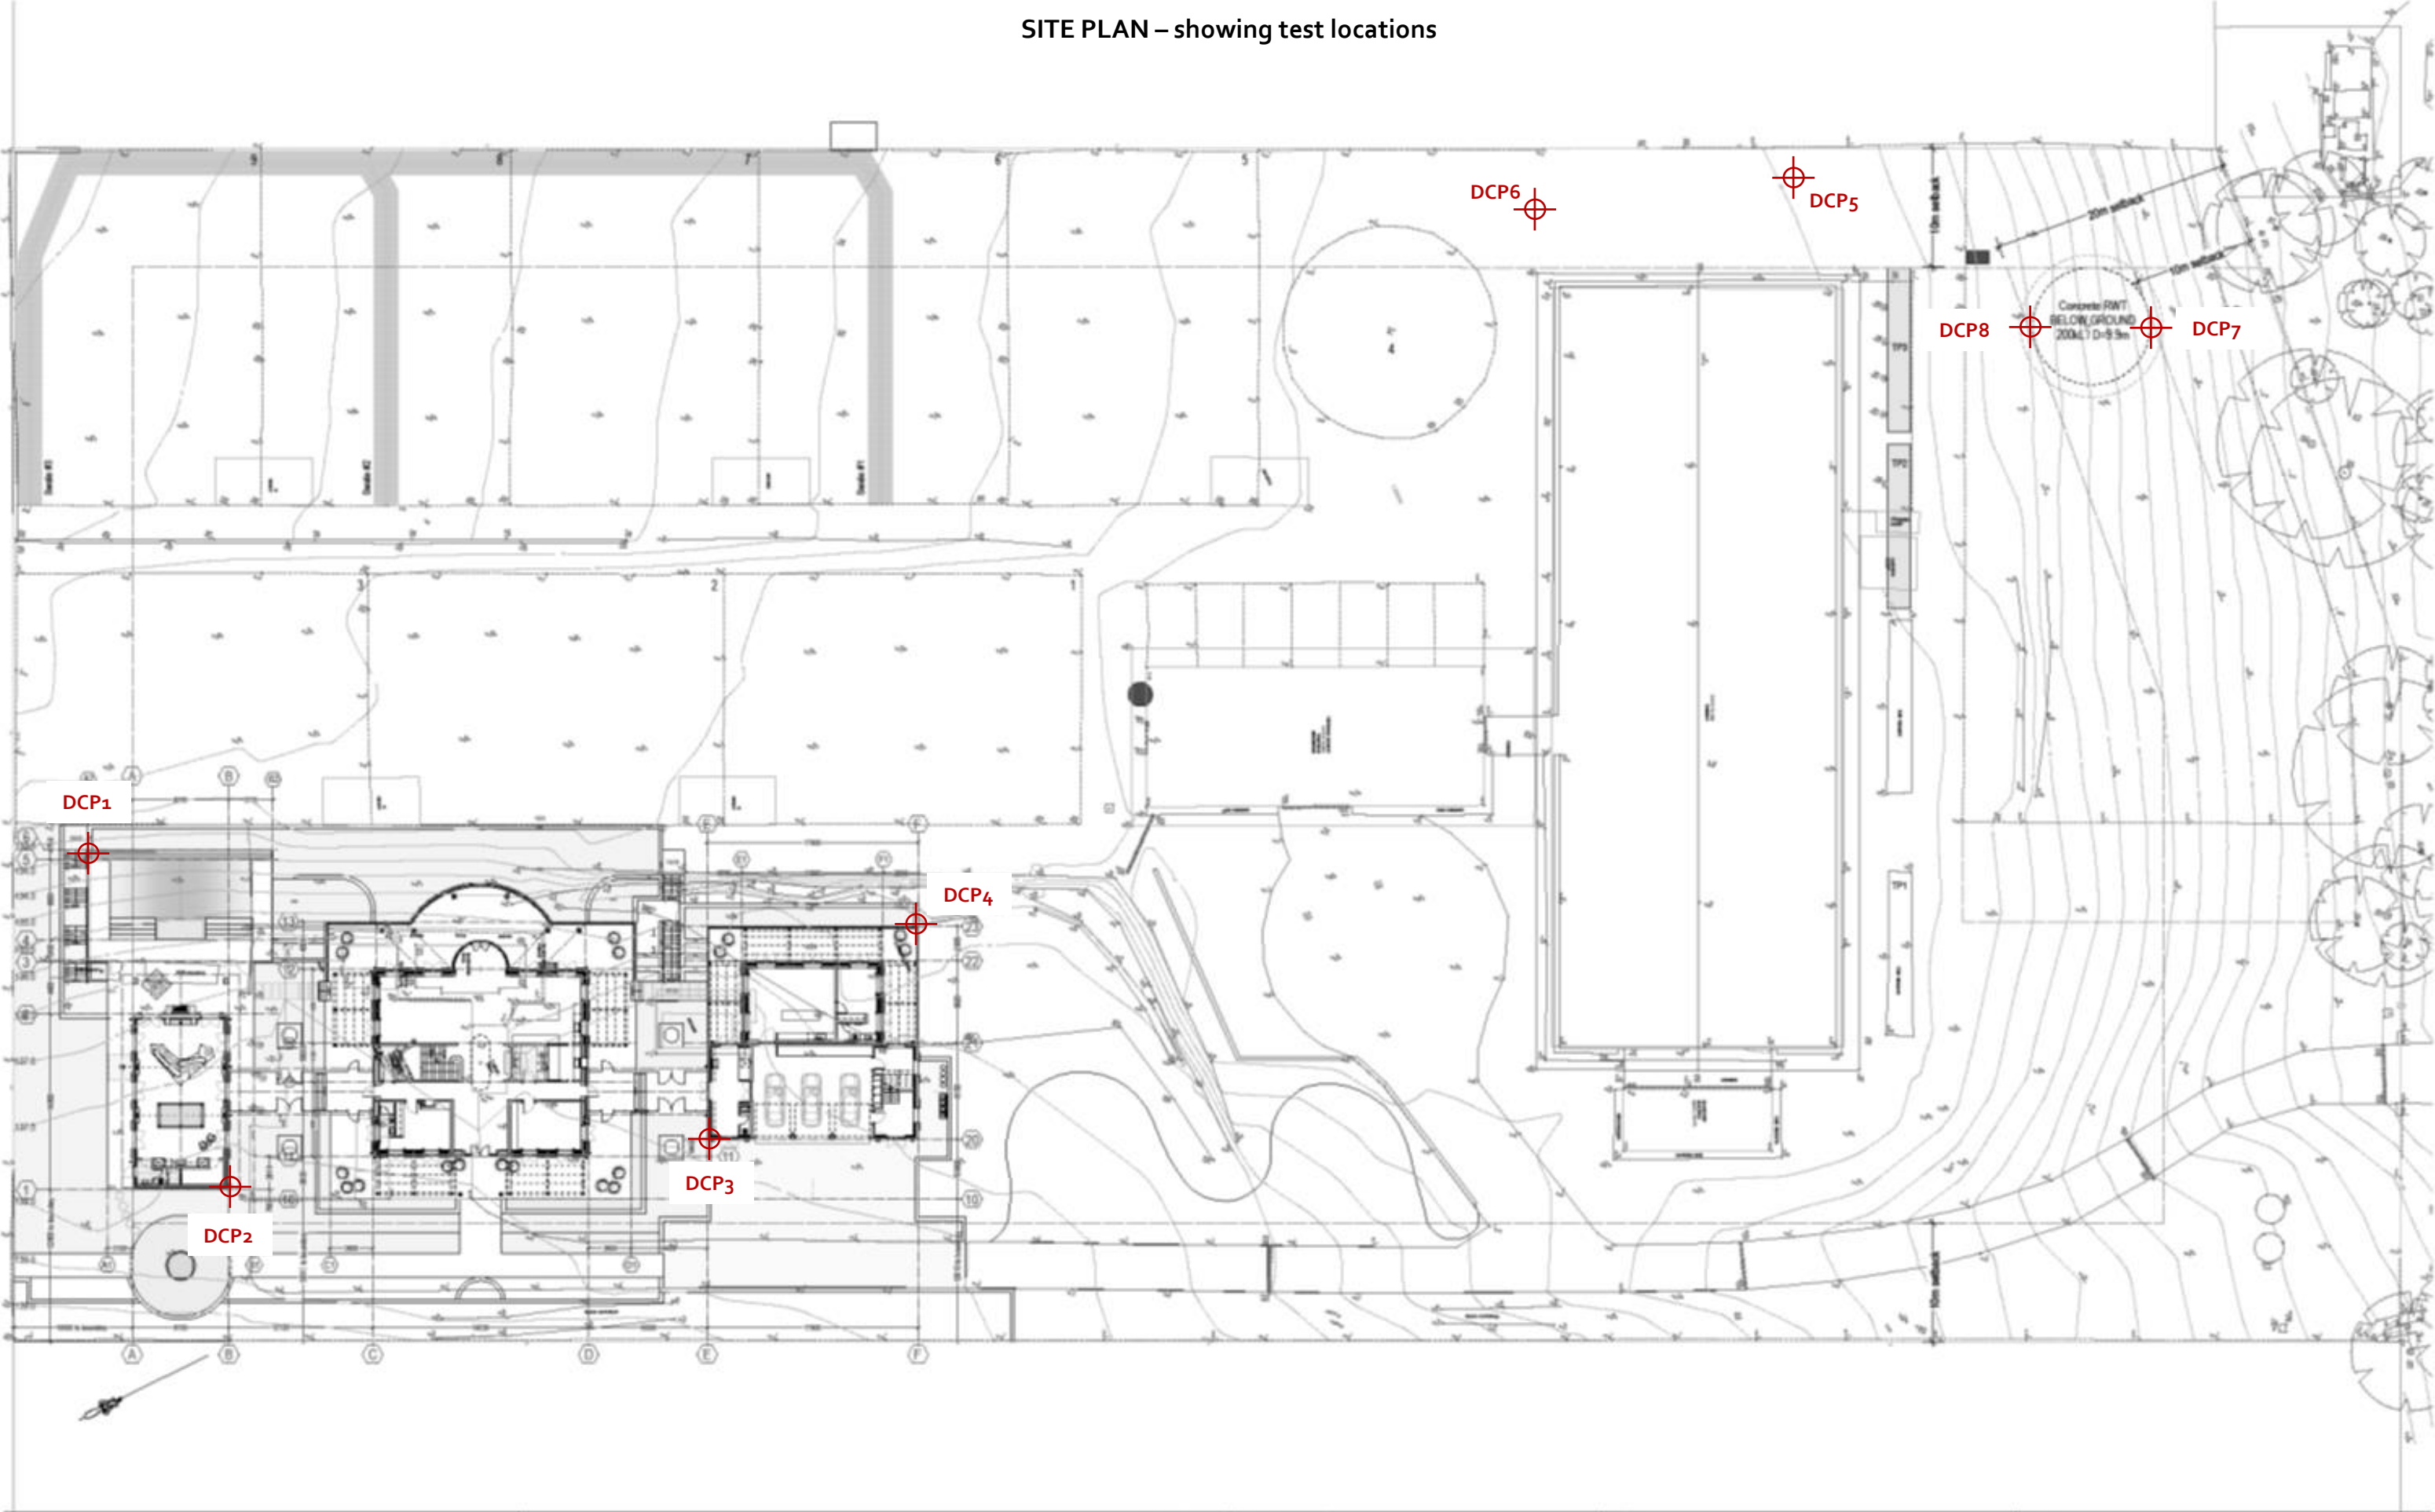
SITE PLAN – showing test locations

Eight DCP (Dynamic Cone Penetrometer) tests were put down to determine the relative density of the overlying soil and the depth to bedrock. The locations of the tests are shown on the site plan attached. It should be noted that a level of caution should be applied when interpreting DCP test results. The test will not pass through hard buried objects so in some instances it can be difficult to determine whether refusal has occurred on an obstruction in

DCP1 – Refusal on rock @ 0.5m, DCP bouncing off rock surface, wet muddy tip.

DCP2 – Refusal on rock @ 0.2m, DCP bouncing off rock surface, orange sandstone fragments on wet tip.

DCP3 – Refusal on rock @ 0.9m, DCP bouncing off rock surface, brown sand on wet tip.

DCP4 – Rock exposed at surface.

DCP5 – Refusal on rock @ 0.9m, DCP bouncing off rock surface, wet muddy tip.

DCP6 – Refusal on rock @ 0.8m, DCP bouncing off rock surface, wet muddy tip.

DCP7 – Refusal on rock @ 1.1m, DCP bouncing off rock surface, white sandstone fragments on wet muddy tip.

DCP8 – Refusal on rock @ 1.0m, DCP bouncing off rock surface, wet muddy tip.

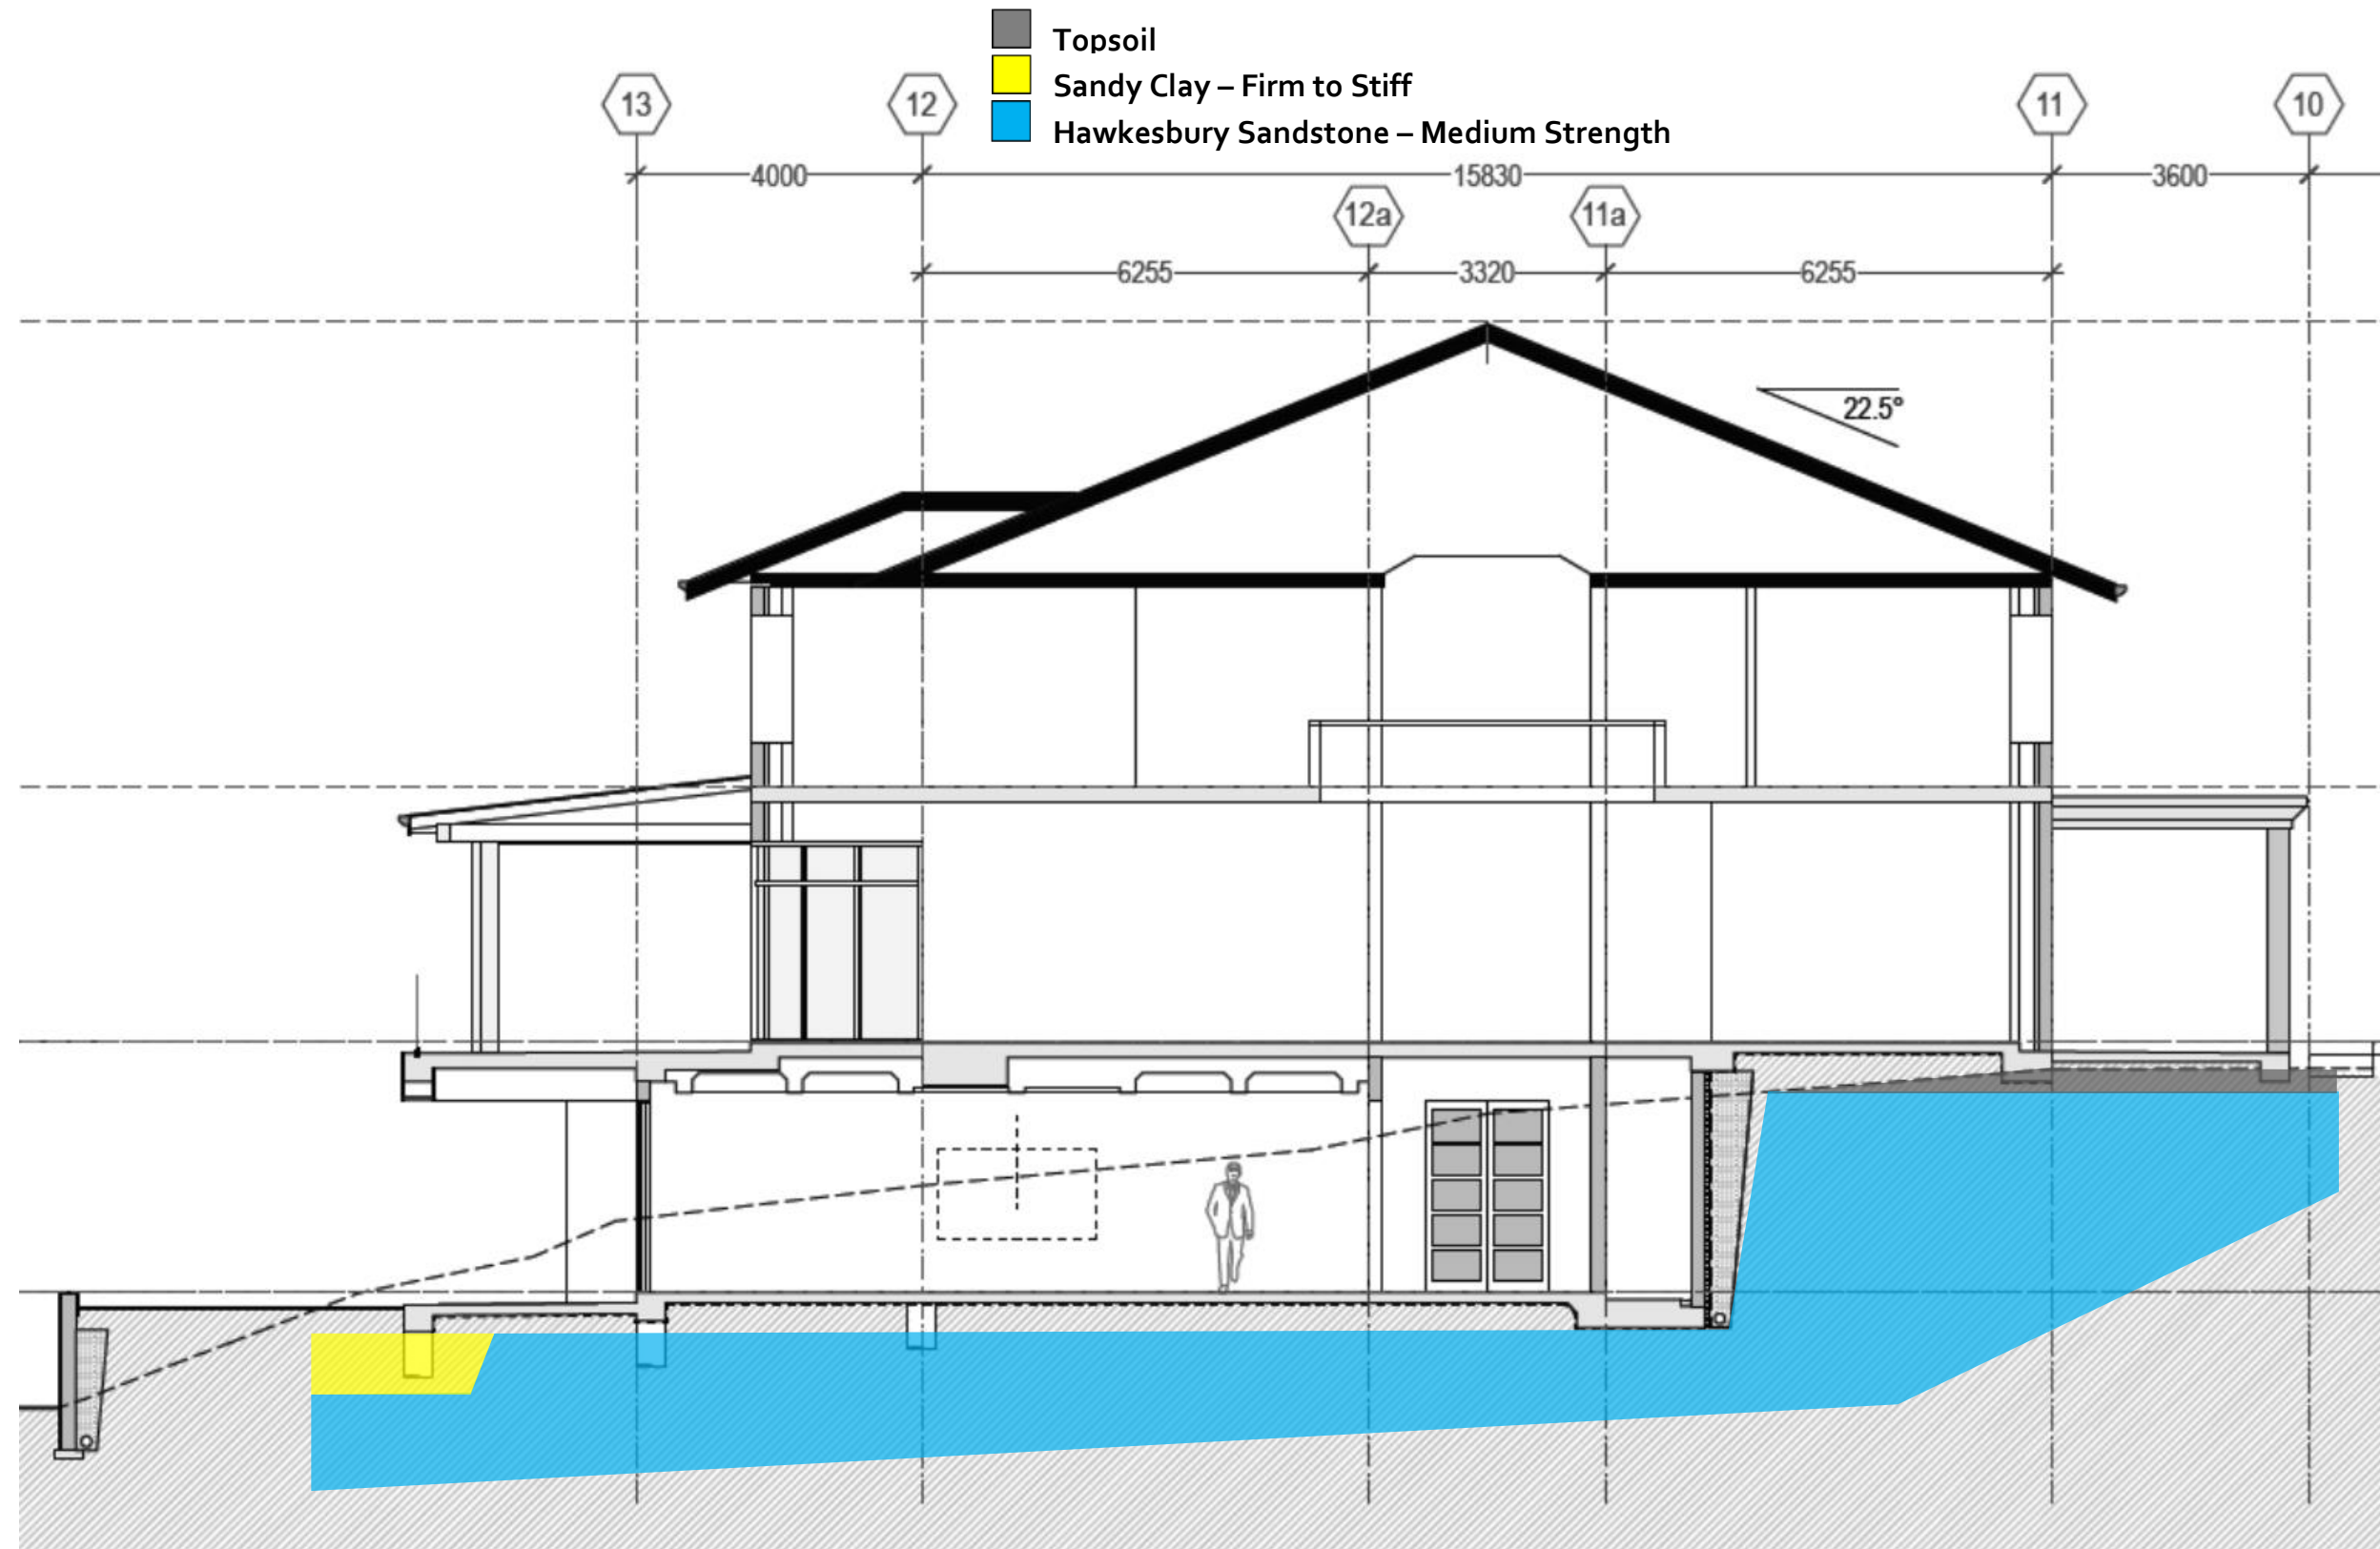
TYPE SECTION – Diagrammatic Interpretation of expected Ground Materials

The surface features of the block are controlled by the outcropping and underlying sandstone bedrock that steps down the property forming sub-horizontal benches between the steps. Where the grade is steeper, the steps are larger and the benches narrower. Where the slope eases, the opposite is true. The rock is overlain by sandy soils over sandy clays that fill the bench step formation. In the location of the testing where rock was not exposed, the depth to rock ranged between 0.2 to 1.1m below the current surface, being slightly deeper due to the stepped nature of the underlying bedrock. The sandstone outcropping on the property is estimated to be medium strength and similar strength rock is expected to underlie the entire site. See the Type Section attached for a diagrammatical representation of the expected ground materials.
