# Geotechnical Assessment

**Project:** New Dwelling  
70 Hilma Street, Collaroy Plateau NSW

**Ref:** AG 25087  
5 March 2025

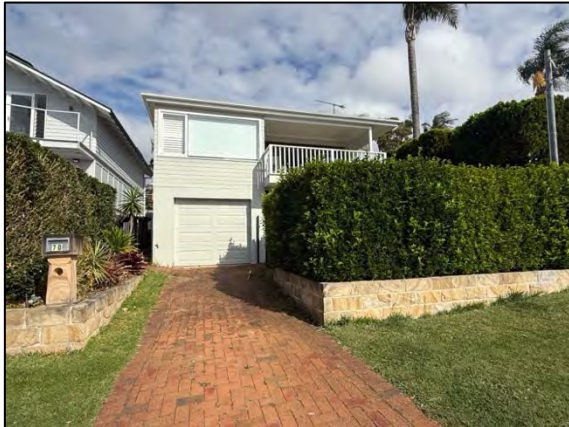
**Photo 1:** Residence frontage.

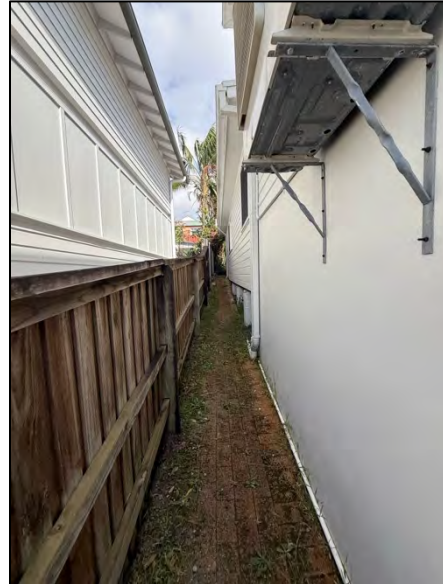
**Photo 2:** Southern side of residence.

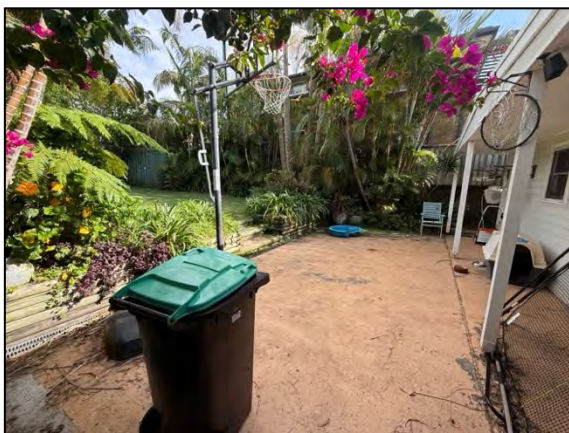
**Photo 3:** Rear of residence.

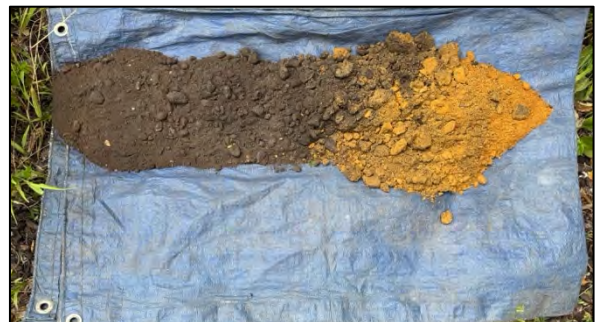
**Photo 4:** Excavated soil profile BH1
