## ARBORICULTURAL IMPACT ASSESSMENT REPORT

Prepared For: The Graham Family  
Site Address: 51 Quirk Street,  
DEE WHY, NSW, 2099

Inspection Dates: 17<sup>th</sup> May 2024  
Report Date: 21<sup>st</sup> May 2025

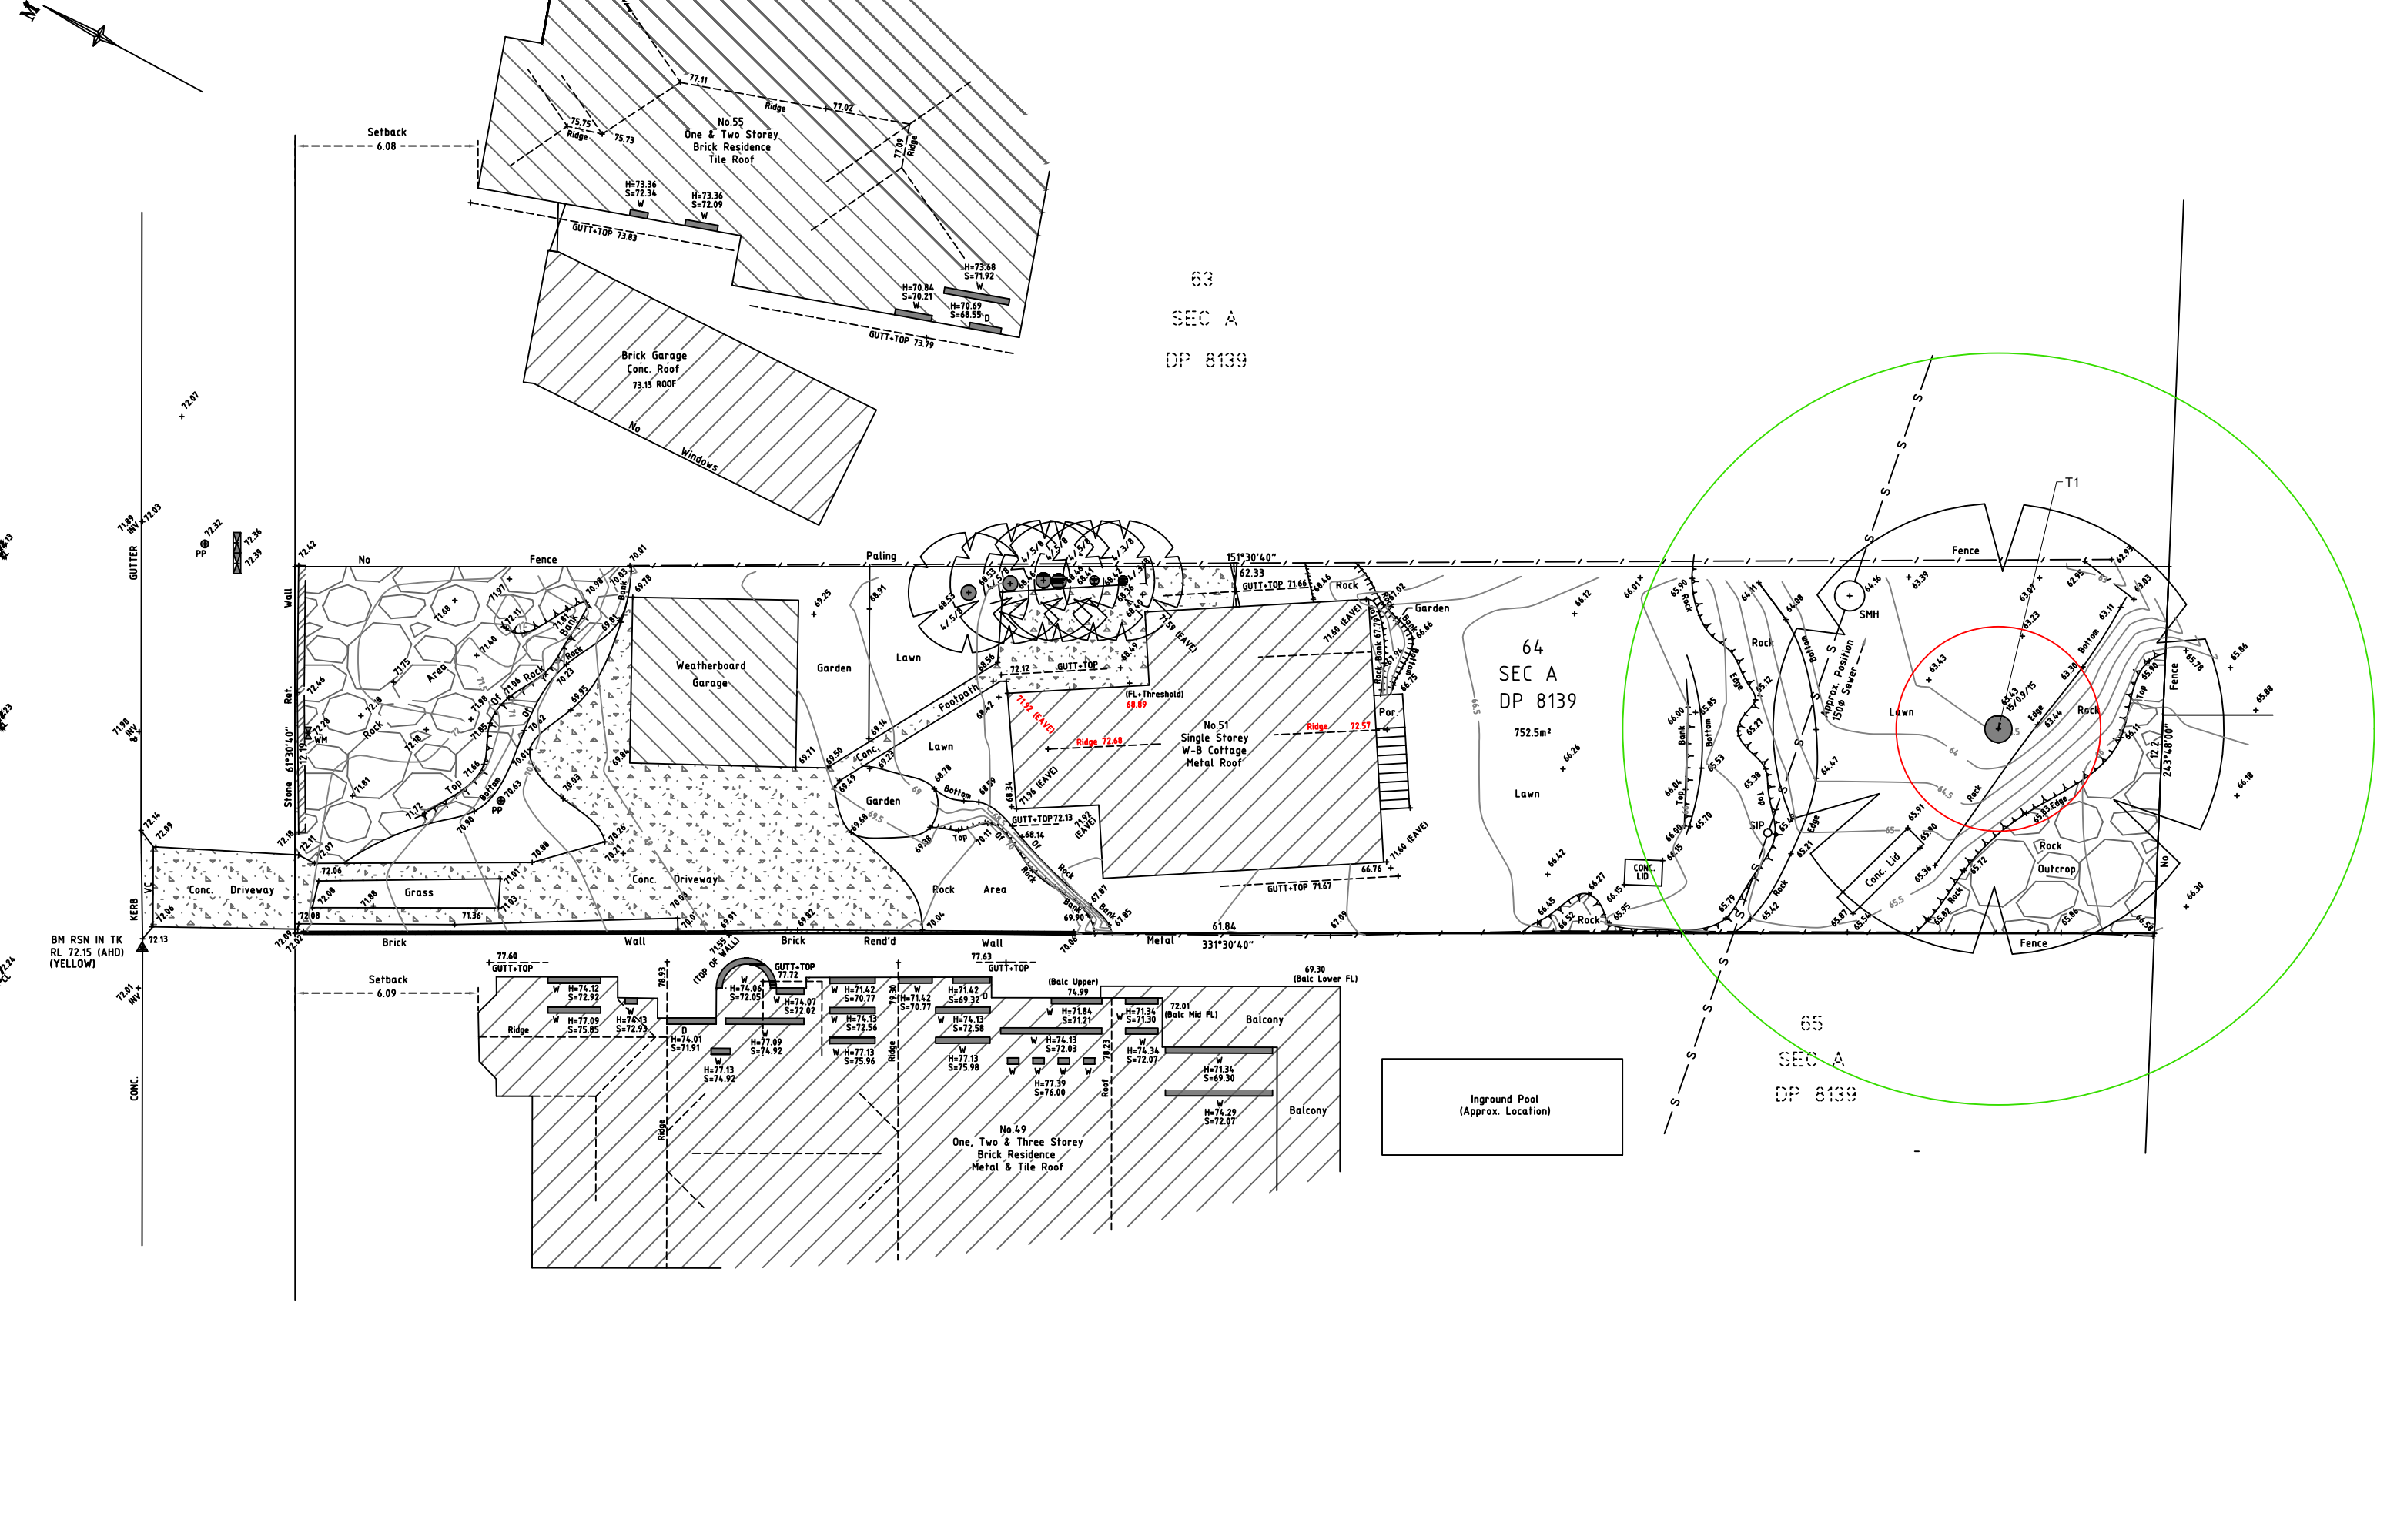
Title:  
Tree Identification

The tree had a DBH of 104cm representing a TPZ area of 12.5m radially from trunk centre. The DGL was 110cm representing an SRZ of 3.4m radially from trunk centre.

- 6.1.1 It is recommended that the tree (T1) be removed as part of the development application.

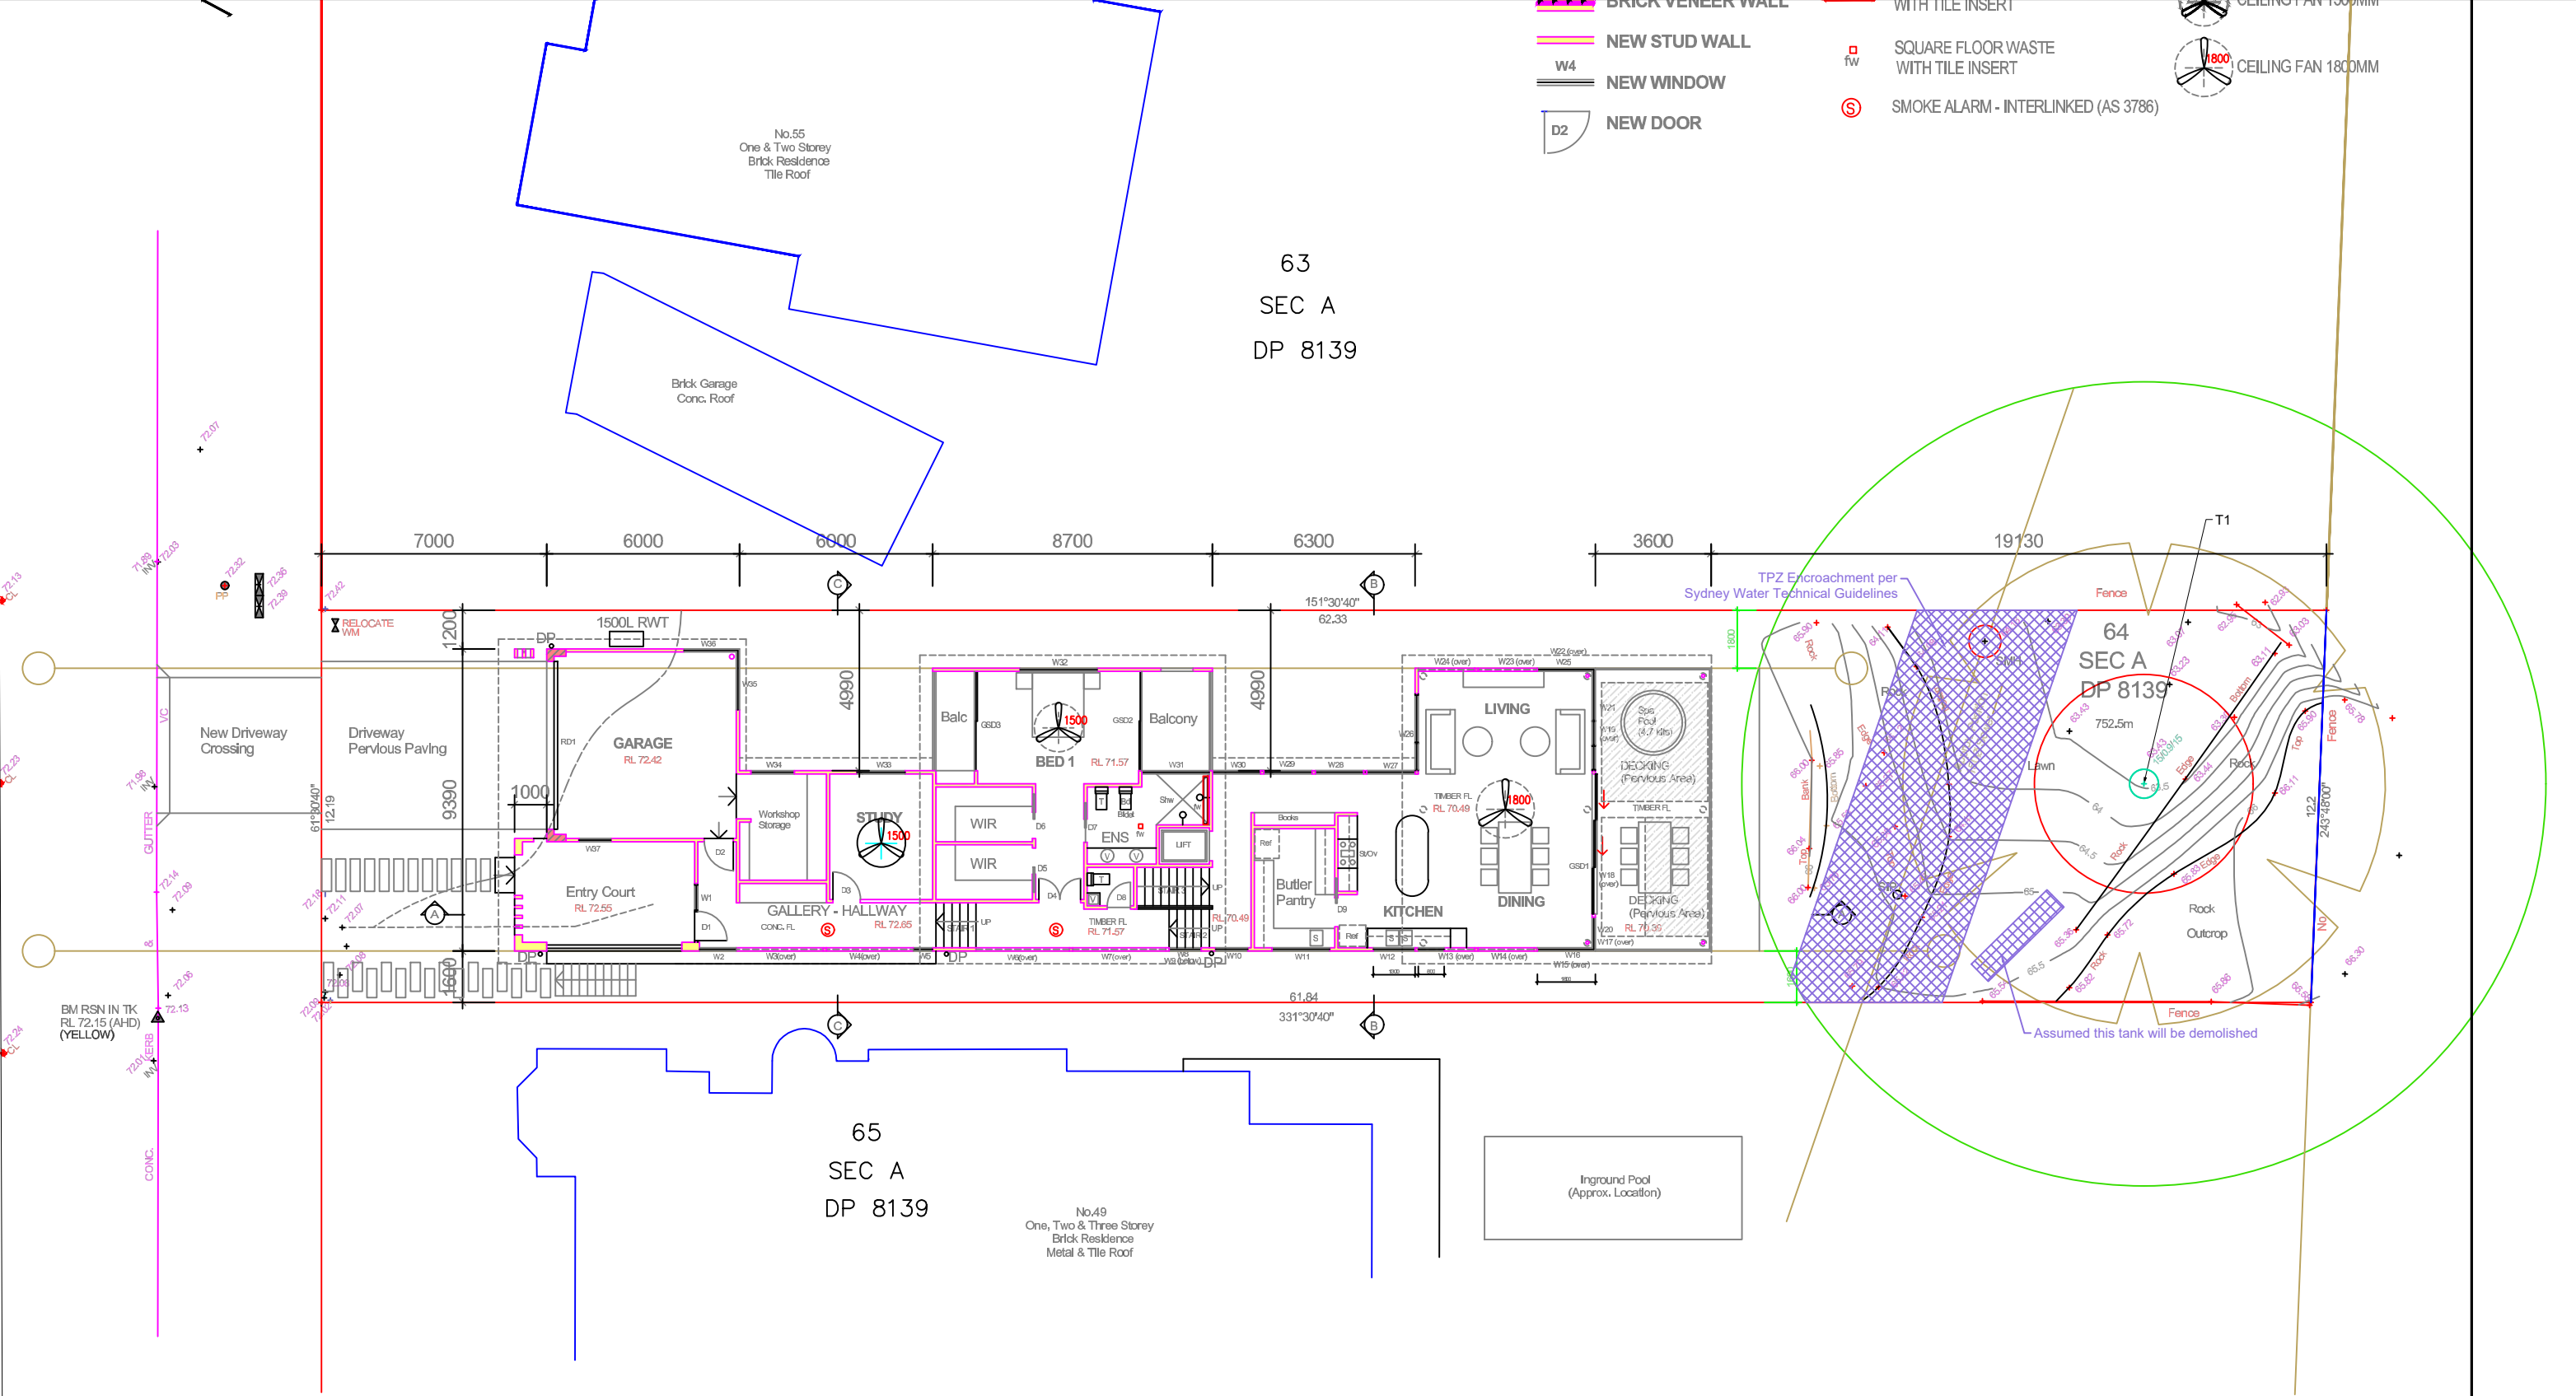
At the worst-case scenario, a 12.8% encroachment of the TPZ area would occur, marginally missing the SRZ area of the tree. This represents *major encroachment* per AS4970:2009.

Sewer remediation, regardless of its scale, is likely to cause *at least* a **moderate impact** to the tree. Tree stability could be weakened.

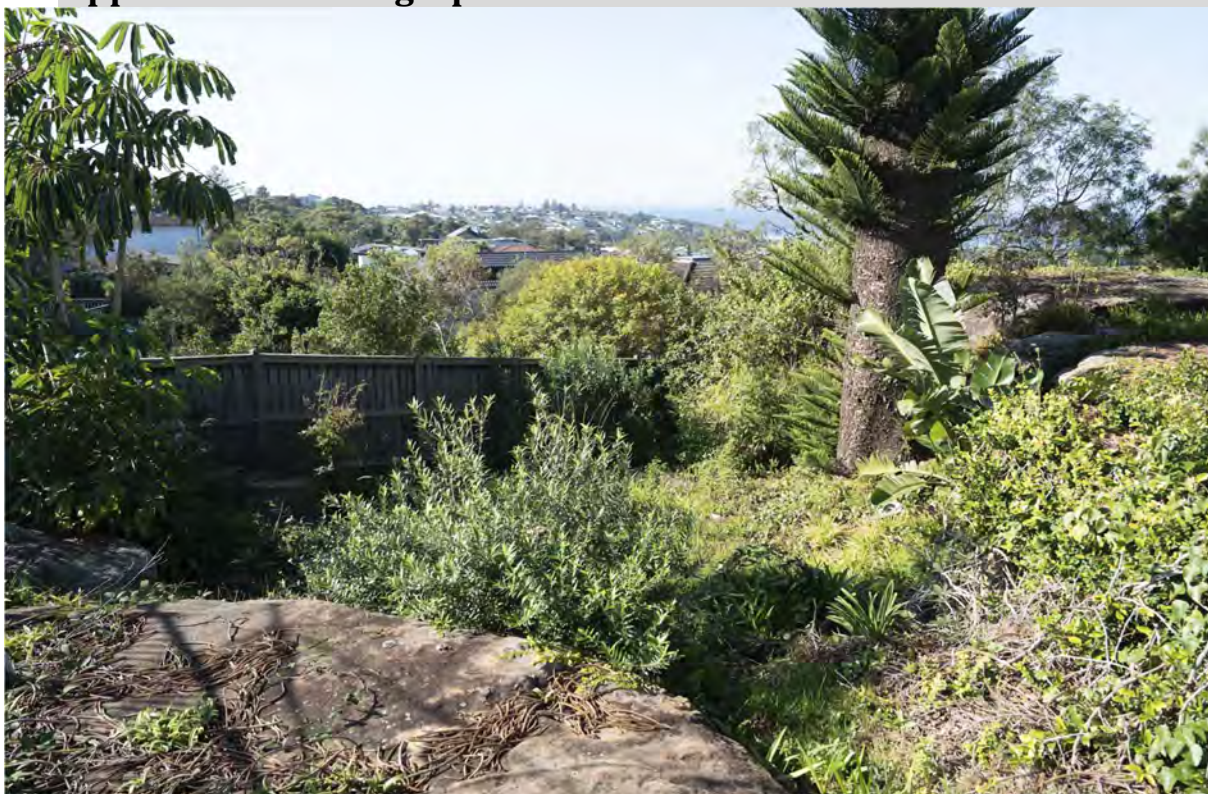
It was however noted that the exposed rock in the vicinity appeared naturally fractured. The tree additionally existed in a region with severely restricted soil volumes and likely relies on fissures for stability and the uptake of water and nutrients.

*Image 2: The tree with respect to an existing Sewer Access chamber and exposed rock.*

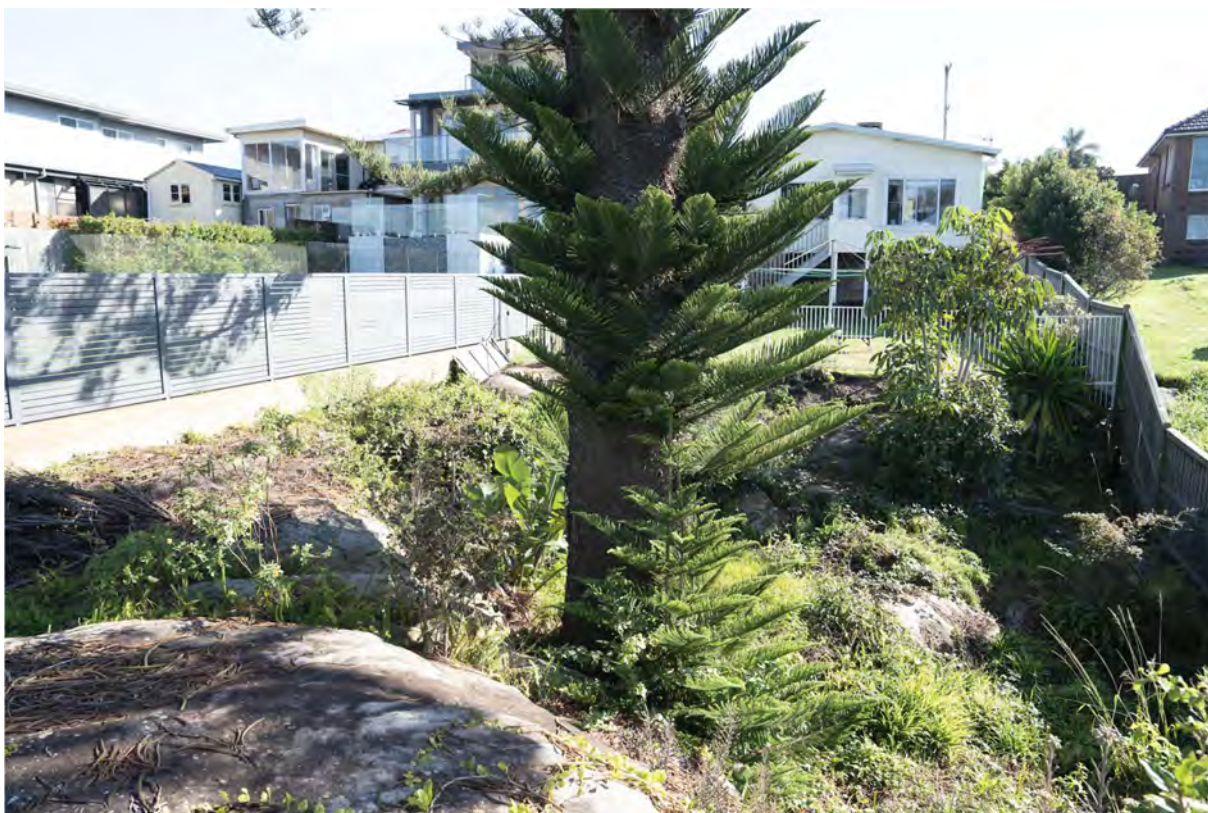
*Image 3: The tree with respect to the existing property. Note extensive rock about the base of the tree resulting in an assessment of reduced soil availability.*

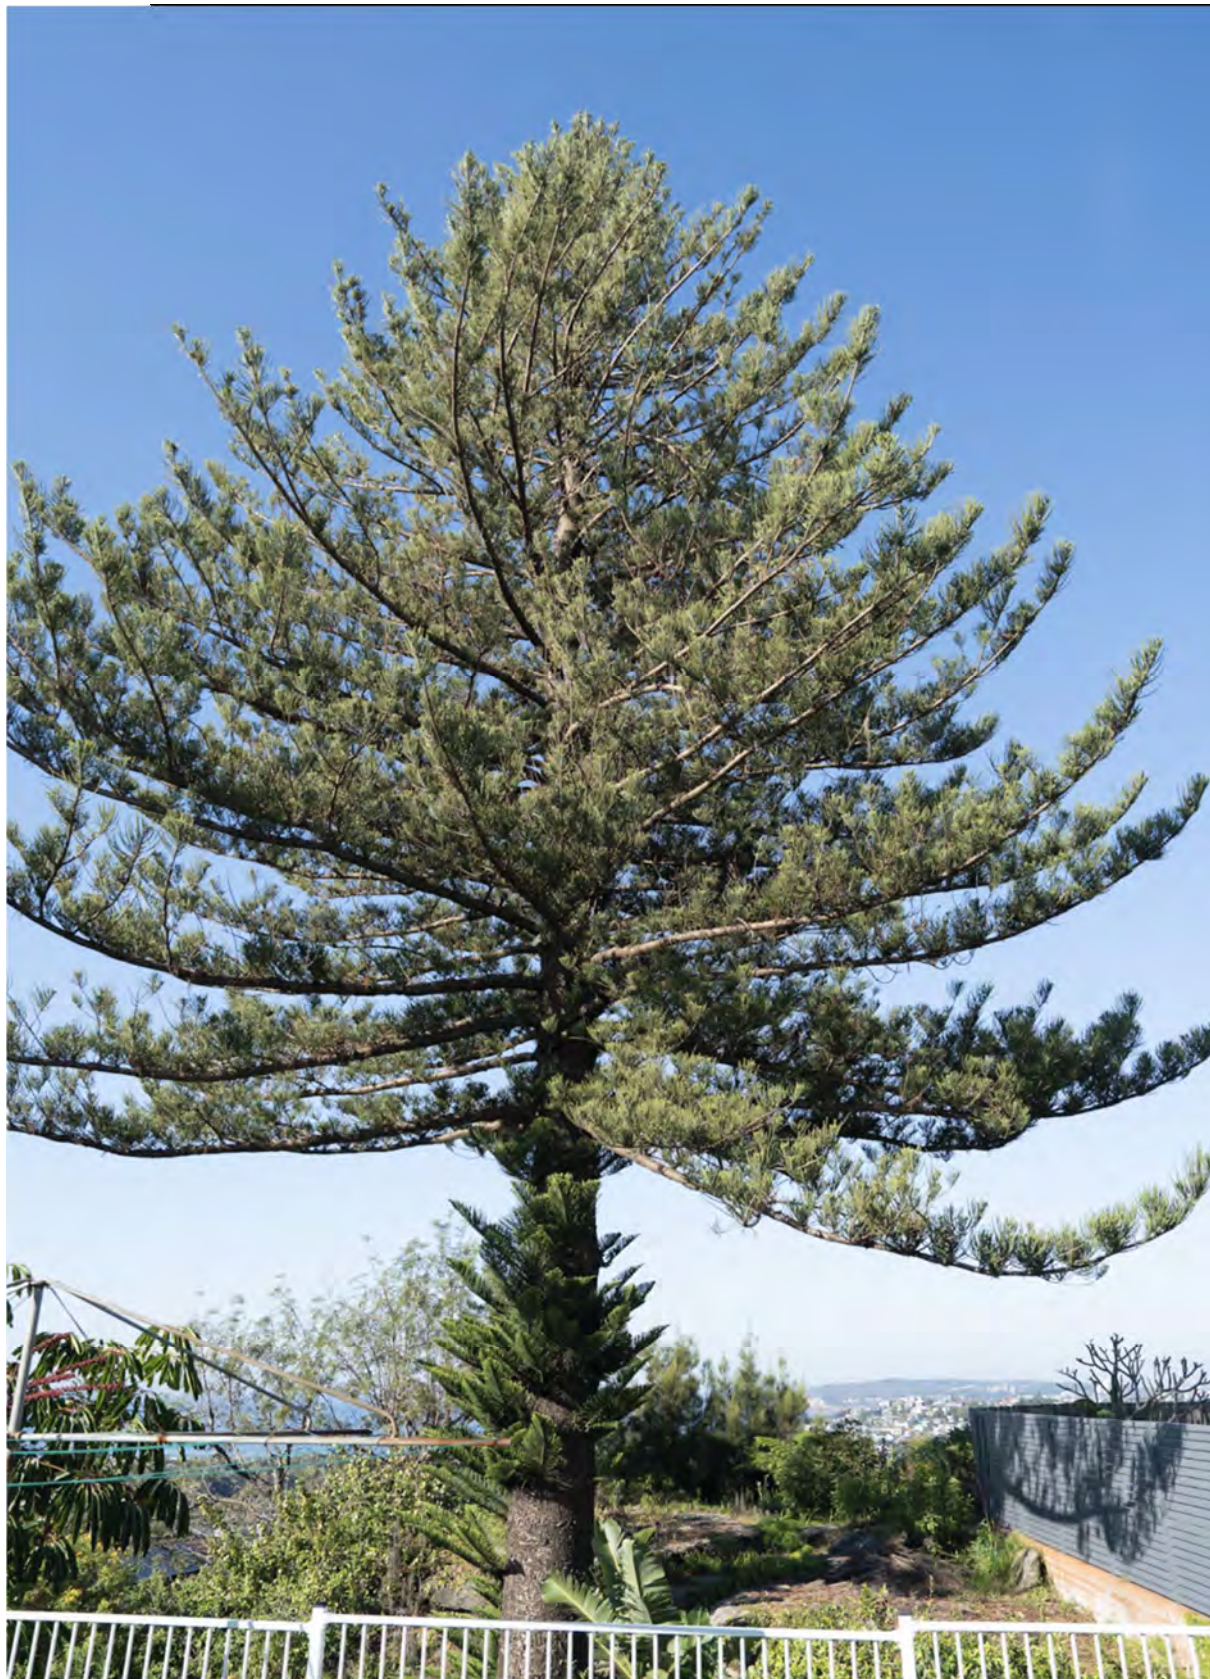
- 3.4.2 The tree had been previously pruned of its lower limbs giving a raised appearance. Pruning appeared mostly consistent with AS4373:2007 – *Pruning of amenity trees*.

Epicormic growth was noted about the lower trunk at previous pruning sites. This is considered somewhat *abnormal* for the species which typically would not exhibit such reactionary behaviours.

*Image 4: Past pruning has resulted in the tree having a raised crown form. Epicormic coppice noted about the tree is not typically found on this species.*
