Report Title: Geotechnical Report 123 Bynya Road, Palm Beach  
Report Date: 9/6/22

## **GEOTECHNICAL INVESTIGATION:**

Alterations and Additions and New Garage at **123 Bynya Road, Palm Beach**

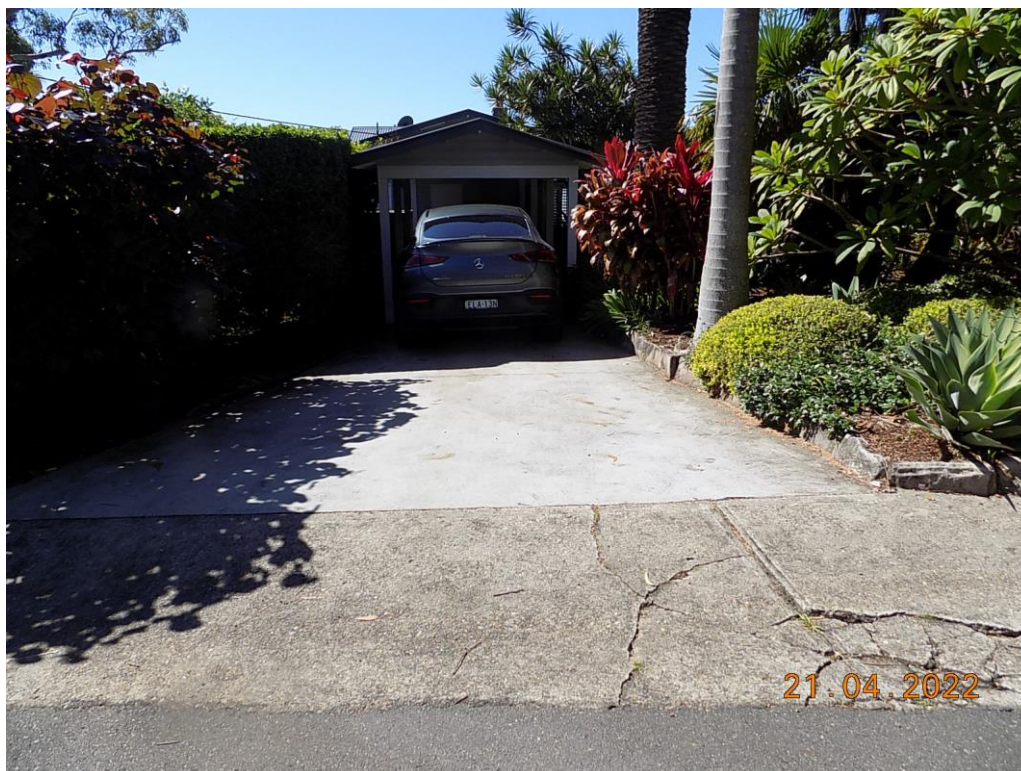
Photo 1

- 2.1** The site was inspected on the 21<sup>st</sup> April, 2022.
- 2.2** This residential property has dual access. It is on the downhill side of Bynya Road and on the uphill side of Pacific Road. The property has a NE aspect. It is located on the gentle to moderately graded upper middle reaches of a hillslope. The slope falls across the site at an average angle of ~8°. The slope above the property continues at similar angles. The grade below the property gradually increases.
- 2.3** At the road frontage to Bynya Road, a concrete driveway runs to a stable carport attached to the uphill side of the house (Photo 1). Between this road frontage and the house is a gently sloping garden area (Photo 2). The part two-storey brick and

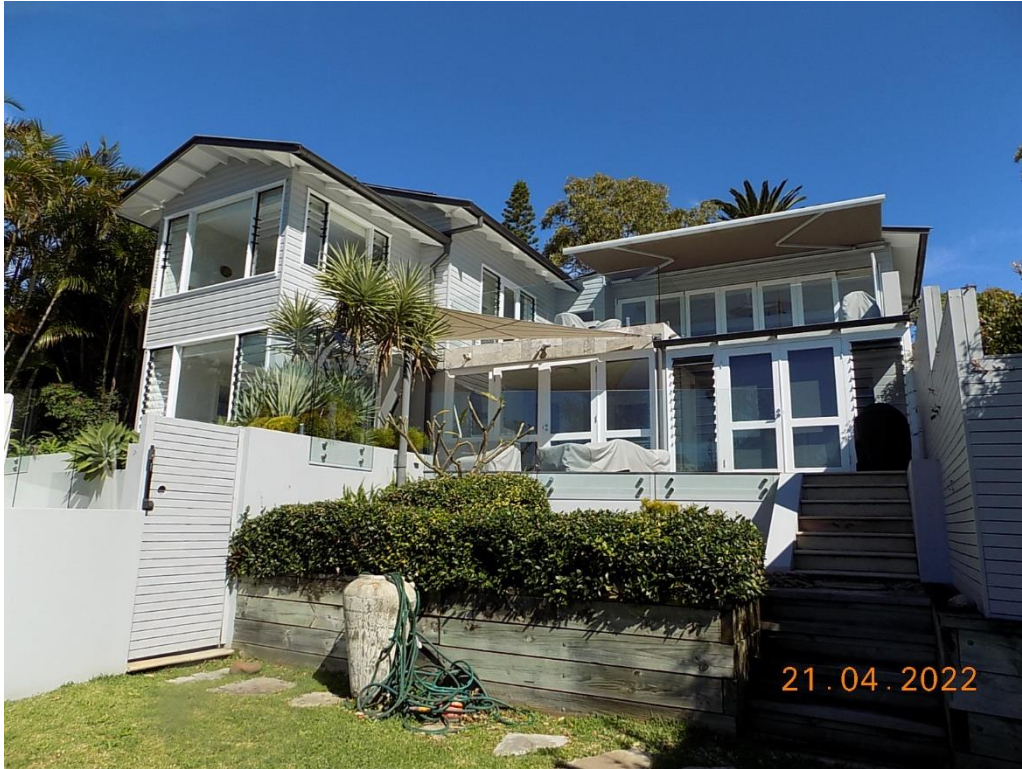
Photo 3

timber framed and clad house is supported on brick walls (Photo 3). No significant signs of movement were observed in the external supporting walls. A pool has been cut into the slope below the house (Photo 4). The cut for the pool area is supported by stable rendered masonry retaining walls (Photo 5). The water level of the pool indicates no ground movement has occurred in the shell of the pool since its construction. A gently sloping lawn falls beside the pool to a parking area in the N corner of the property (Photo 6). Competent Medium Strength Sandstone outcrops through the downhill side of this lawn area. The parking area is accessed from Pacific Road and will be demolished as part of the proposed works (Photo 7).

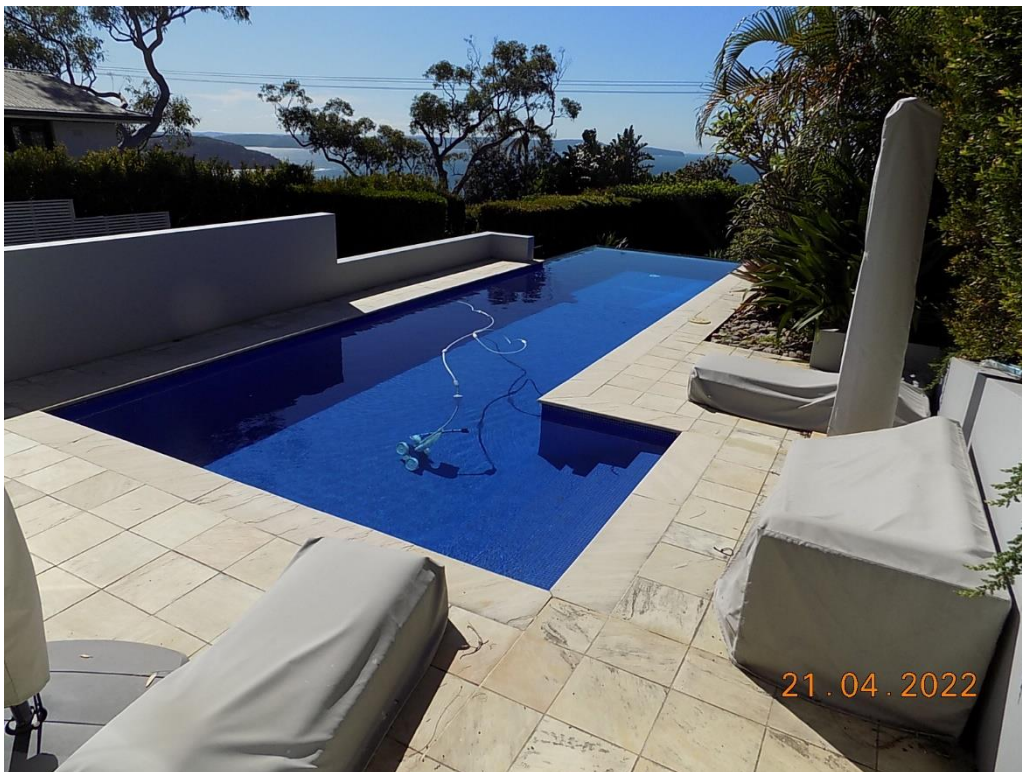
Photo 4

| HAZARDS | Hazard Three | Hazard Four |
|---|---|---|
| TYPE | The proposed excavation undercutting the footings of the pool causing failure. | The proposed fill failing and impacting on the subject property before the retaining walls are in place. |
| COMMENTS | This level of risk to life and property is 'UNACCEPTABLE'. To move risk to 'ACCEPTABLE' levels, the recommendations in <b>Section 13</b> are to be followed. | This level of risk to life and property is 'UNACCEPTABLE'. To move risk to 'ACCEPTABLE' levels, the recommendations in <b>Section 14</b> are to be followed. |

Given the depth to rock, we think it likely the pool is supported on rock. However, this is to be confirmed with building records or with exploration pits put down by the builder along the downhill edge of the pool to determine the foundation material. These are to be inspected by the geotechnical consultant.

If the foundations are determined to be supported on competent rock or below the base of the proposed excavation, the excavation may commence. If they are not on rock, the pool will need to be underpinned prior to the excavation commencing.

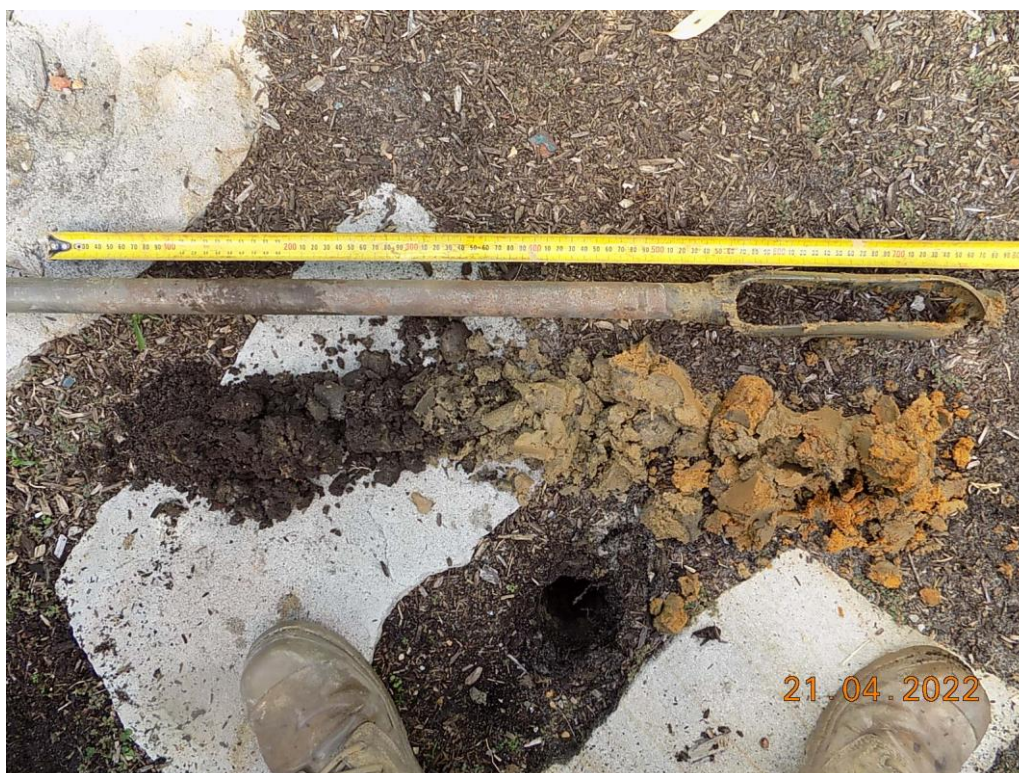
## AUGER HOLE 1 (~RL97.4) – AH1 (Photo 8)

| Depth (m) | Material Encountered |
|---|---|
| 0.0 to 0.3 | <b>FILL</b> , disturbed sandy soil, dark brown, very loose, dry, fine to coarse grained with fine trace organic matter and rock fragments. |
| 0.3 to 0.5 | <b>SAND</b> , brown, medium dense, wet, coarse grained. |
| 0.5 to 0.8 | <b>SANDY CLAY</b> , derived from weathered sandstone, orange and mottled brown, firm to very stiff, wet, fine to coarse grained with a sugary texture. |

End of test @ 0.8m in sandy clay. No water table encountered.

Photo 8: AH1 – Downhole is from left to right.
